REPORT OF PHASE I ENVIRONMENTAL SITE ASSESSMENT

**FORMER GALLMAN SCHOOL
NEWBERRY, SOUTH CAROLINA**

JANUARY 4, 2024

**GALLMAN SCHOOL
BUILDING CONDITION ASSESSMENT**

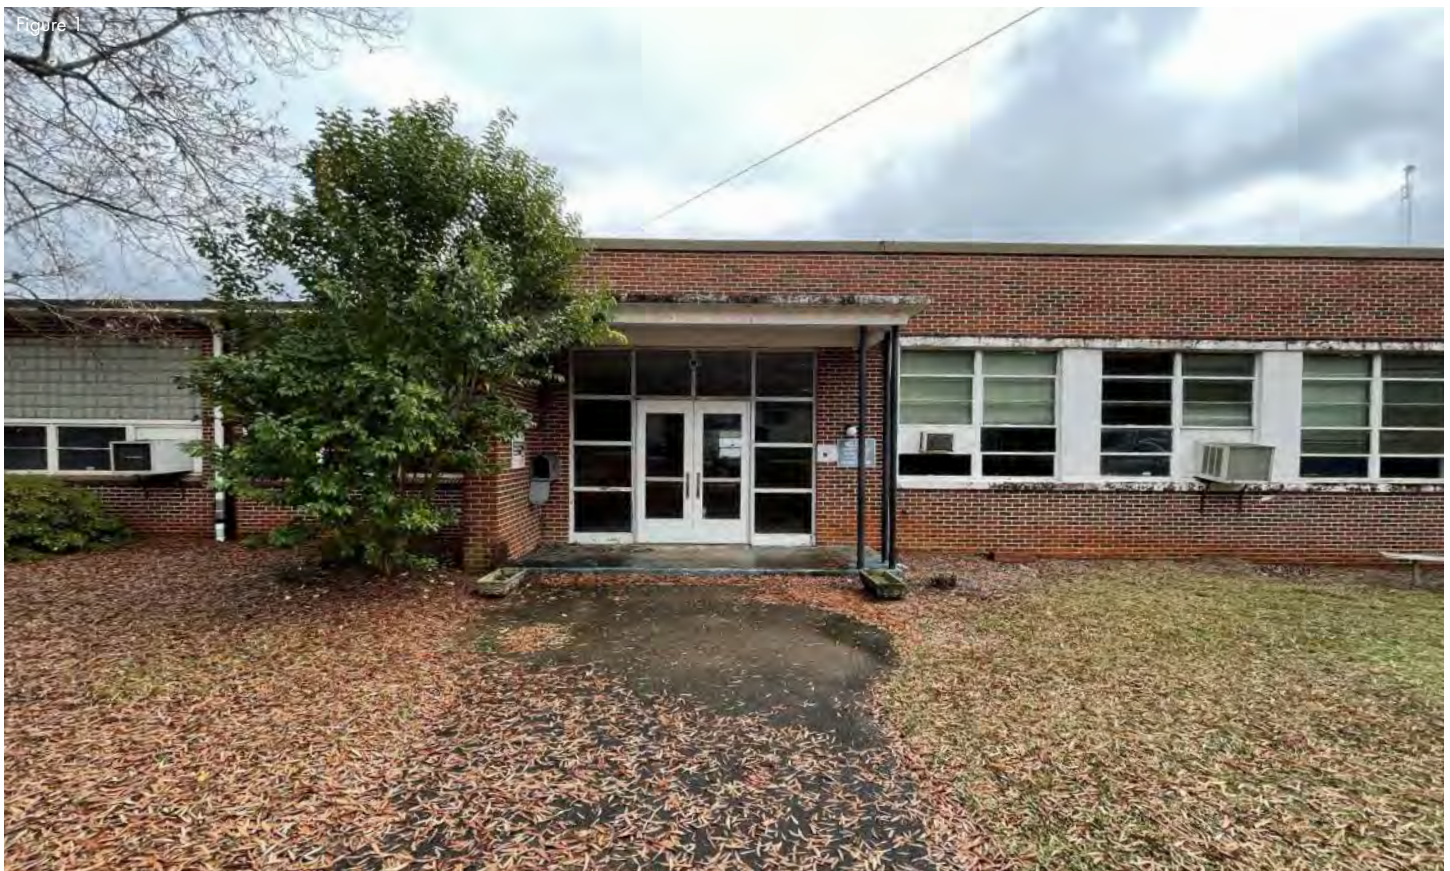
Exterior siding condition- Typical

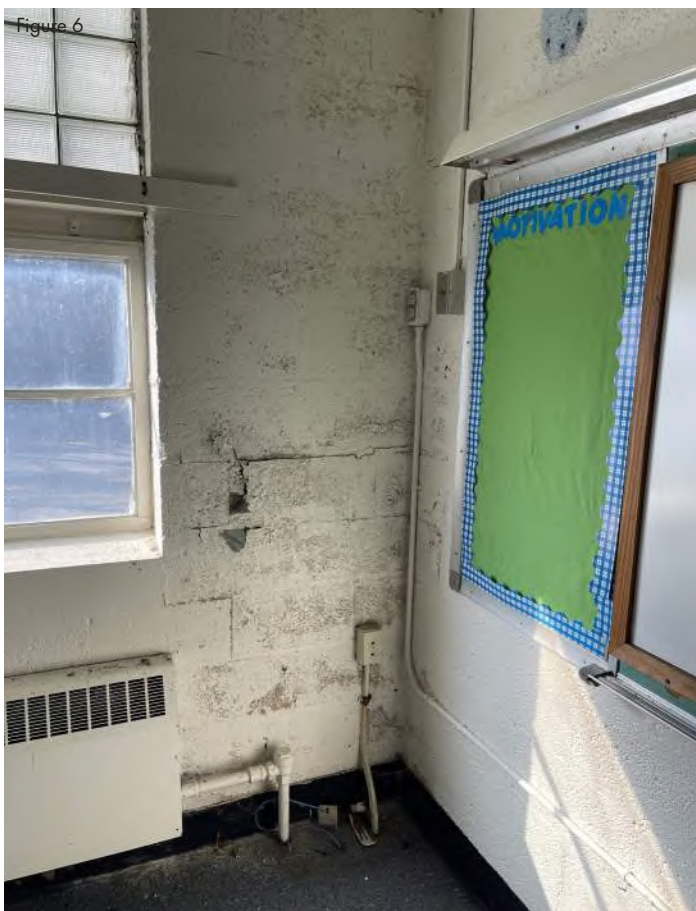
Evidence of moisture infiltration at exterior walls

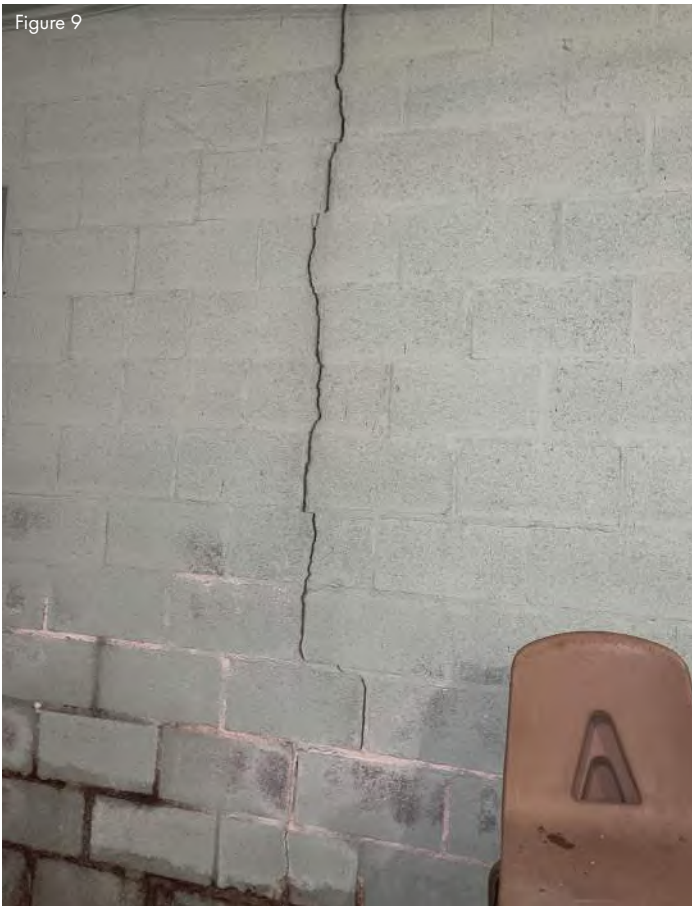
Figure 10

Crack in cmu in gym

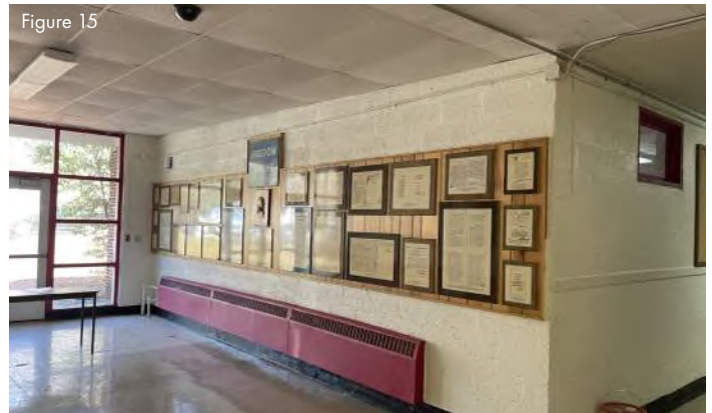
ACP ceiling in fair condition - notice bending of the panel edges

areas of the school as well. The painted concrete ceilings with exposed concrete joists and deck are in good condition where there has been no moisture infiltration. These areas could remain as is for future use unless there is a specific need for acoustical treatments. This could be achieved by using wall panels as well. The 2x2, and 2x4 ceiling panels would not have been original to the building. Most locations are in fair condition with noticeable bending of the panel edges (Figures 15-18) It is recommended that all dropped ACP ceilings be removed. The 12x12 ACT are more than likely original. Although many of these period tiles are associated with asbestos, the S&ME report tested negative for the samples gathered. There are many areas of ACT that are damaged and should be replaced. (Figures 19-22)

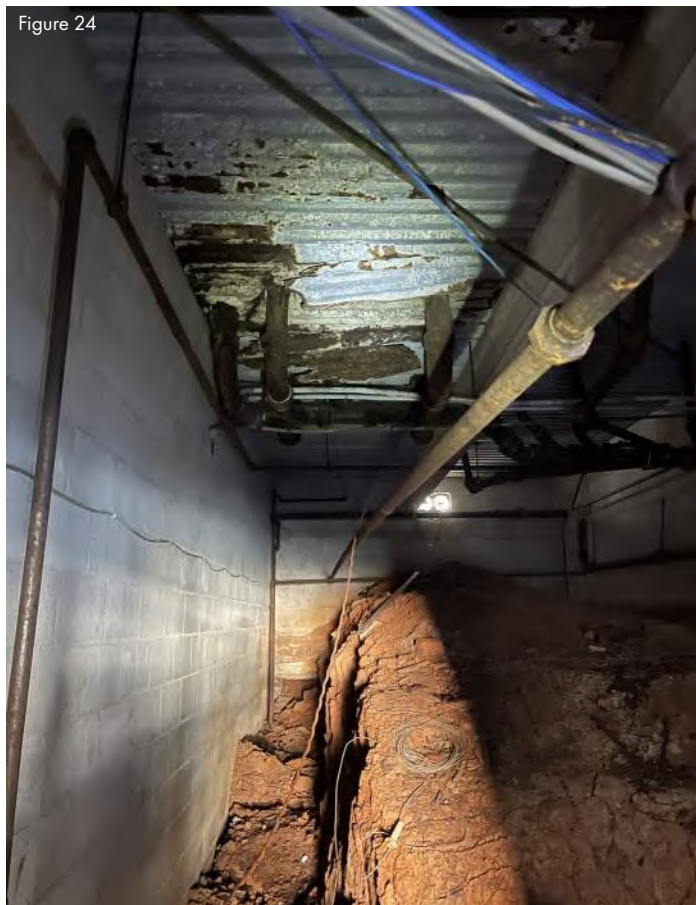
Figure 25

Damaged floor system from below

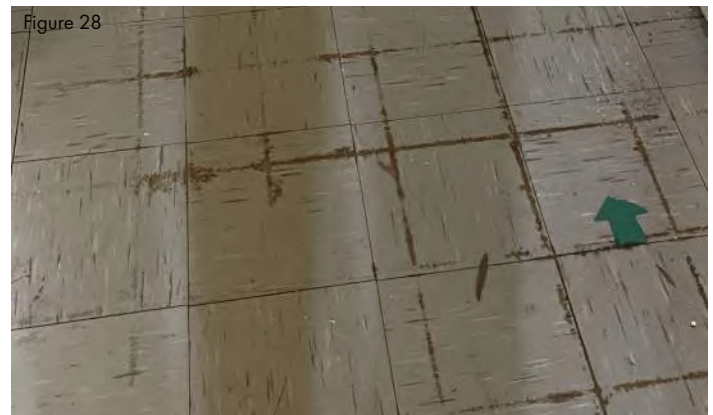
Figure 28
12x12 VCT over 9x9 asbestos tile in corridor

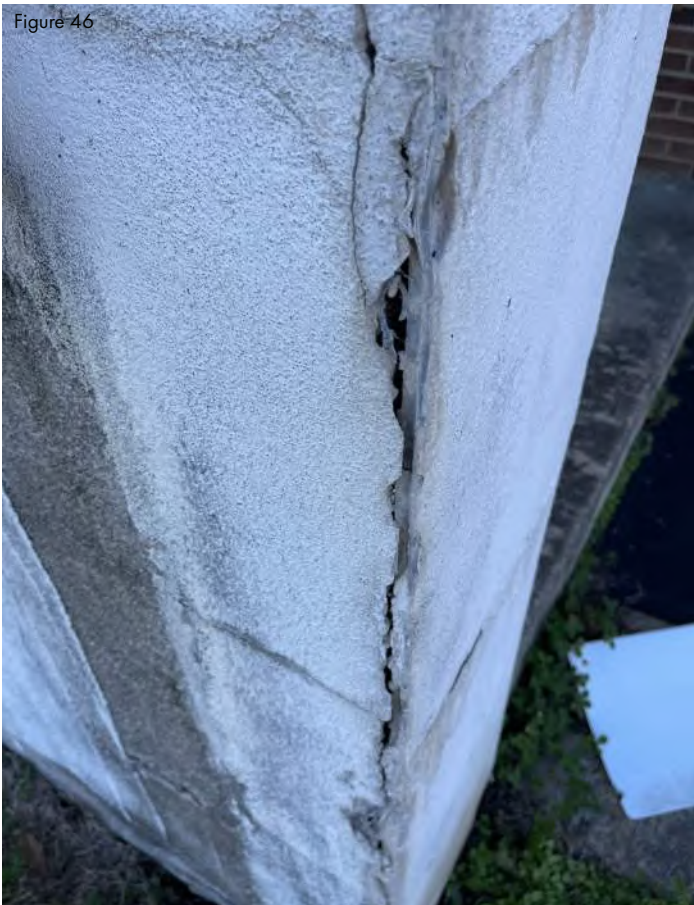
Rusting metal components and spalled stucco

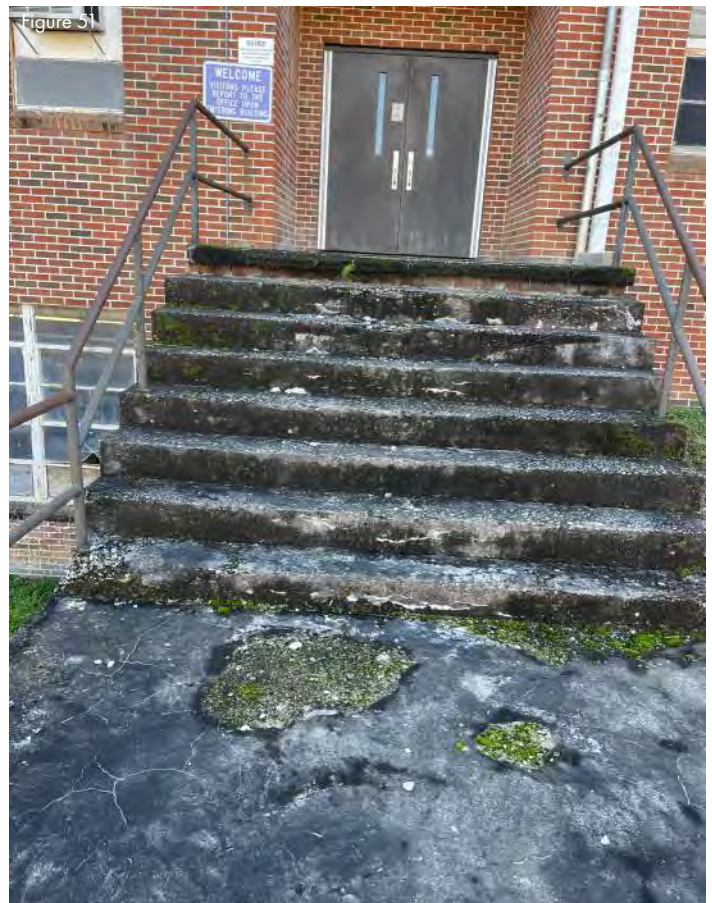
Gym side entrance - notice spalled concrete

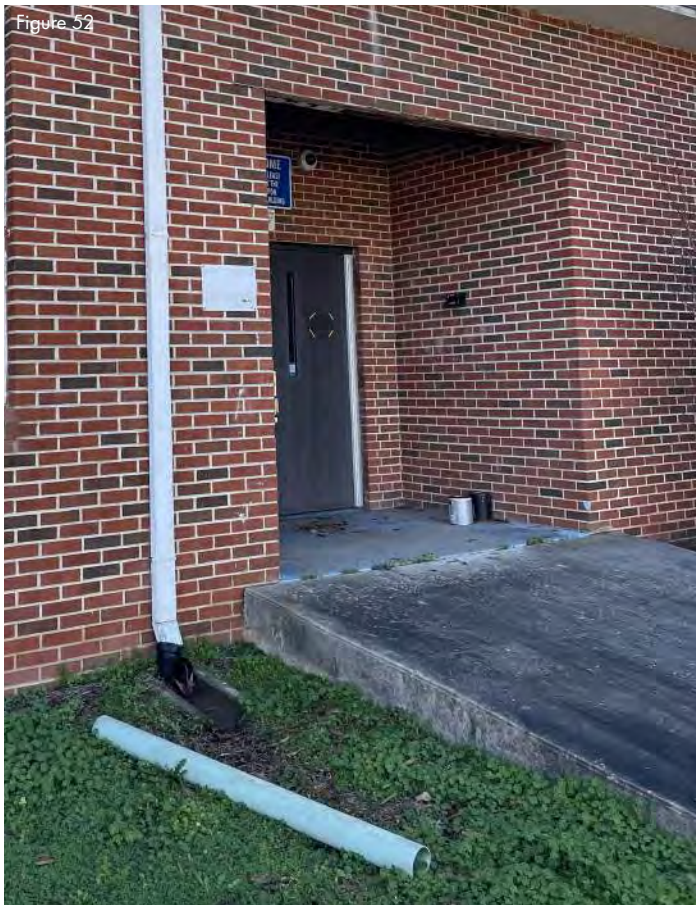
Ramp with approximate 12" rise - anything greater than 6" should have railing

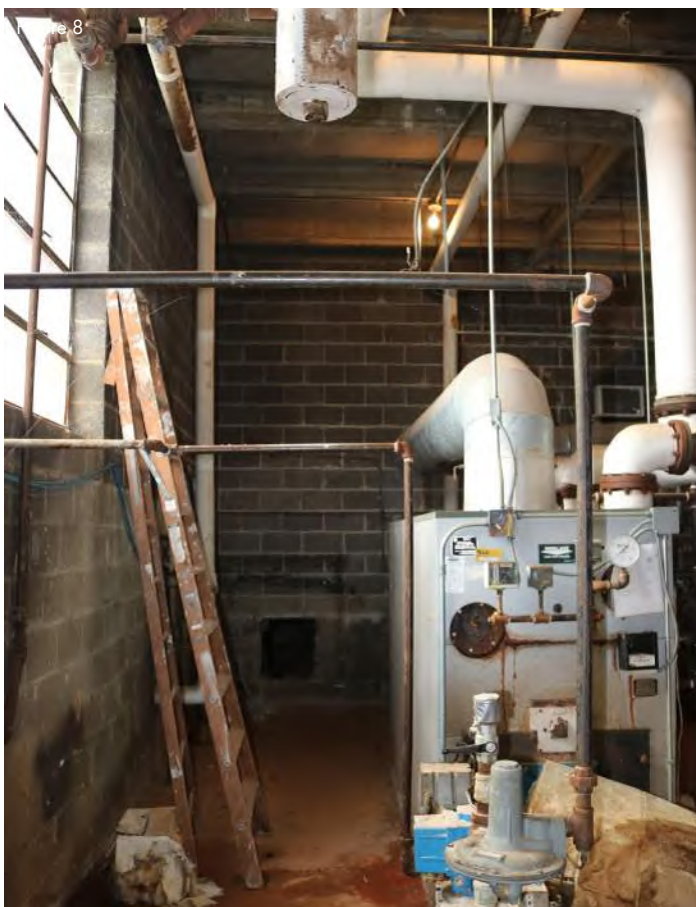
Boiler in Fair condition. Could not verify age or operation but equipment has exceeded its normal service life.

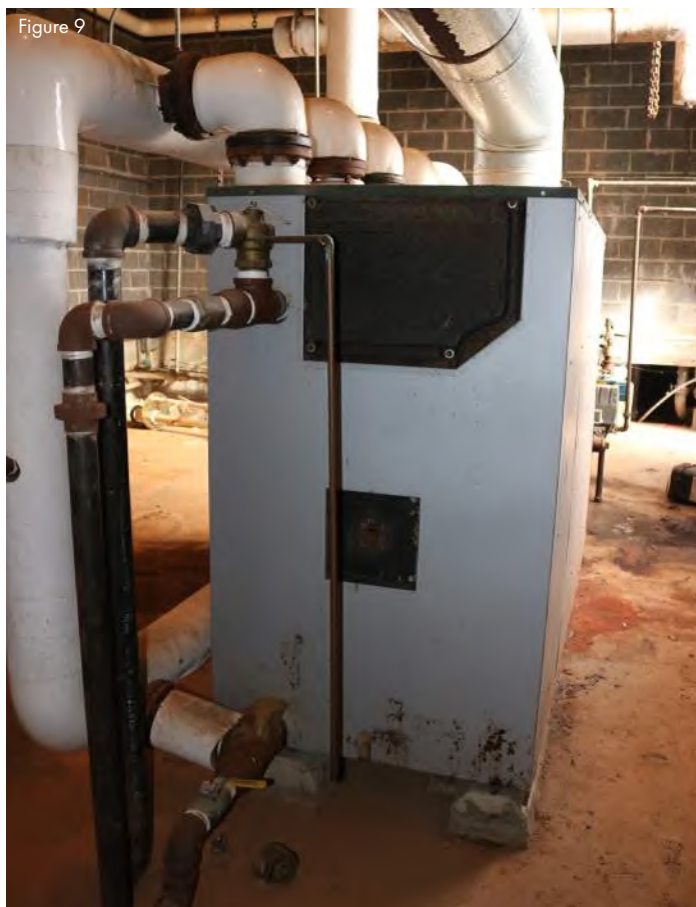
Back side of boiler. Cabinet is rusting.

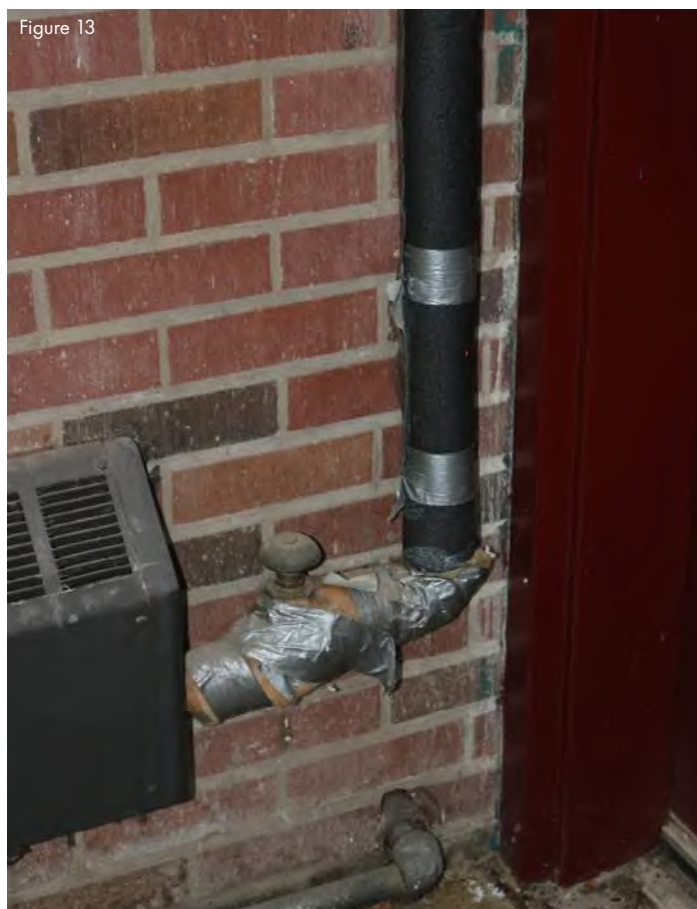
The radiator at bottom of classroom stairwell needs to have pipe insulation replaced.

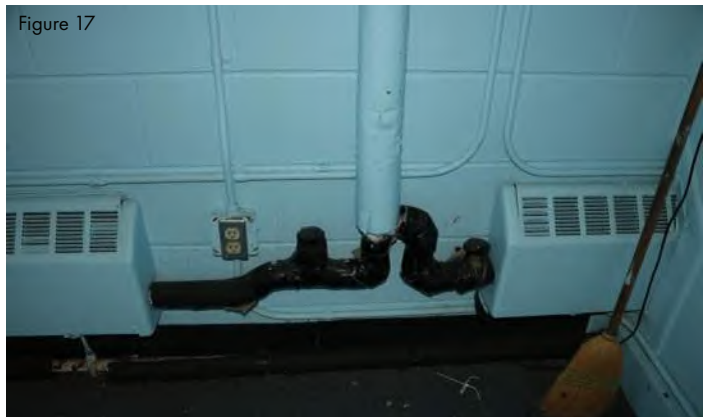
Figure 18

Lower-level classroom stairwell needs to have pipe insulation replaced.

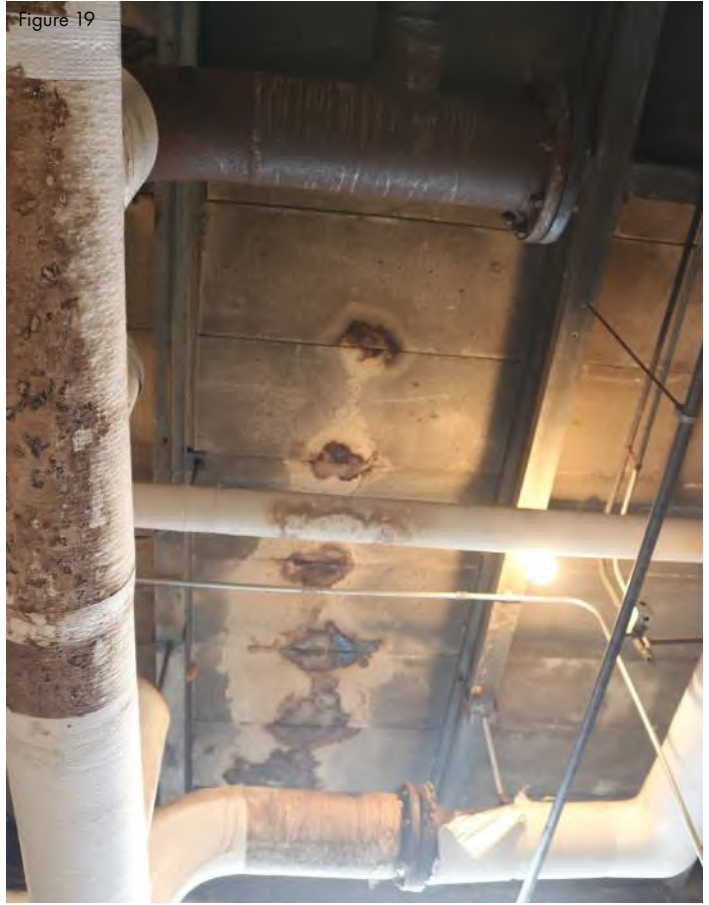
Figure 21

Roof leaks damaging pipe insulation. Insulation needs to be replaced.

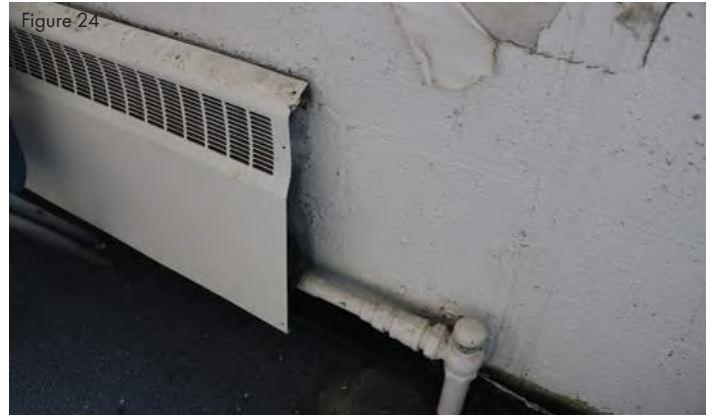
Figure 25

Classroom radiator cabinet missing end caps.

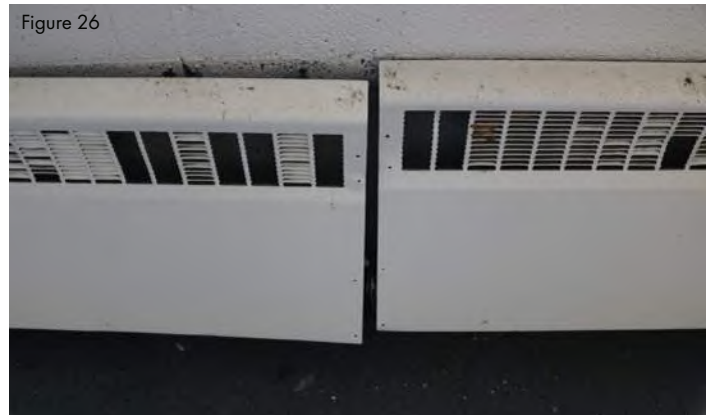
Figure 27

Classroom radiator cabinet damage.

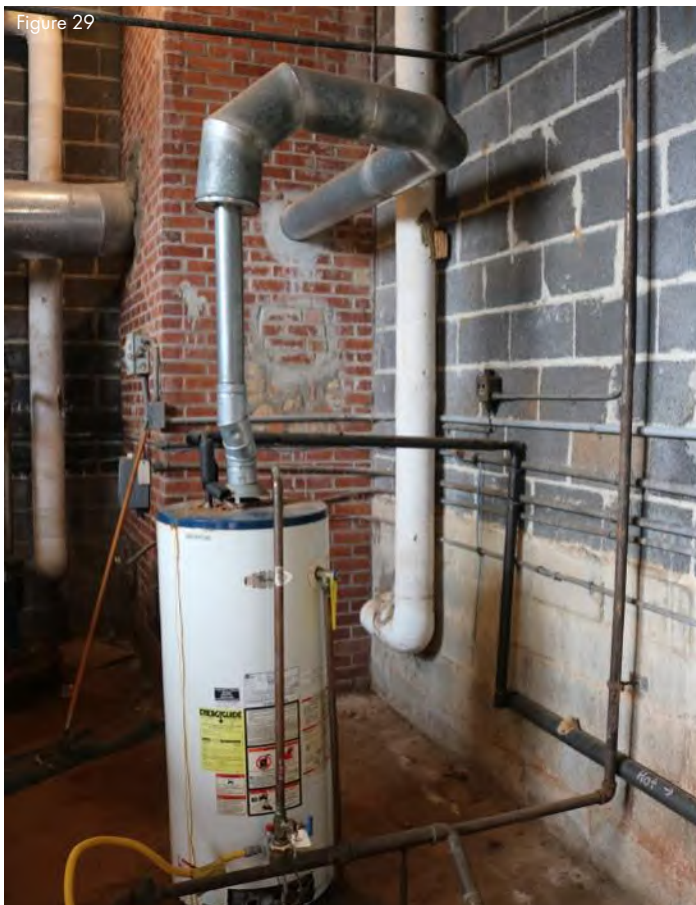
Figure 29
Chimney should be inspected if it is to be reused in the future for boiler and water heater flues.

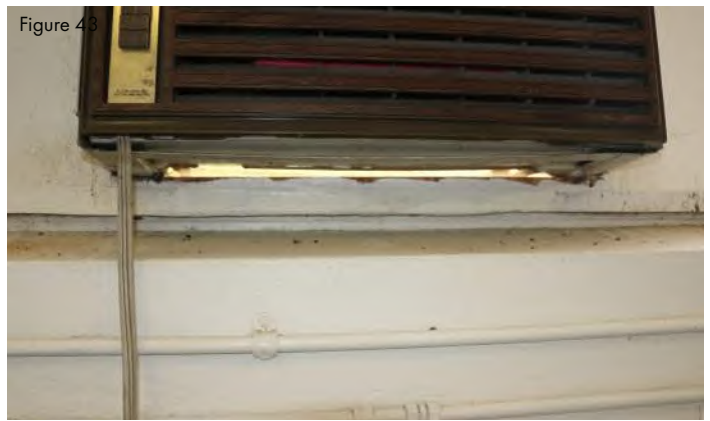
Figure 44

Window air conditioned not properly installed.

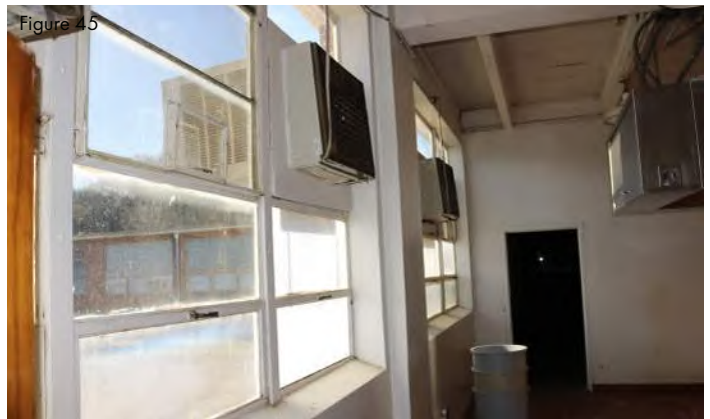
Figure 46

Kitchen air conditioned with multiple window mounted units. Could not verify age or operation but equipment has exceeded their normal service life.

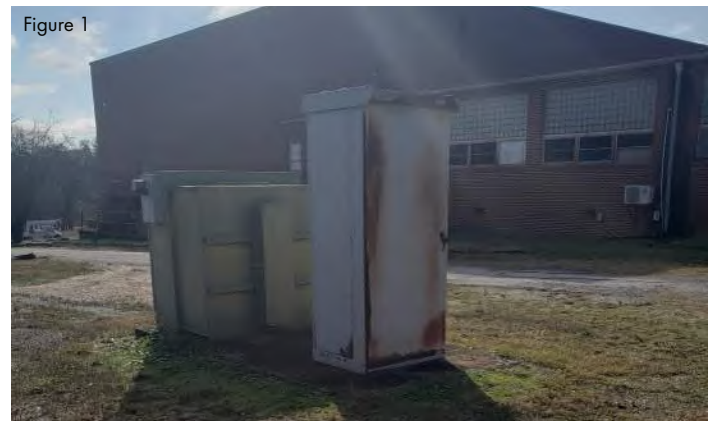
Transformer and Distribution panel are rusting and showing signs of age.

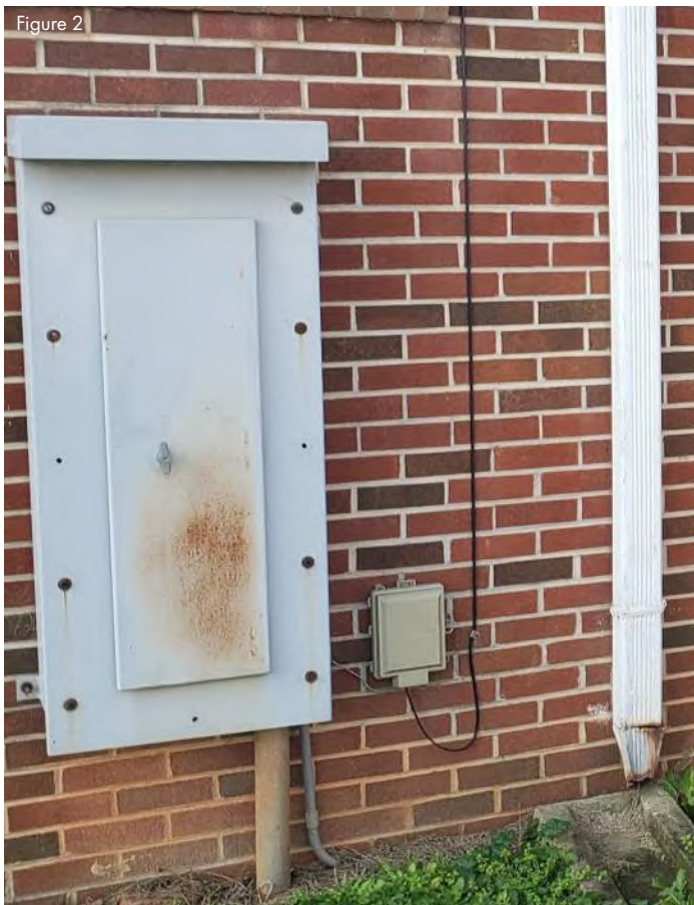
South wing exterior surface mounted panel is rusting.

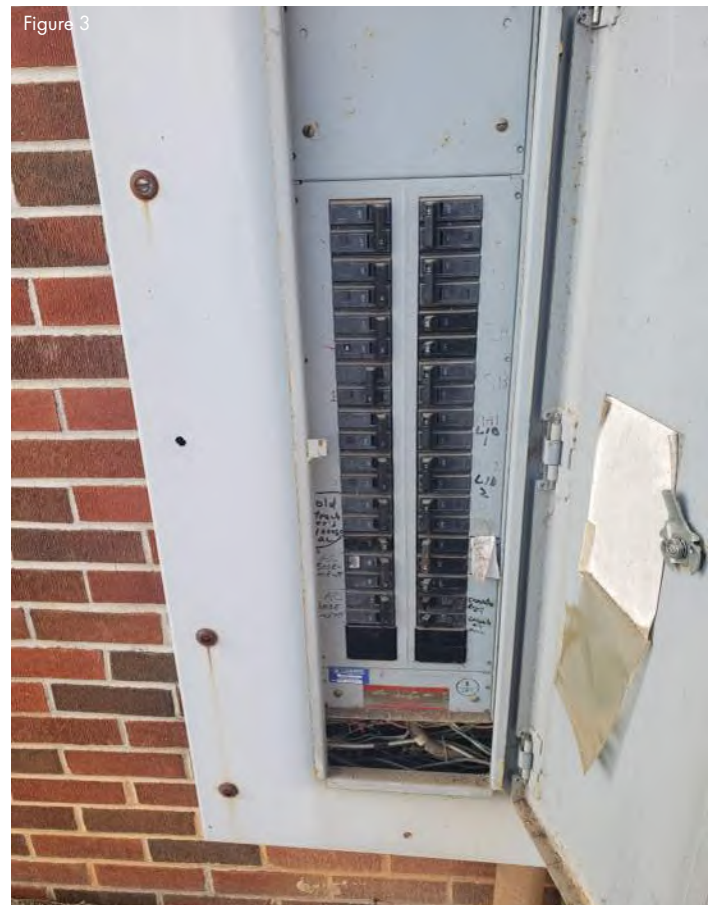
Figure 4

Interior south wing of electrical panel missing escutcheon and has dirt, cobwebs and debris inside.

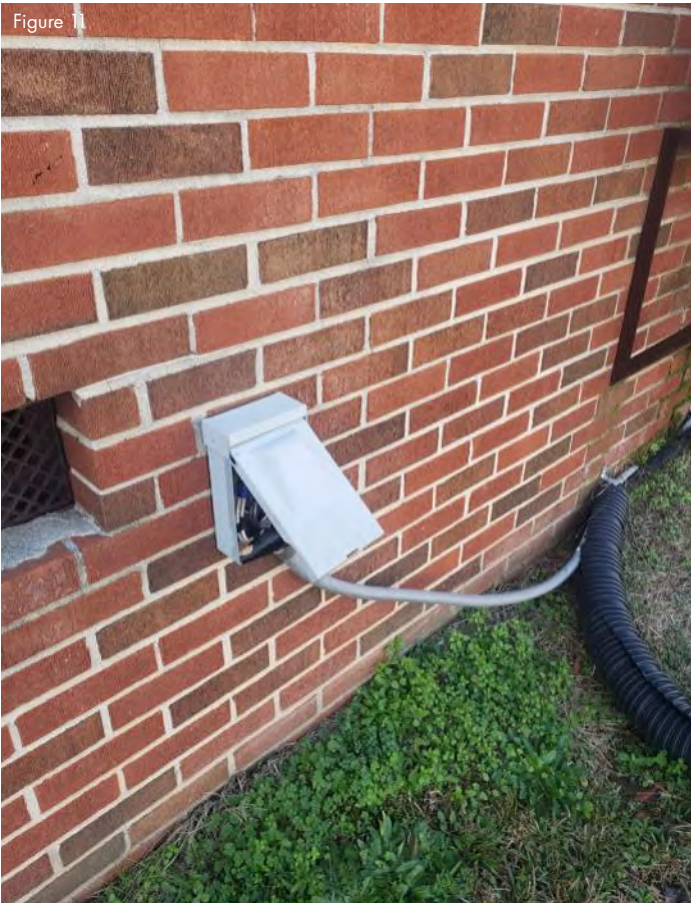
Figure 12

Exterior disconnect is missing interior escutcheon to conceal the wiring and is open to the elements.

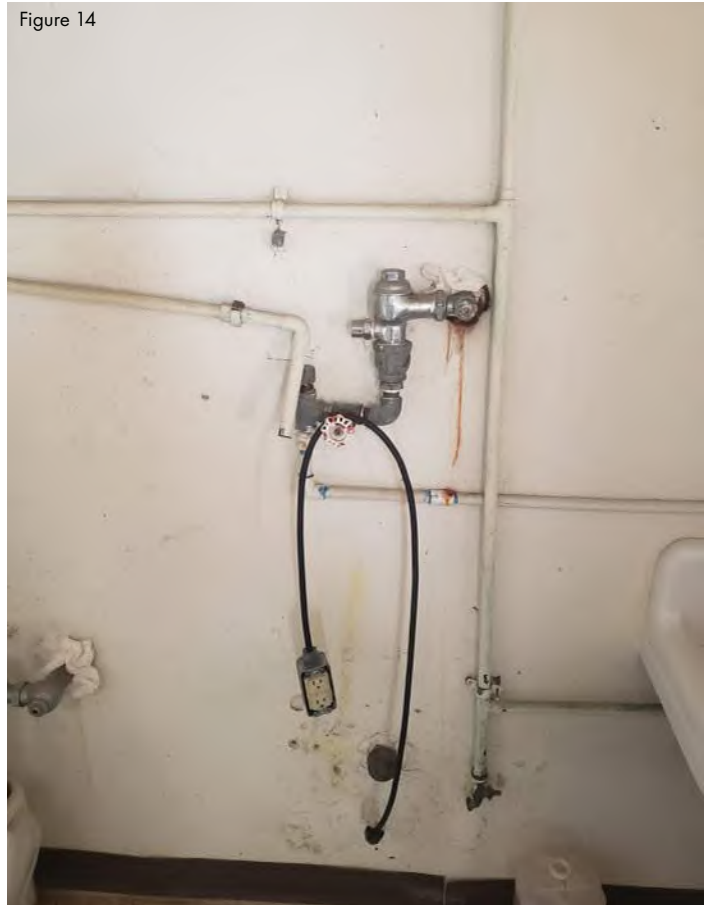
Figure 16

Receptacle not terminated properly.

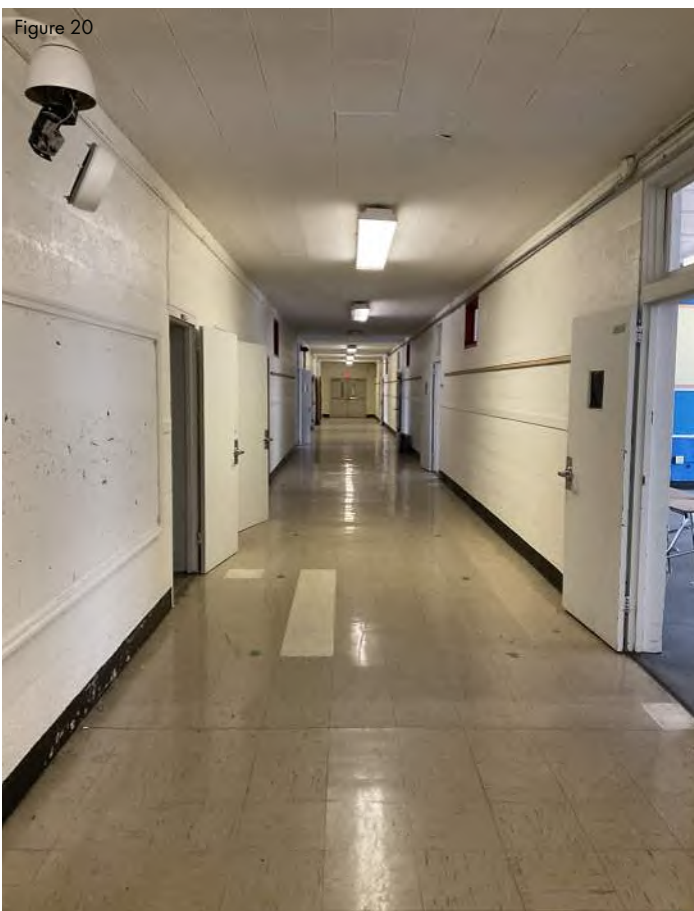
Typical Hallway Lighting and broken security camera.

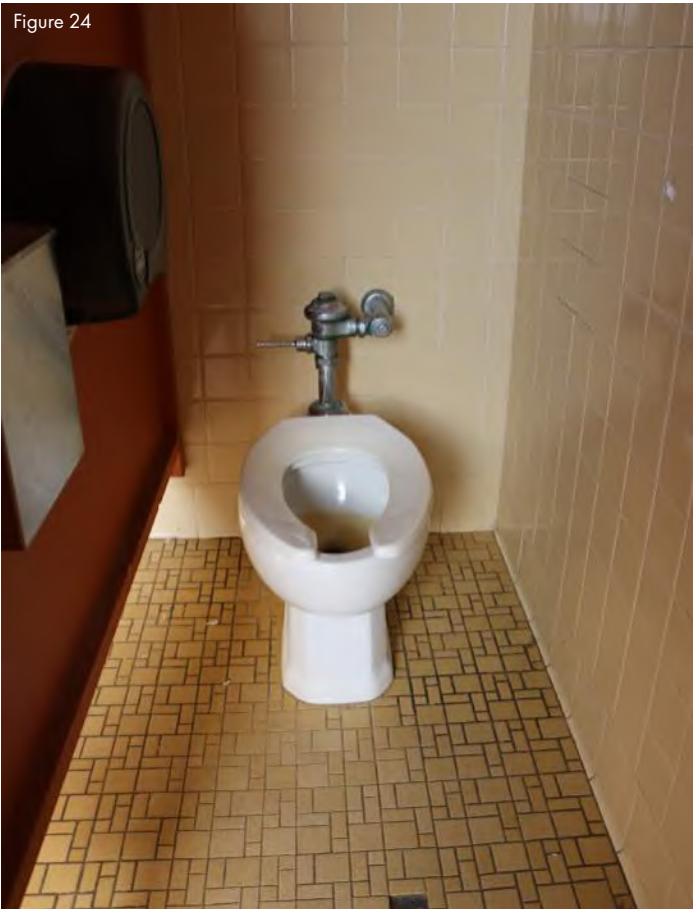
Figure 25

Women's gang toilet #1 – Pitted flush valve and stained toilet.

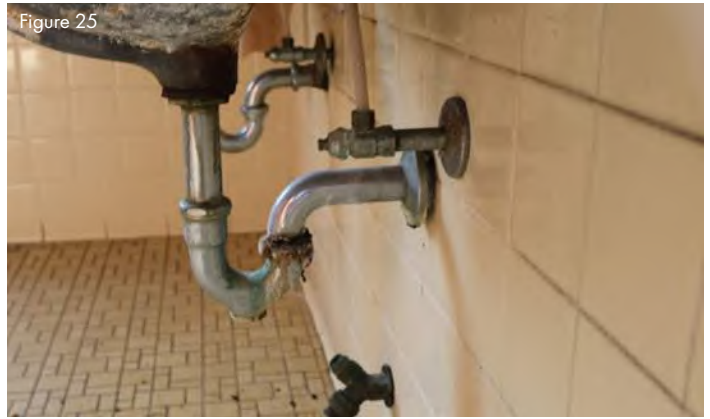
Figure 26

Women's gang toilet #1 – Lavatory p-traps rusting.

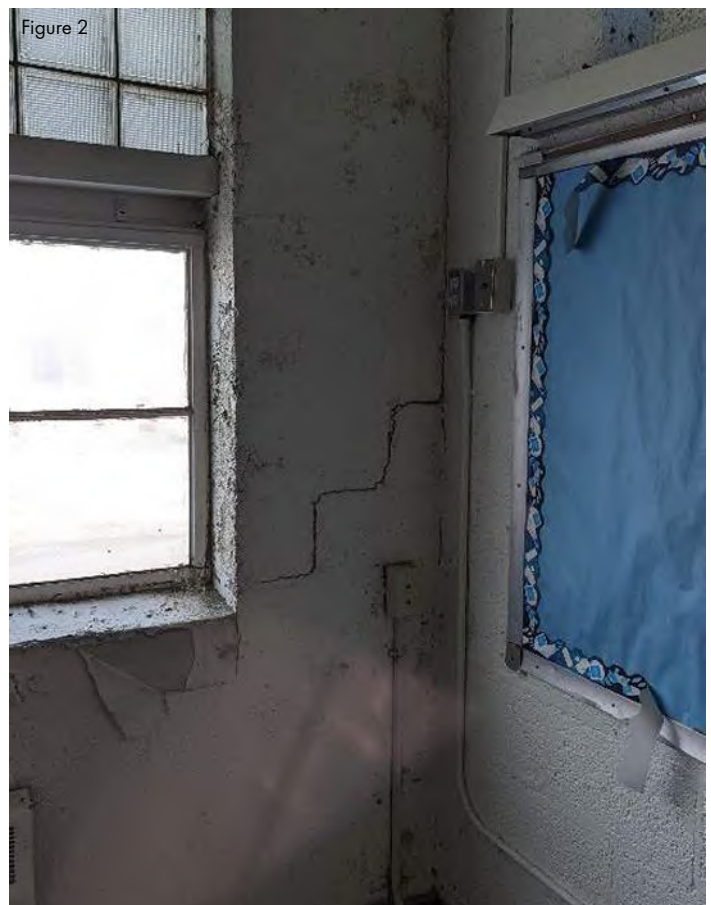
Front wall cracking and indication of moisture intrusion

admin wing). The cracks are both horizontal and stair-step configuration and in some cases are open as much as one-half inch (1/2"). We also noted that the window and door openings are supported with steel angle lintels. In most cases the lintels were in poor condition and exhibited excessive rust with material loss. In some cases, excessive deflection is also evident.

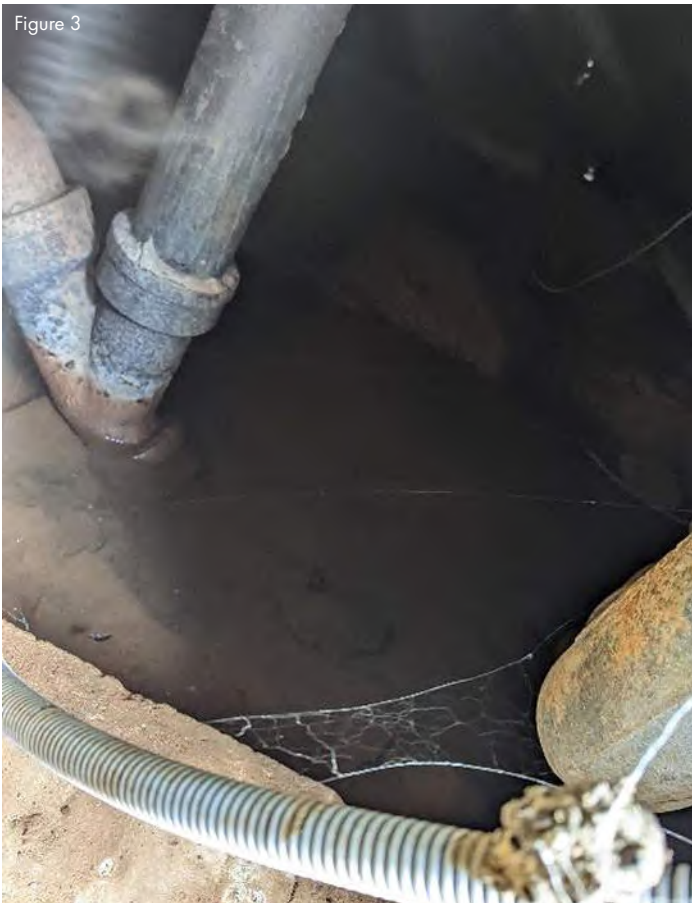
Standing water in crawl space

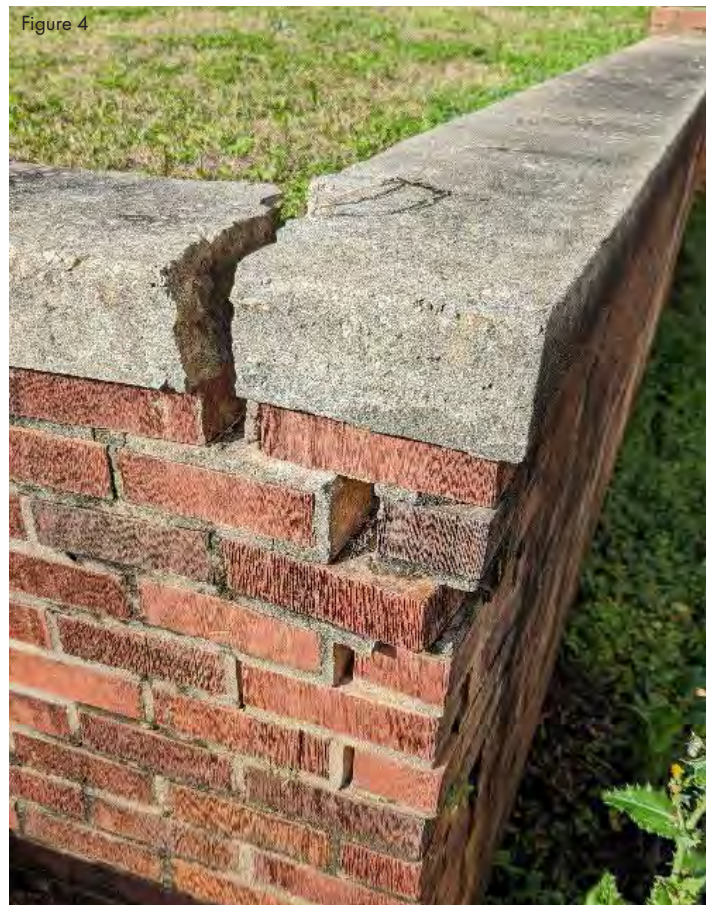
Masonry retaining wall failing

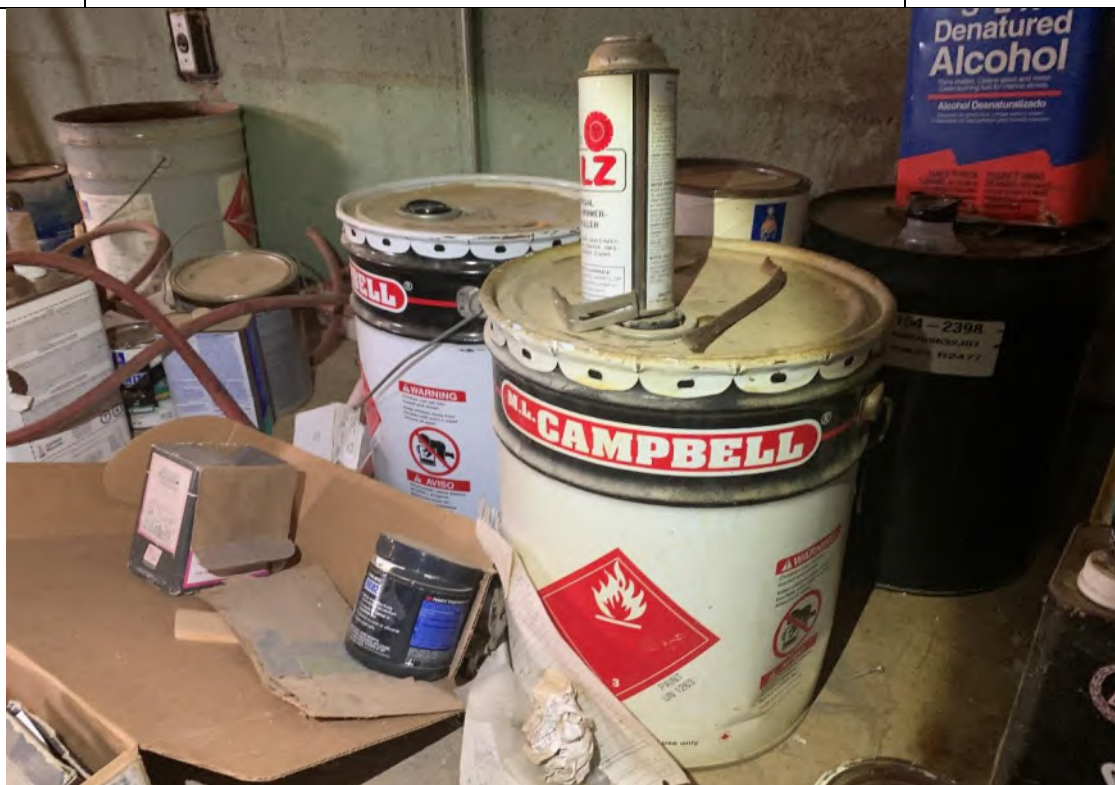
- Several containers of hazardous substances were observed in the shop area of the building. Containers were staged directly on the concrete floor as well as on a pallet.
- Several containers of hazardous materials were observed in the shop space staged on the floor and on a wooden pallet.

Containers of paints, lacquers, and hazardous materials staged on the concrete floor in the shop area

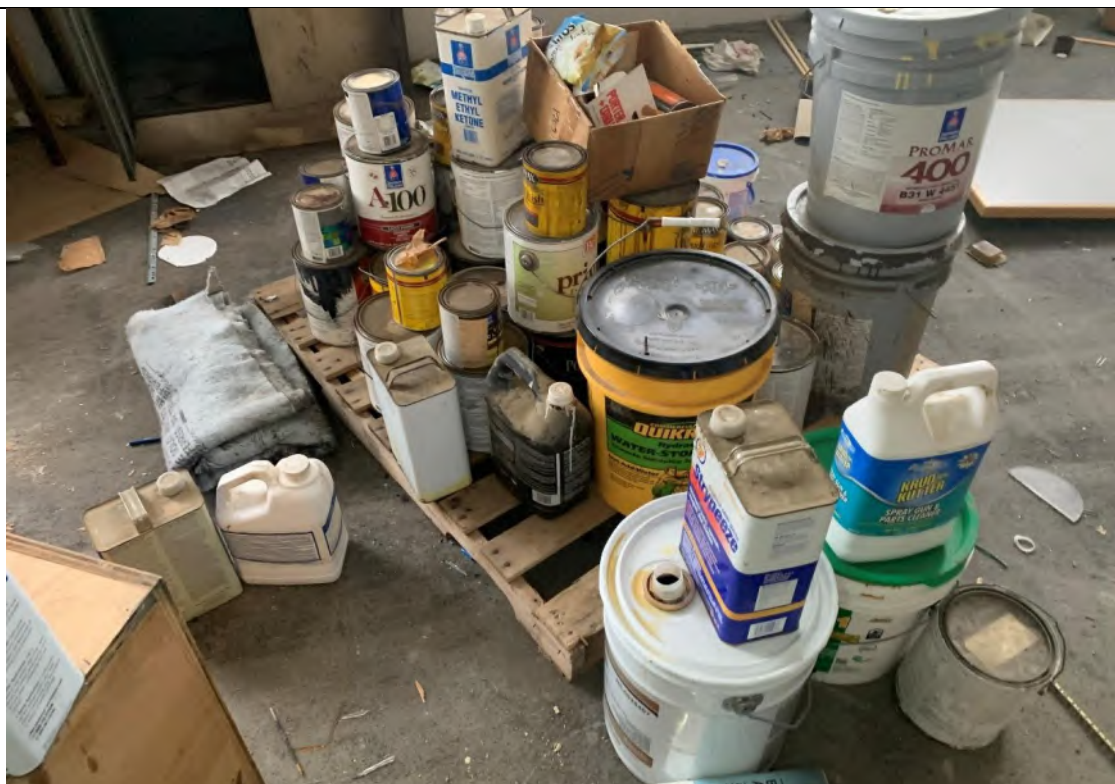
Additional hazardous materials staged on a wooded pallet
