REPORT OF PHASE I ENVIRONMENTAL SITE ASSESSMENT

**FORMER GALLMAN SCHOOL
NEWBERRY, SOUTH CAROLINA**

JANUARY 4, 2024

**GALLMAN SCHOOL
BUILDING CONDITION ASSESSMENT**

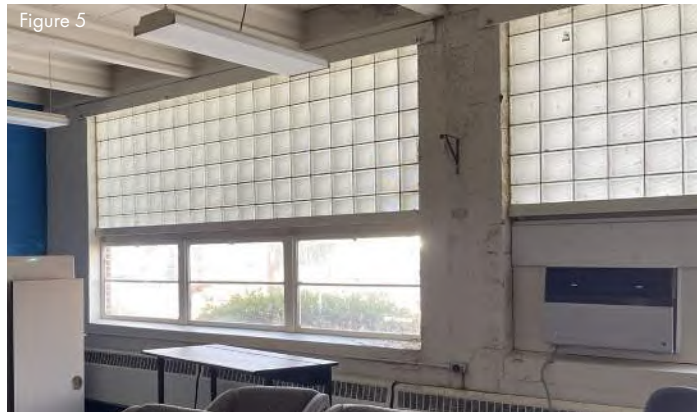
Evidence of moisture infiltration at exterior walls

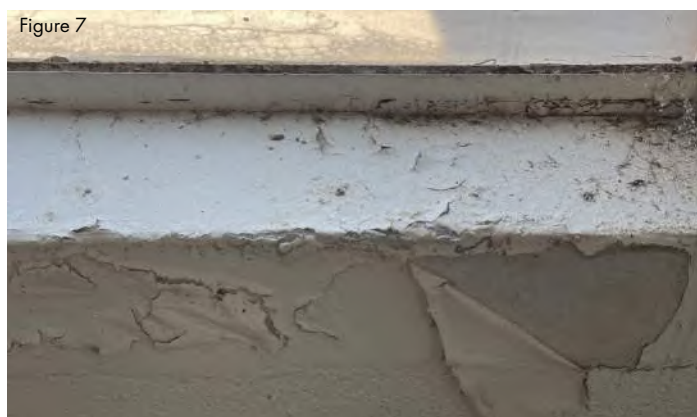
Evidence of moisture infiltration at exterior walls

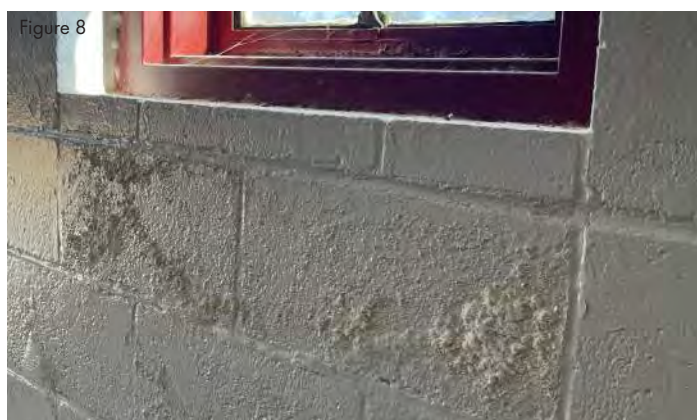
Evidence of moisture infiltration in addition stairwell

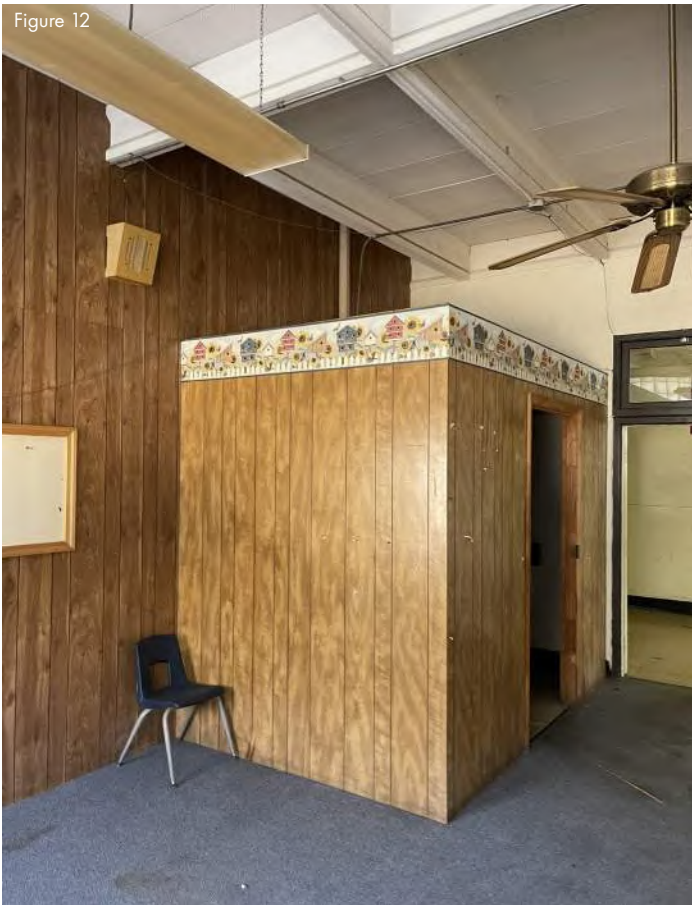
Figure 12

There is 1/4" wood paneling on some of the interior walls. They are in the locations of new walls (constructed after original building) (Figure 11) and to areas around the original principal's office and teacher lounge area. (Figures 12-14) The wood is not original or period and is recommended to be removed during the next renovation.

Walls not original

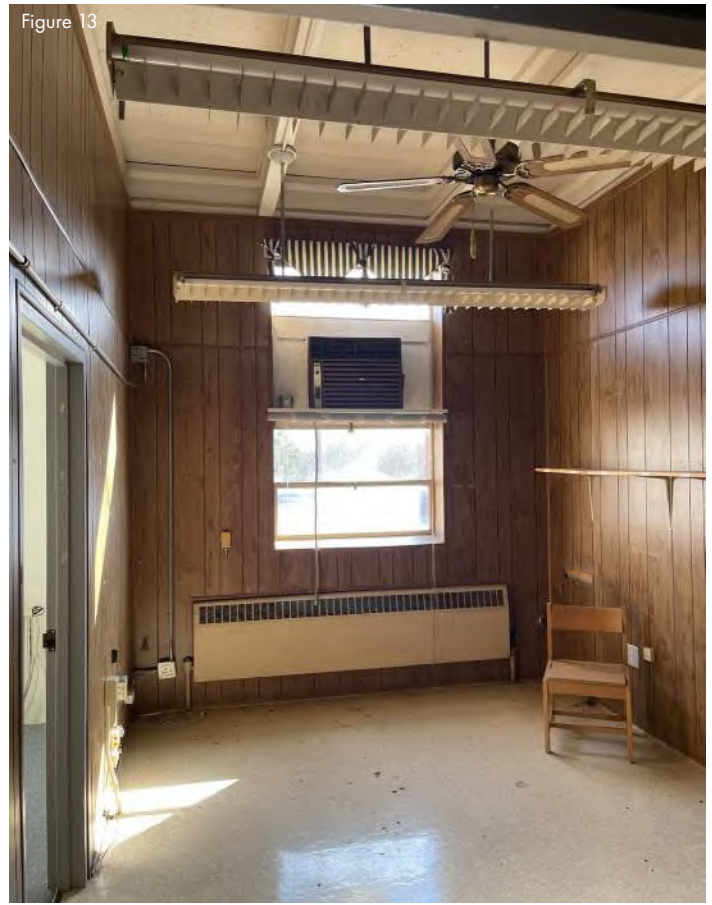
Figure 13

Office area adjacent to entrance lobby

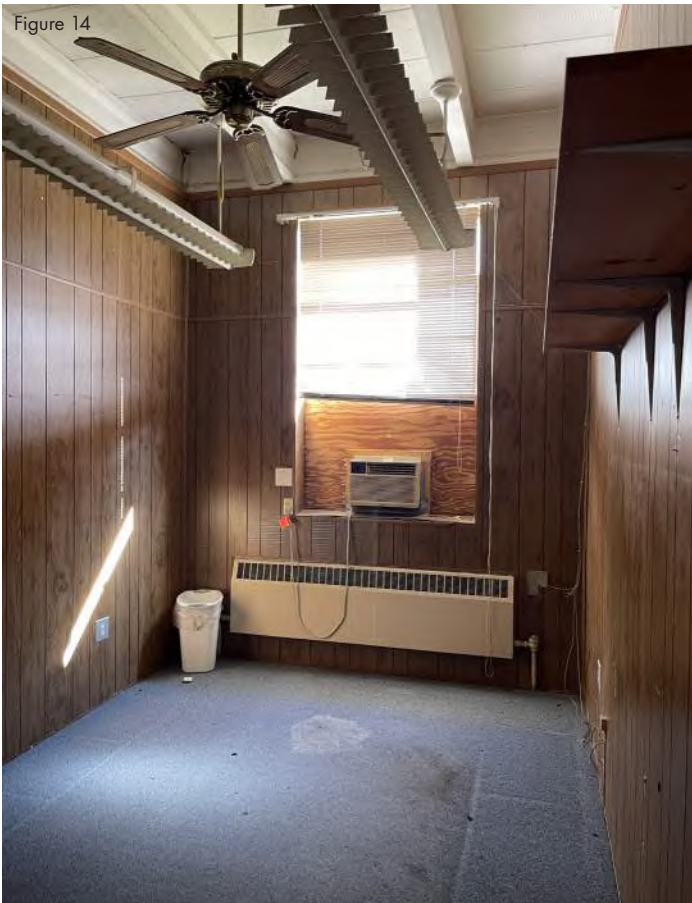
Figure 14

Original principal's office

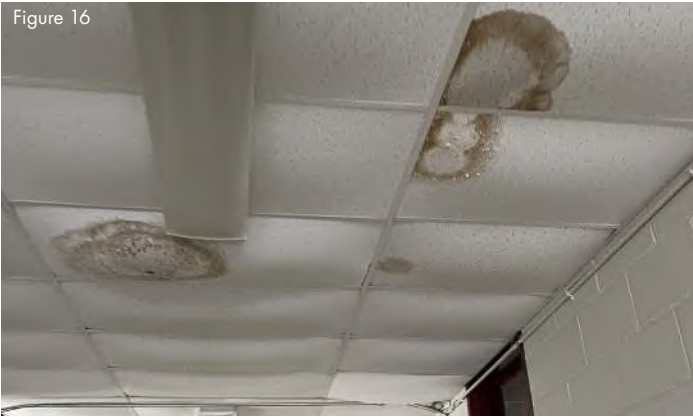
Figure 16

ACP ceiling - notice moisture damage

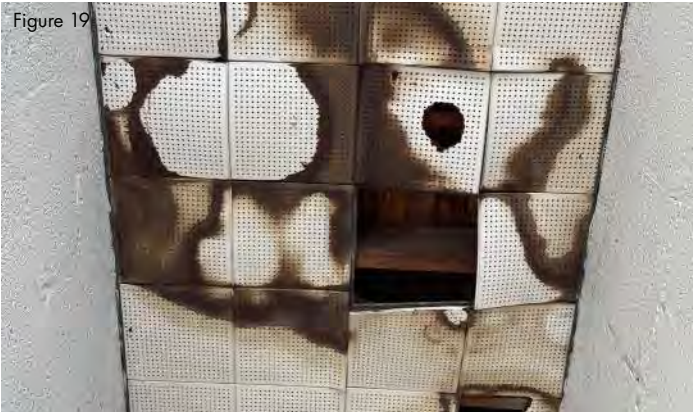
Figure 19

Damaged ACT in gym

areas of the school as well. The painted concrete ceilings with exposed concrete joists and deck are in good condition where there has been no moisture infiltration. These areas could remain as is for future use unless there is a specific need for acoustical treatments. This could be achieved by using wall panels as well. The 2x2, and 2x4 ceiling panels would not have been original to the building. Most locations are in fair condition with noticeable bending of the panel edges (Figures 15-18) It is recommended that all dropped ACP ceilings be removed. The 12x12 ACT are more than likely original. Although many of these period tiles are associated with asbestos, the S&ME report tested negative for the samples gathered. There are many areas of ACT that are damaged and should be replaced. (Figures 19-22)

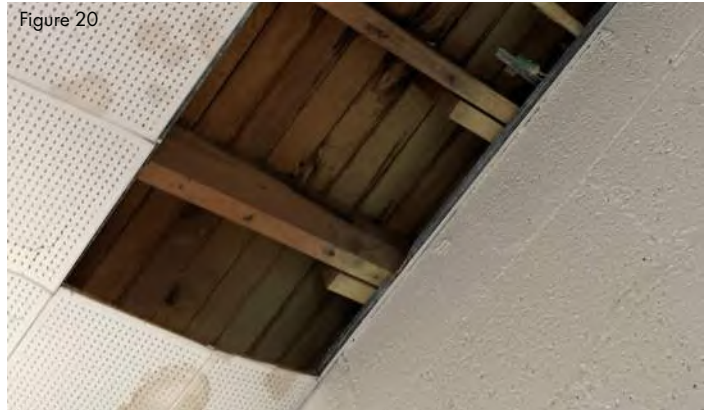
Figure 20

Damaged and missing ACT in gym

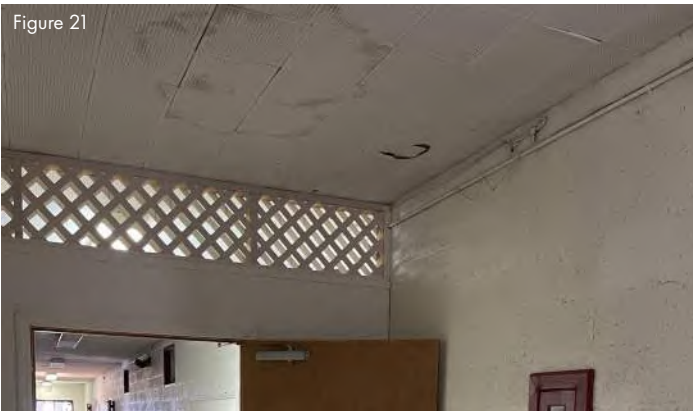
Figure 21

Damaged ACT in main corridor

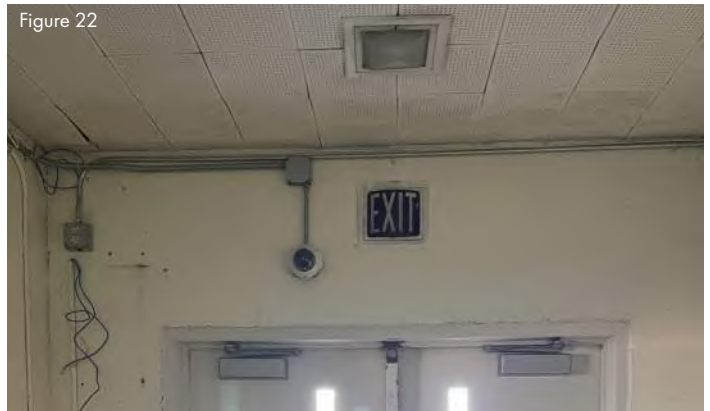
Figure 22

Damaged ACT in corridor

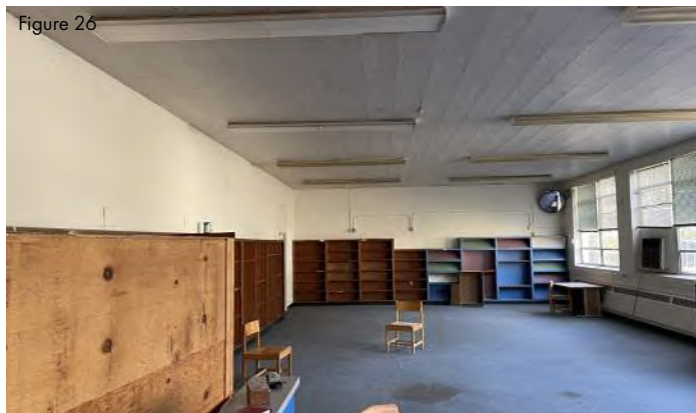
Carpet in a classroom/poor condition

The floor finishes are vinyl composition tile, carpet, sheet vinyl, ceramic tile and quarry tile. Most of the floor finishes do not appear to be original. The 9x9 tile under the 12x12 could be original, but it contains asbestos and should be removed. The carpet is in poor condition and is also covering existing asbestos tile. The quarry tile in the kitchen is in fair condition (Figure 23) but could be replaced with matching tile when there is a renovation. The kitchen and restroom area shows a damaged floor system from below and will more than likely need to be replaced (Figure 24). The ceramic tile in the restrooms is in good condition. It could potentially remain in place pending owner use of the current spaces (Figure 25). The wood floor in the gym appears to be original and is in good condition. It is recommended that no mechanical conditioning be introduced into the gym without being properly designed. It would probably be best to add large fans rather than mechanically heat and cool. Cooling or heating could cause the wood to buckle and fail. (Figures 26-28). Other than the wood floor in the gym, there are no floor finishes in the building that would be considered “character defining” or historic and worthy of saving.

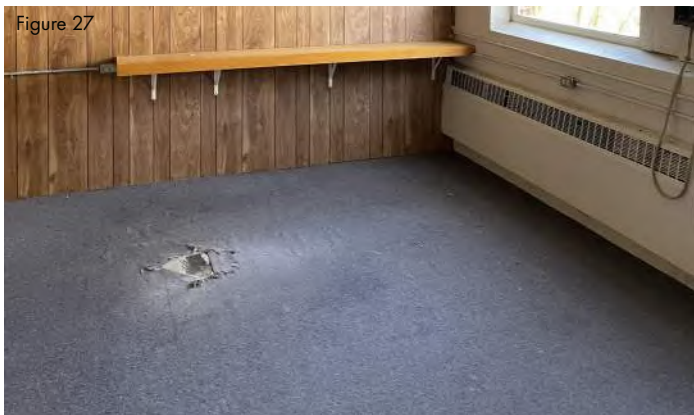
Figure 27
Condition of carpet/poor condition

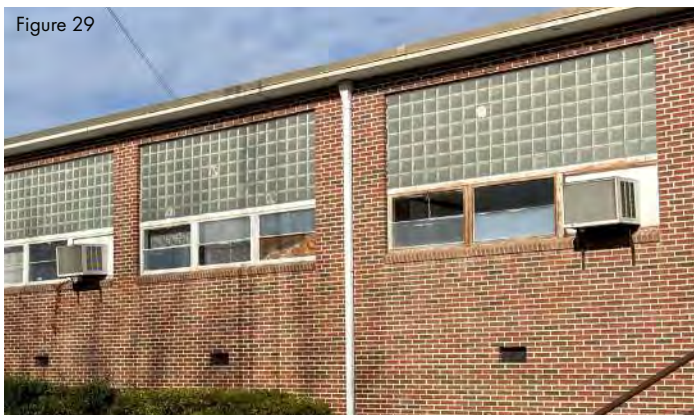
The windows and doors are typical for the age of the building. The glass block and horizontal single glazed windows would have let a lot of natural light into the once used classrooms. The windows are in fair condition and could be refurbished. They are single glazed so there is not much existing R-value. Typically, when historic windows are saved interior vented storm windows can be added to increase the thermal performance. (Figure 29) It can be difficult to remove steel windows to refurbish them, so a discussion should be made to understand expectations and goals prior to renovations. There is noticeable moisture damage on many of the interior window sashes and sills. Glazing putty has failed in most areas as well. (Figures 30-33) The doors are in fair condition, however most of the hardware is not compliant with ADA/ANSI A117.1. Most of the doors appear to be original with transoms above (Figures 34-35). A survey of all doors and windows to describe necessary renovations would be included in future renovation drawings for a contractor. The exterior panic hardware should be replaced in all locations. (Figures 36-37)

Figure 29
Typical condition of windows and glass block

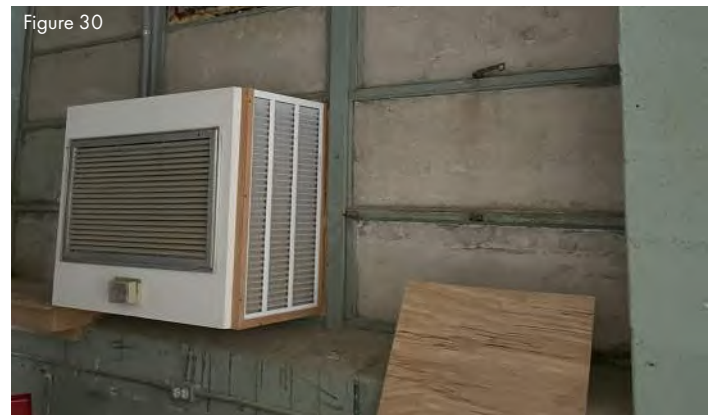
Figure 30
Windows in the space under the gym have been covered

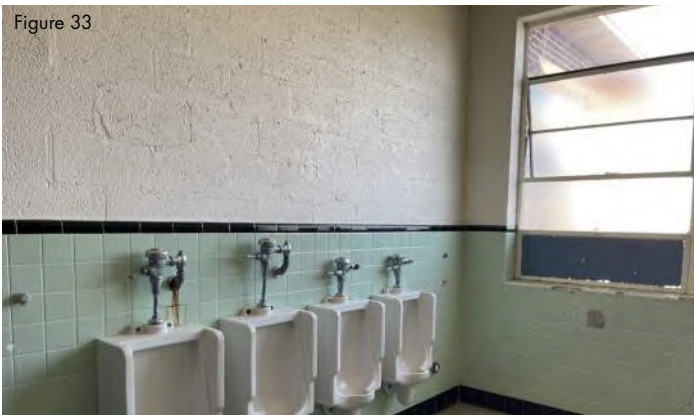
Notice the painted coating on the inside face of the awning windows

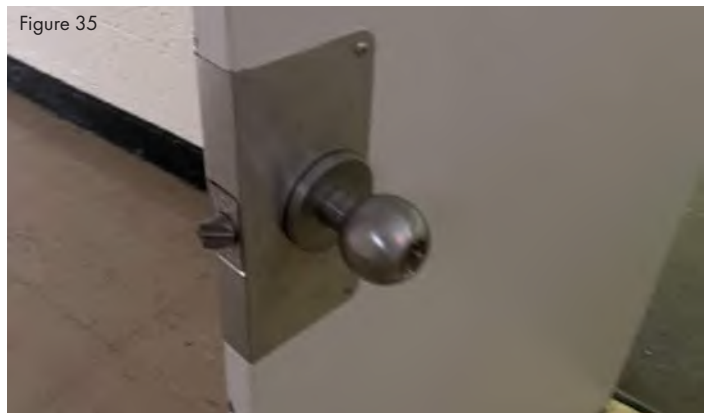
Noncompliant knob hardware

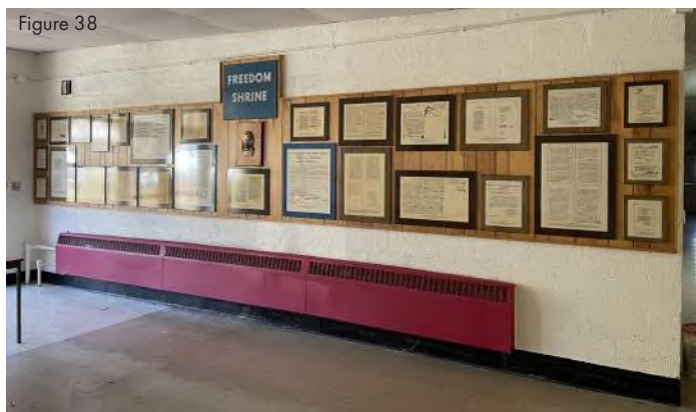
There is not much interior trim in the building. The baseboards are 1x wood and are in good/fair condition depending on location (Figure 38).

Wood baseboard throughout

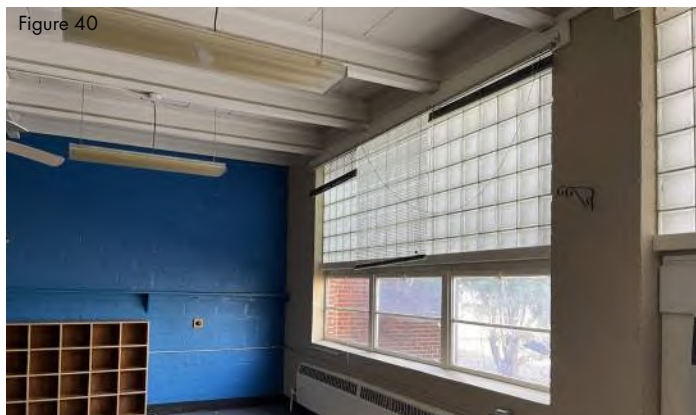
No insulation was observed during the visit. (Figures 40-43)

Typical exposed ceiling in classrooms - underside of concrete roof deck & concrete joists

Adding rigid roof insulation should be explored prior to any roof renovations. A minimum R-19 should be achieved. Wall insulation could be tough to add without changing the original aesthetic of the interior and exterior. The original design has concrete masonry units as the load bearing wall with a brick veneer and no insulation. Interior framed walls could potentially be added around the inside face of the exterior walls for a cavity to add insulation. A breathable and moisture resistant insulation (mineral wool) could potentially be used after discussions with the mechanical engineer that will be designing a new heating and cooling system.

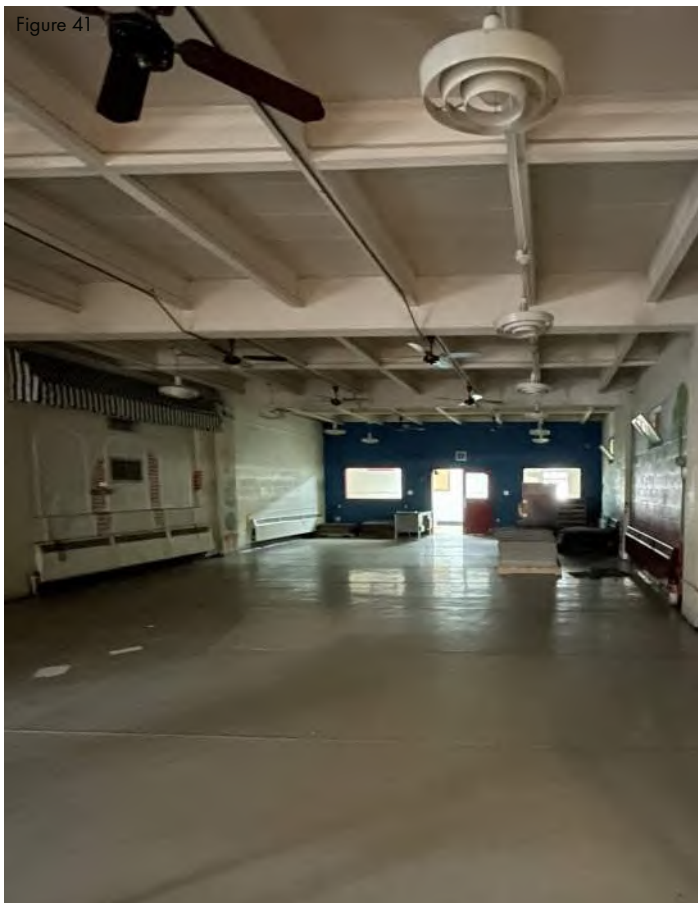
Exposed ceiling in cafeteria - underside of concrete roof deck & concrete joists

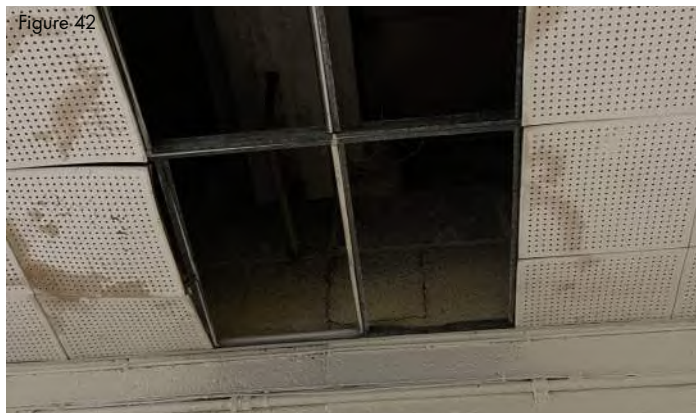
No insulation above the acoustical ceiling tiles in corridors

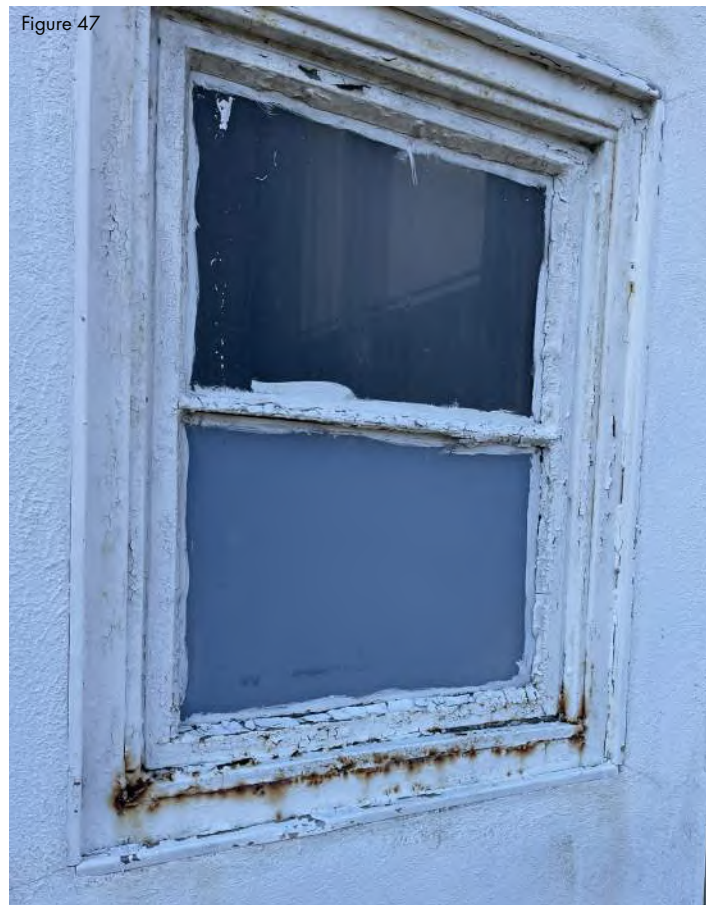
Figure 48

Steel window condition

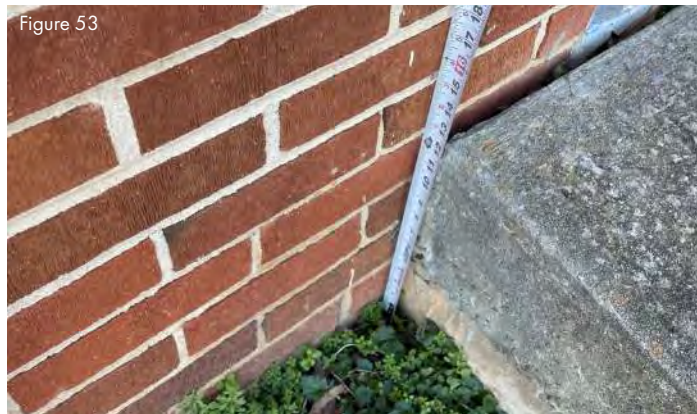
Ramp with approximate 12" rise - anything greater than 6" should have railing

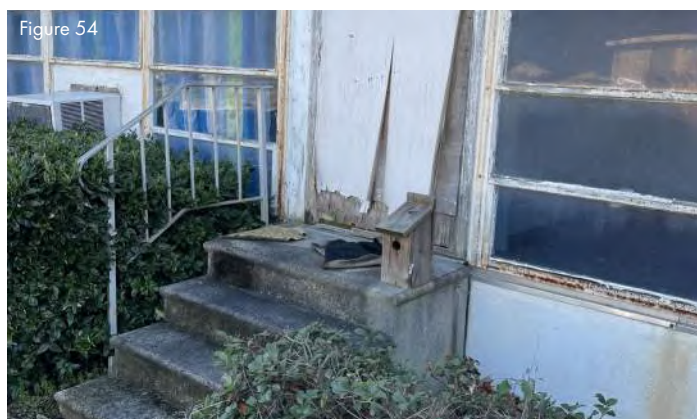
Stair to closed in door

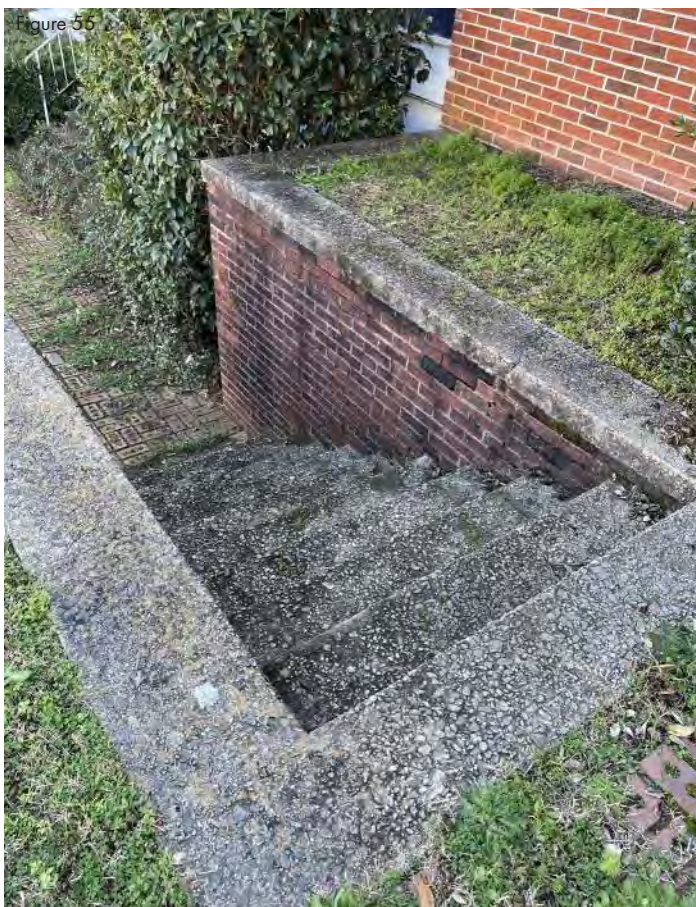
Exterior stair on site adjacent to gym - notice no handrail

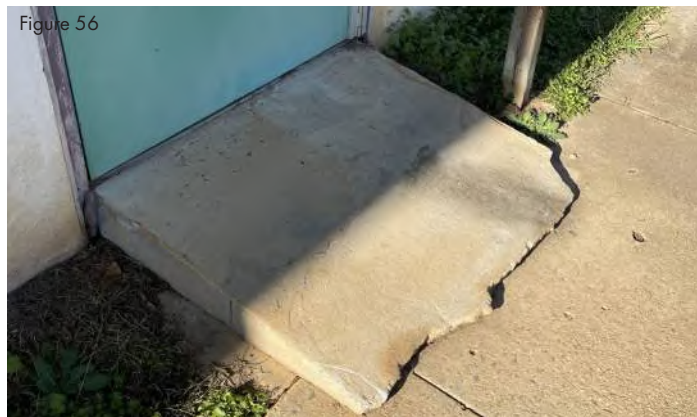
Not an accessible path into the ground floor of the addition

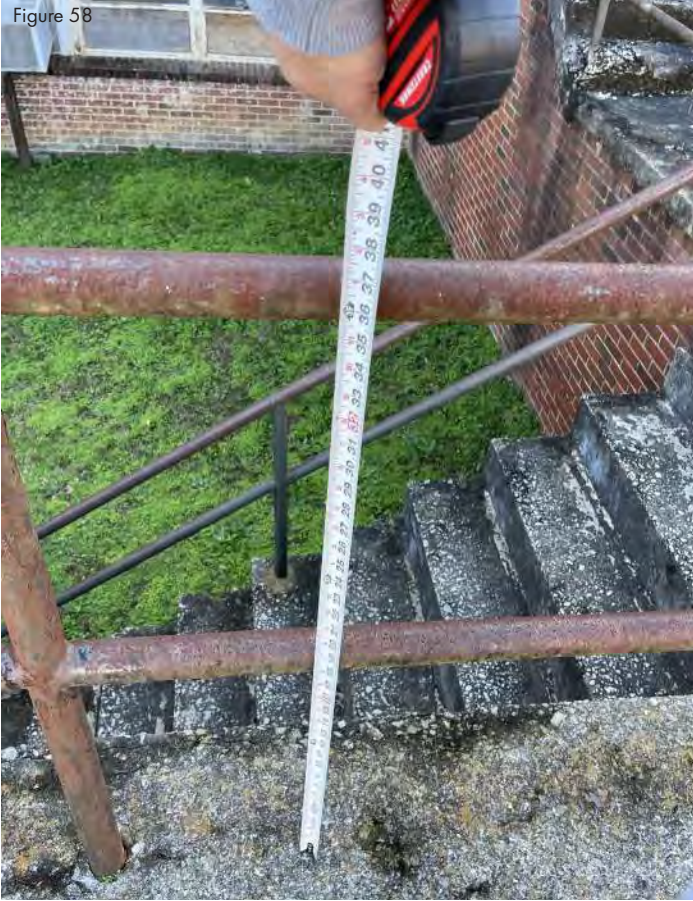
Figure 59

Guardrail is not high enough, 42" above 30" drop, and no pickets or panels between rails is a safety concern

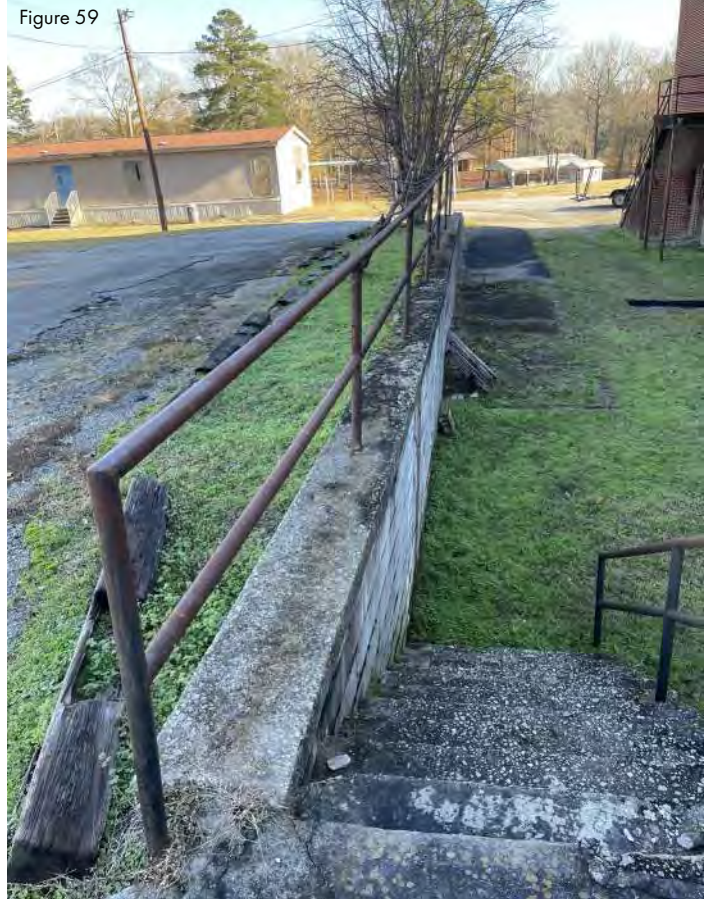
Figure 60

Guardrail is not high enough, 42" above 30" drop, and no pickets or panels between rails is a safety concern

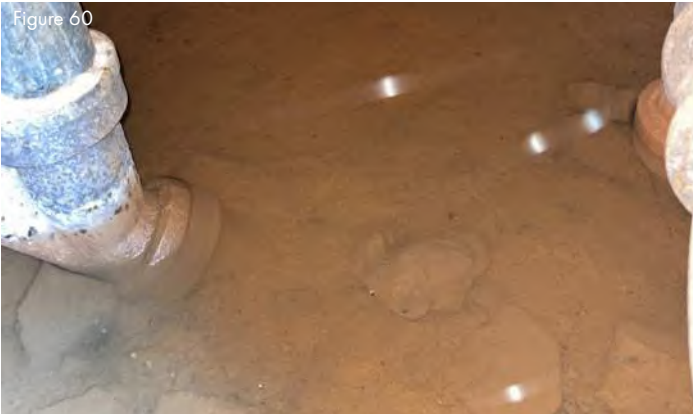
Figure 61

Standing water at boiler room access

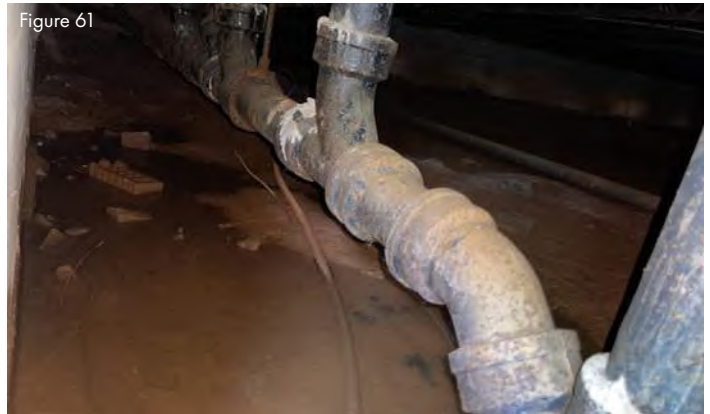
Figure 62

Standing water at boiler room access

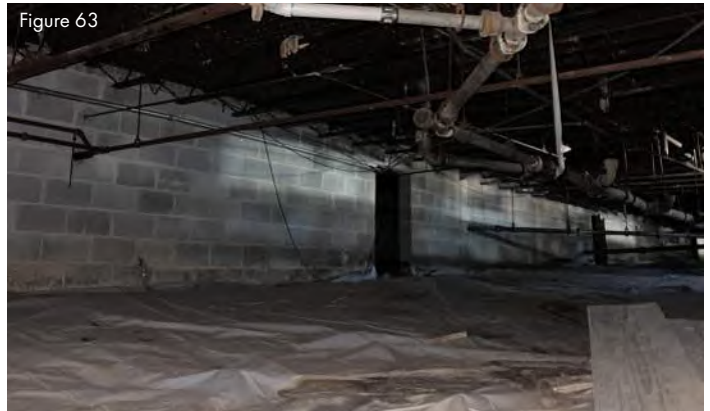
Figure 64

View from door in addition

Crawl Space – The crawl space is accessible from the exterior of the building and several locations from the interior. The addition has doors that access the crawl space of the original building. The boiler room of the original building also has an access to the crawl space. There was no noticeable standing water on the Langford Street side of the original building, but there was a good amount of water viewed from the boiler room access (Figures 60-63). The moisture issue should be dealt with during the renovations. One recommended solution could be waterproofing the exterior wall and installing of a French drain system (Figure 64).

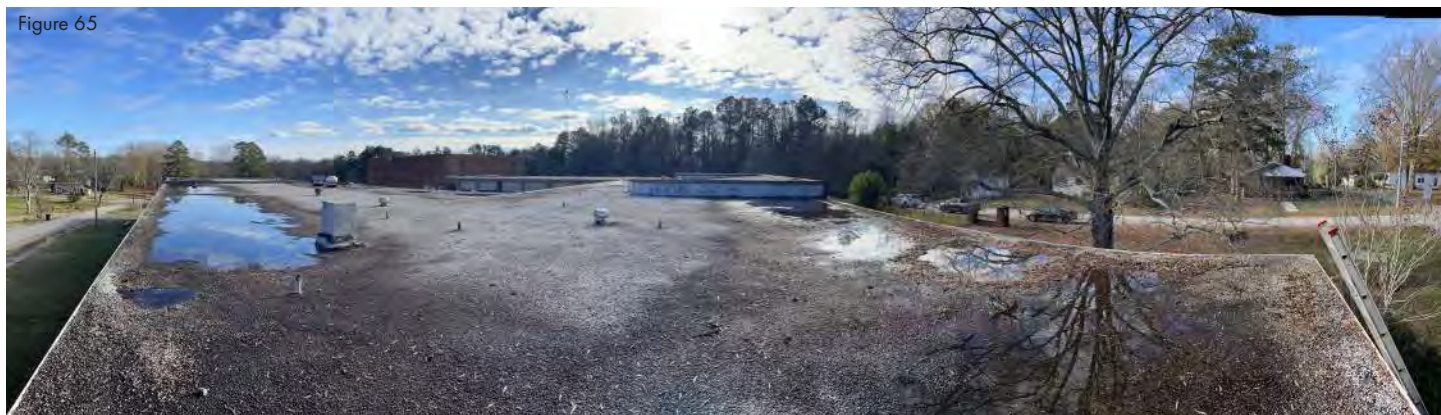
Roof– The existing built-up roofing is past the end of its useful life and needs to be replaced. (Figures 65-69)

Panorama of the roof

The roof should be considered a primary concern to be replaced even if a use is not determined for a considerable time. As mentioned in the insulation section, it would be a good idea to add insulation above the roof deck prior to reroofing. The gym roof could not be accessed, but from the moisture evident inside the gym it is recommended to also be replaced. Site drainage from downspouts should also be studied to ensure water carry off from the building perimeter (Figure 70).

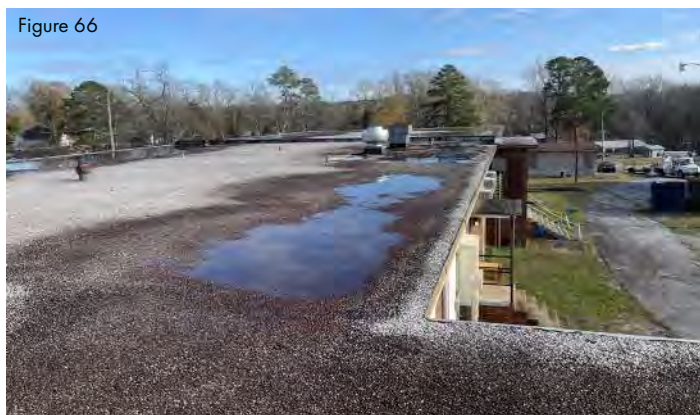
Ponding on roof

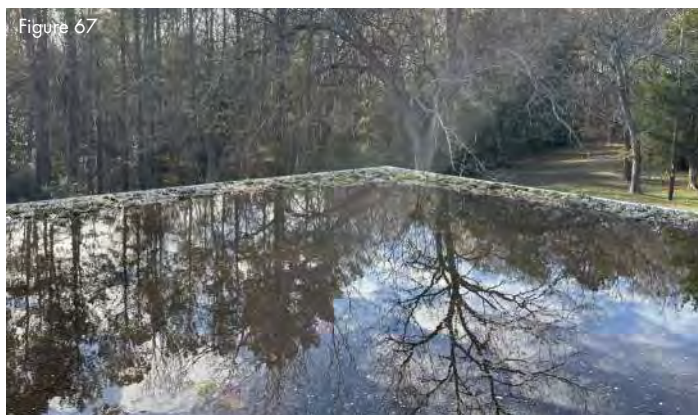
Ponding on roof

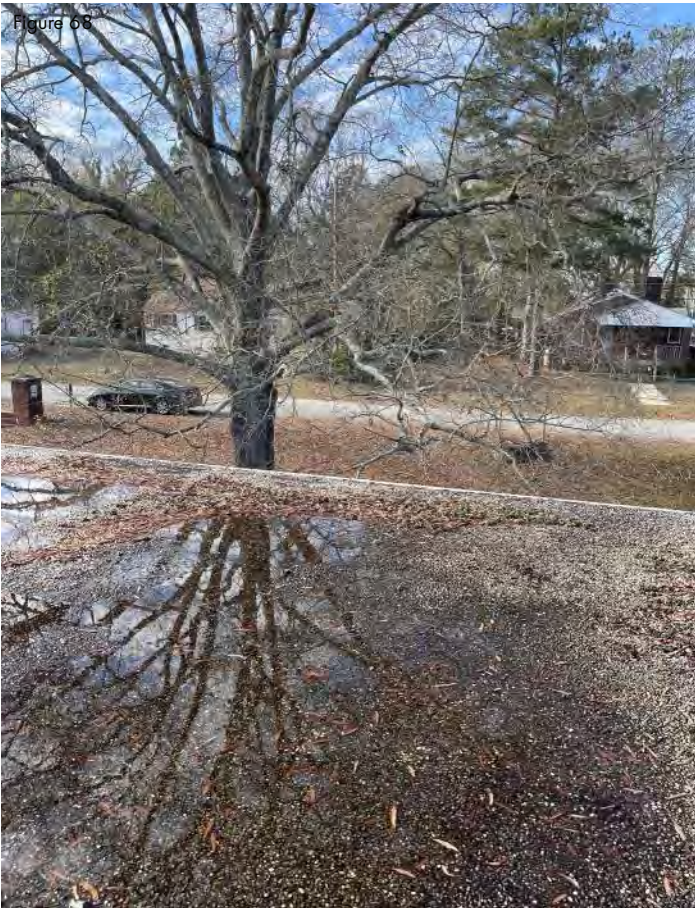
Ponding on roof

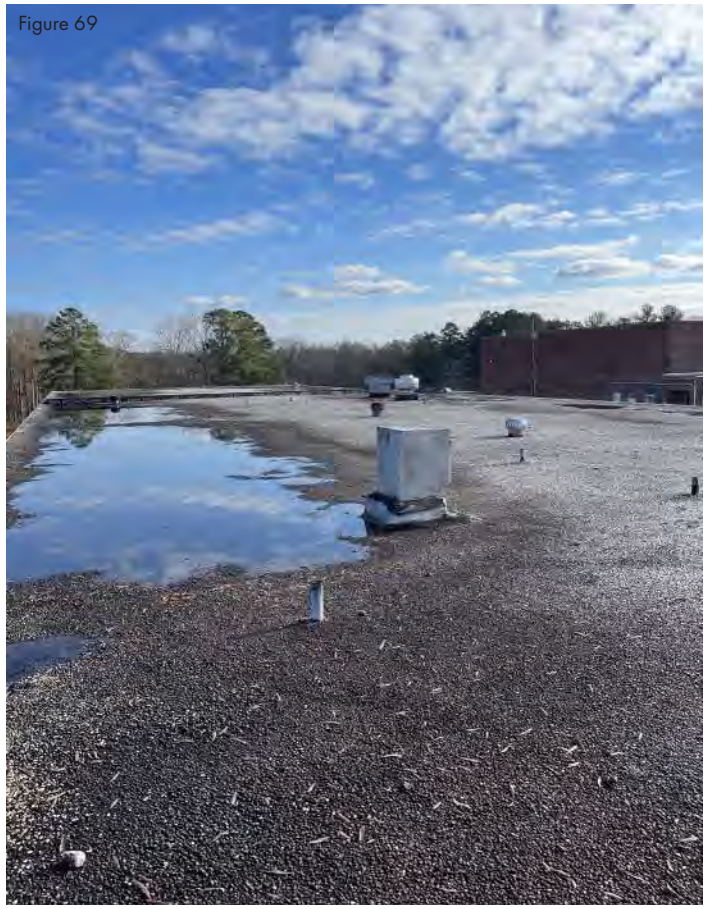
Ponding on roof

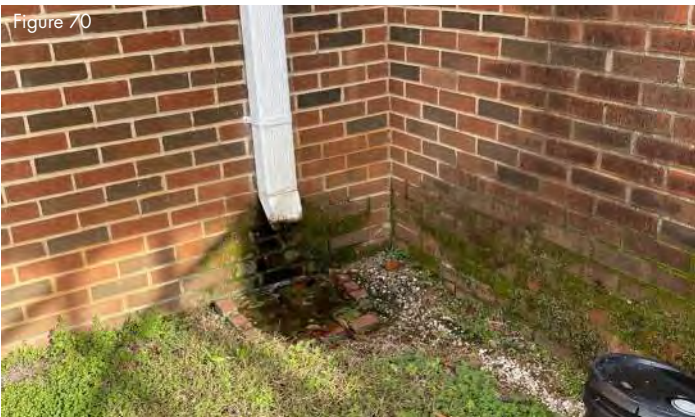
Typical downspout condition

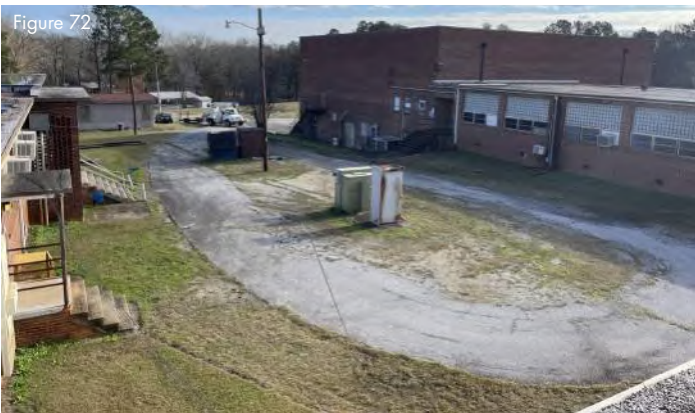
General condition of paving

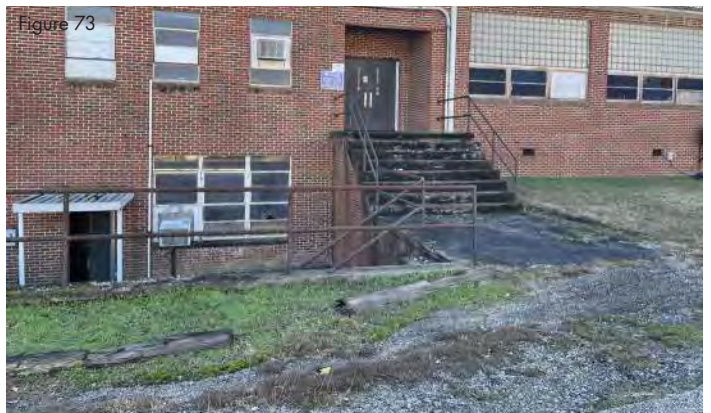
General condition of paving

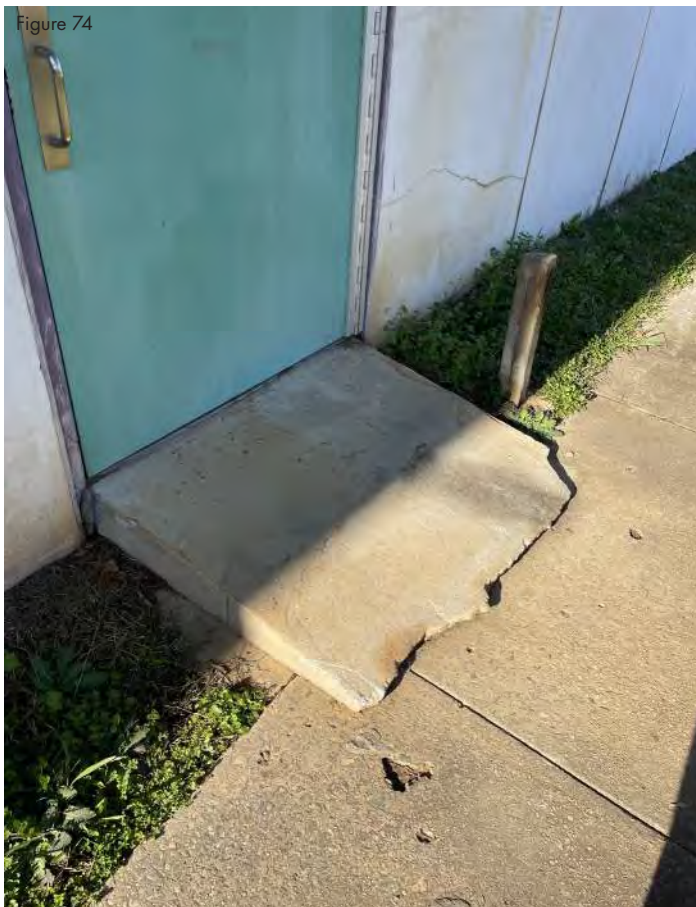
Non accessible ramp

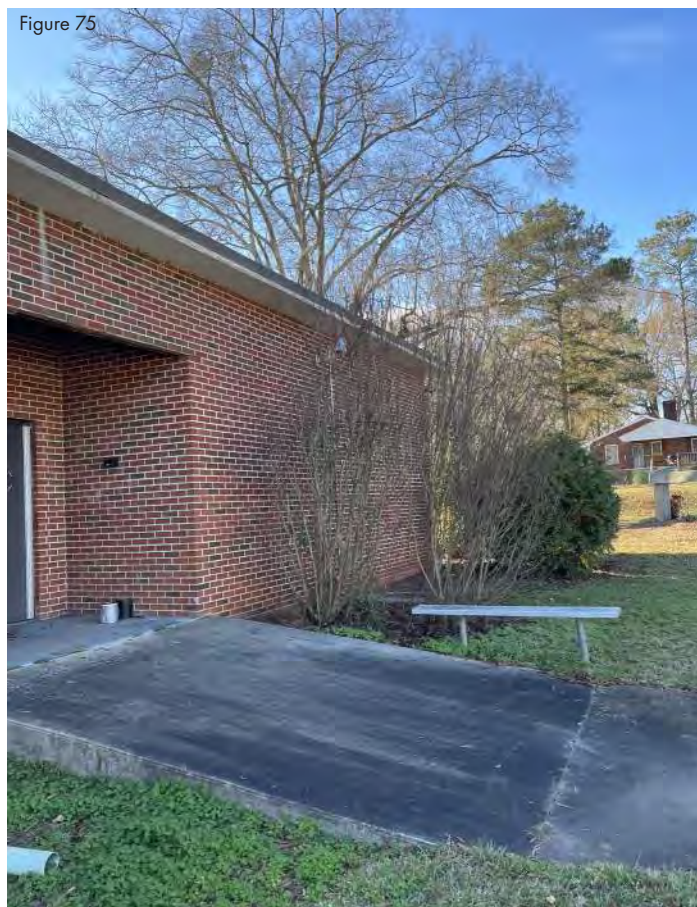
Non accessible ramp

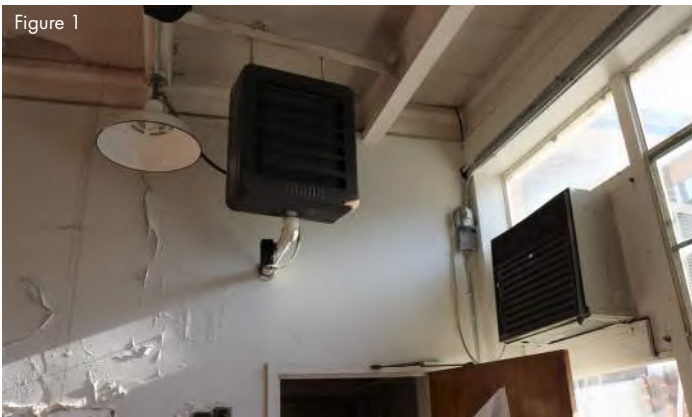
Figure 1
Kitchen heated with fan forced heater suspended from the roof structure.

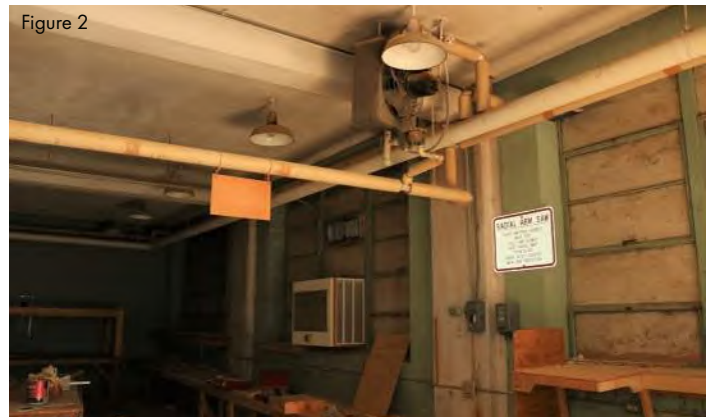
Figure 2
Shop area heated with two fan forced steam unit heater. Heaters in fair condition. Air handler serving classroom in fair condition.

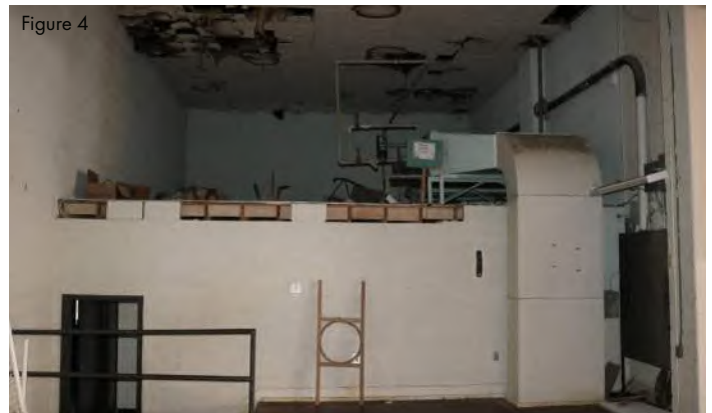
Figure 4
Gym heating unit #1. No cooling. Could not verify age or operation but equipment has exceeded its normal service life.

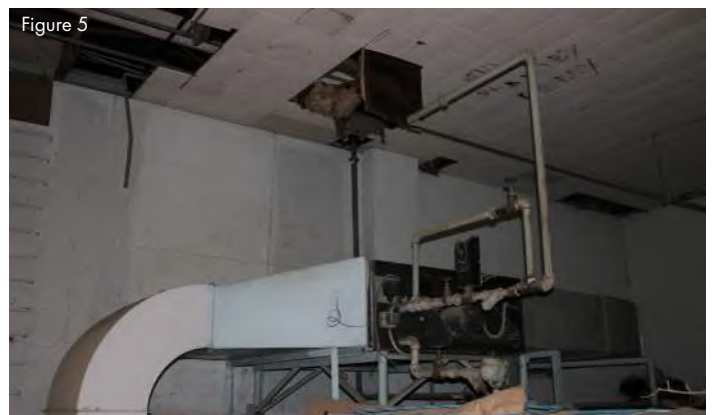
Figure 5
Gym heating unit #2. No cooling. Could not verify age or operation but equipment has exceeded its normal service life.

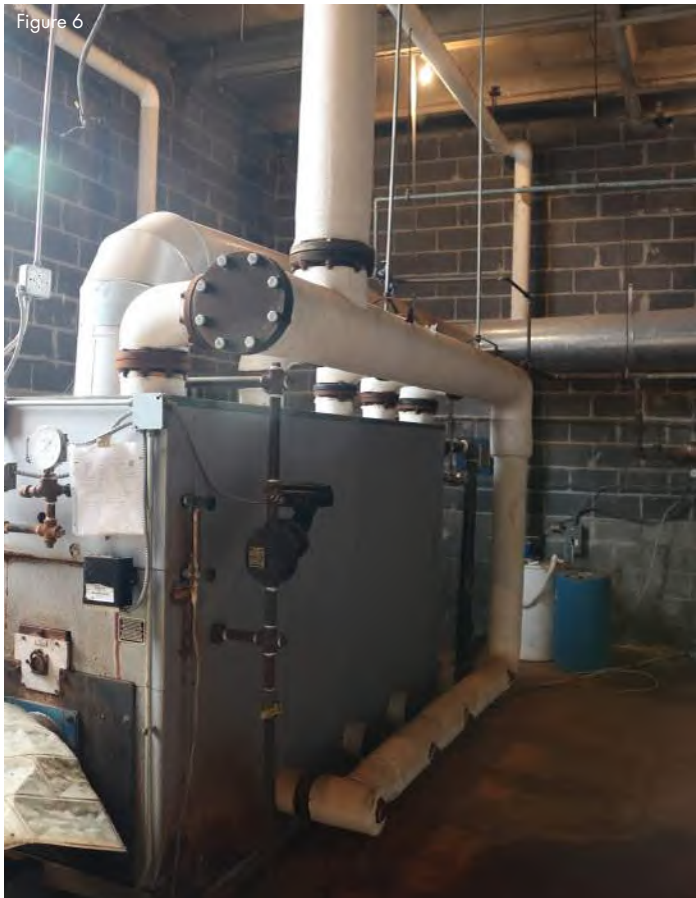
Boiler last inspected in 2015.

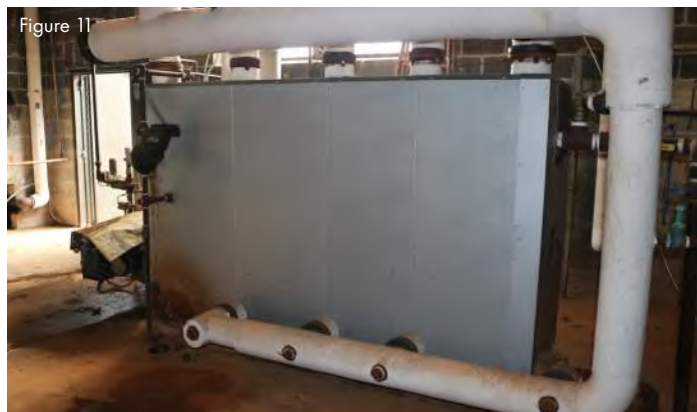
Hot water/Steam pipe insulation in various conditions. Some sections need to be replaced.

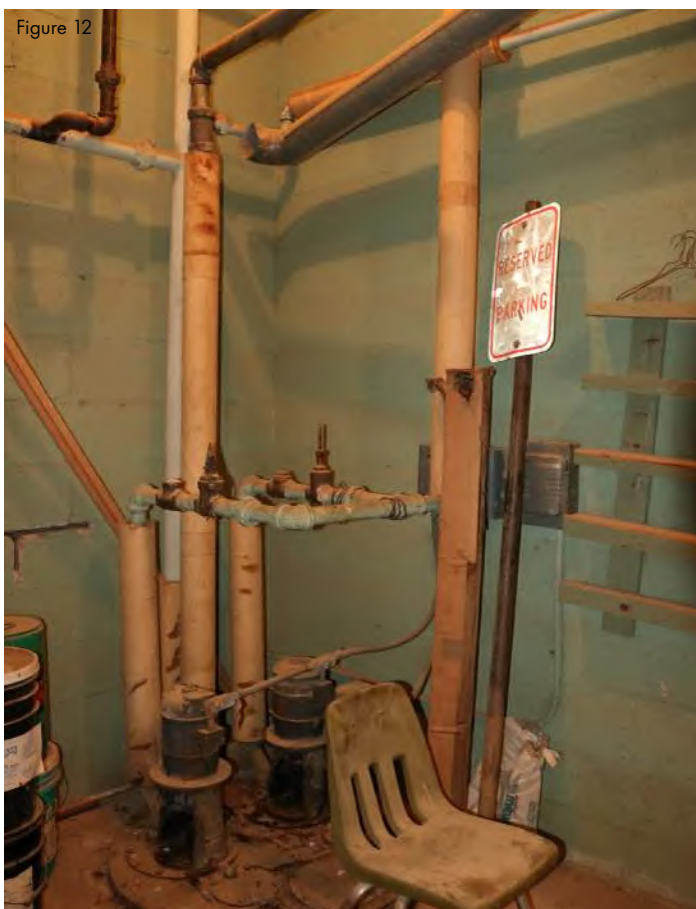
Steam condensate return pumps in fair condition. Could not verify age or operation but equipment has exceeded its normal service life.

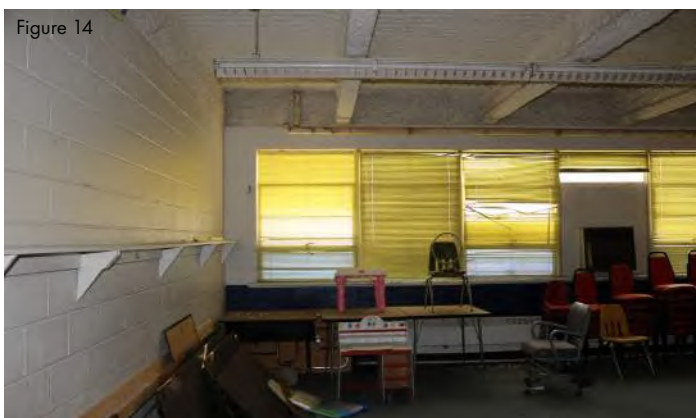
Exposed steam piping in lower-level classrooms. Window unit for cooling.

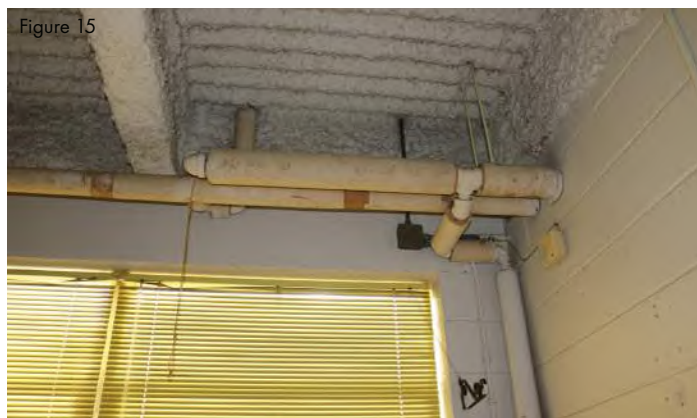
Figure 16

Gaps in the piping insulation need to be addressed.

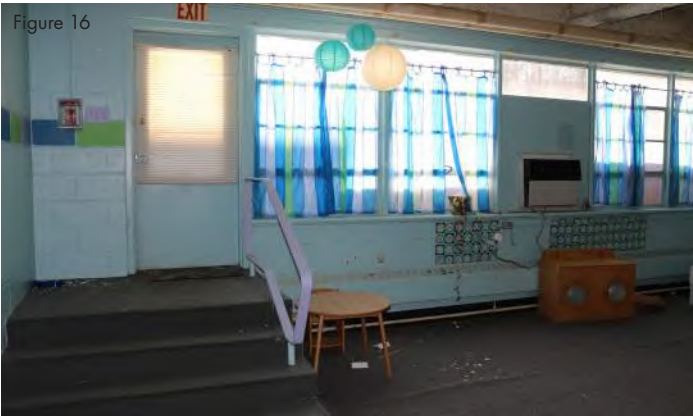
Exposed steam piping in lower-level classrooms. Window unit for cooling.

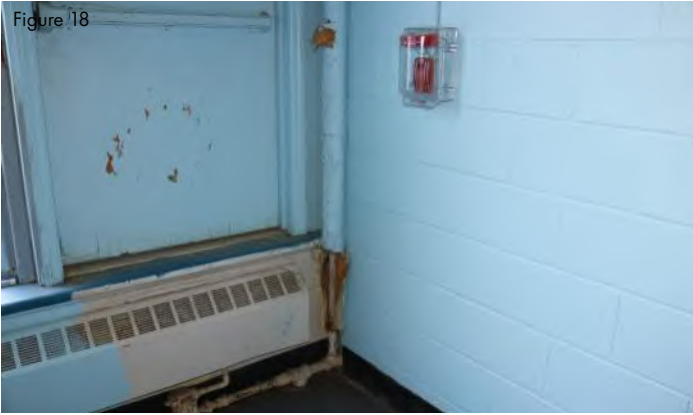
Figure 18

Lower-level classroom stairwell needs to have pipe insulation replaced.

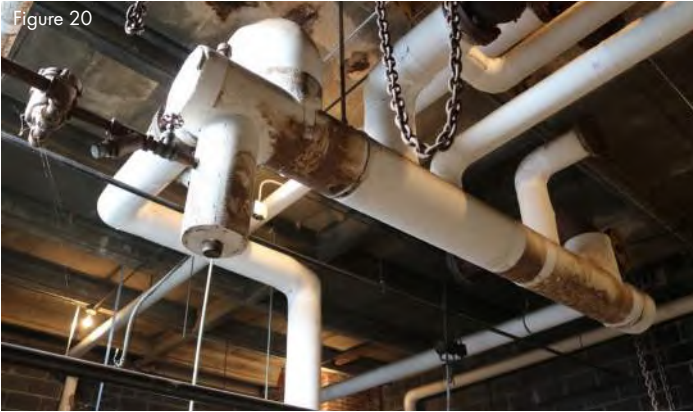
Figure 20

Roof leaks damaging pipe insulation. Insulation needs to be replaced.
