REPORT OF PHASE I ENVIRONMENTAL SITE ASSESSMENT

**FORMER GALLMAN SCHOOL
NEWBERRY, SOUTH CAROLINA**

JANUARY 4, 2024

**GALLMAN SCHOOL
BUILDING CONDITION ASSESSMENT**

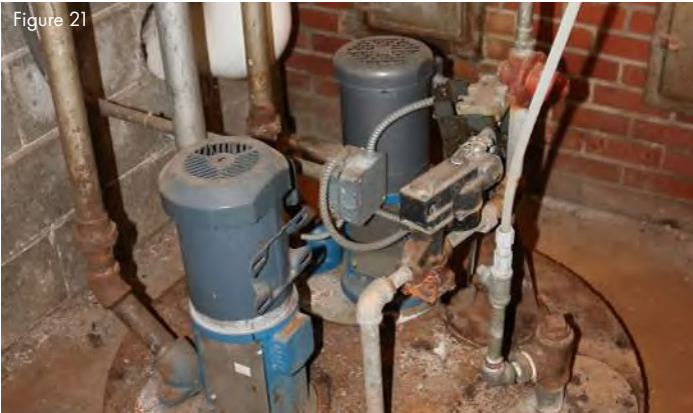
Figure 21

Steam condensate return pumps in fair condition. Could not verify age or operation but equipment has exceeded its normal service life.

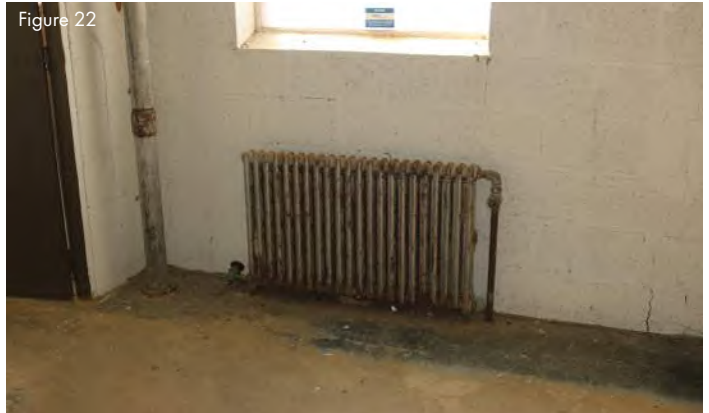
Figure 22

Exposed radiator in gym men's toilet.

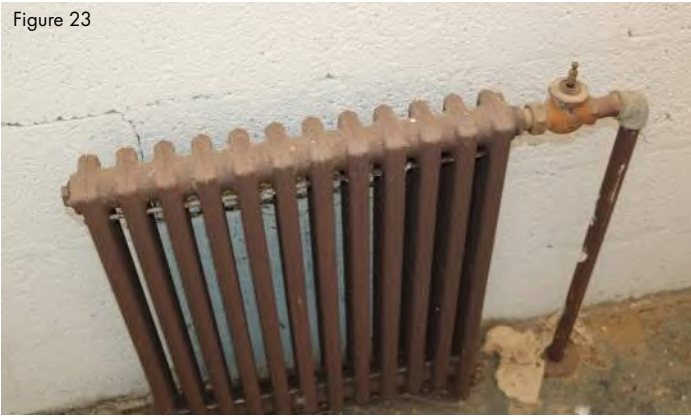
Figure 23

Exposed radiator in gym women's toilet.

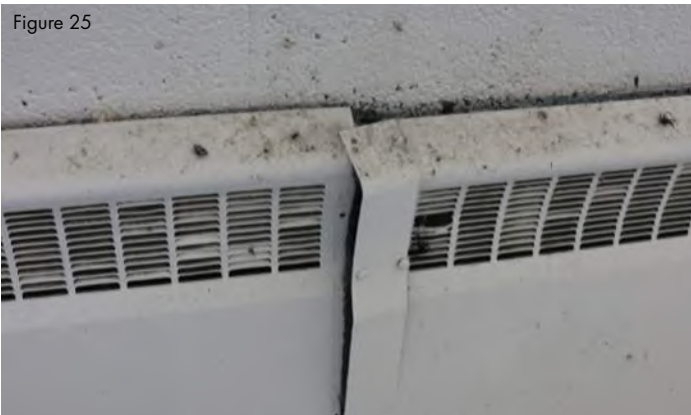
Figure 25

Classroom radiator cabinet damage.

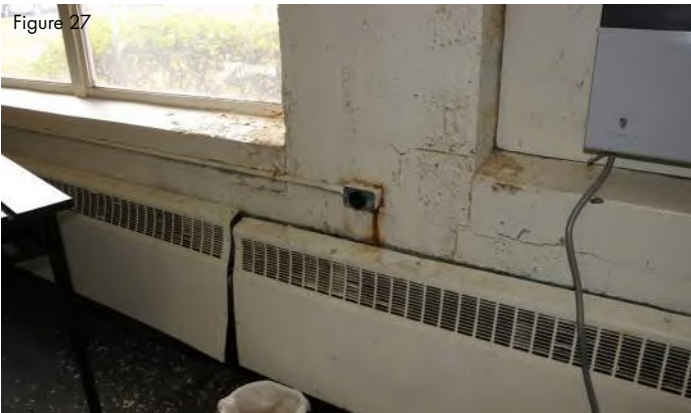
Figure 27

Classroom radiator cabinet damage.

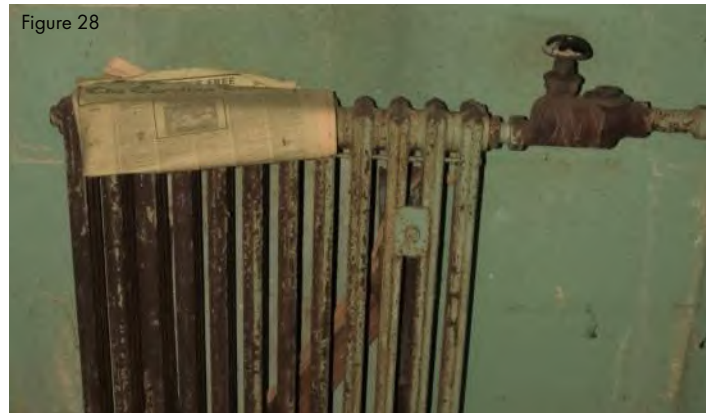
Figure 28

Exposed radiator in toilet/shower room. No pipe insulation. Typical.

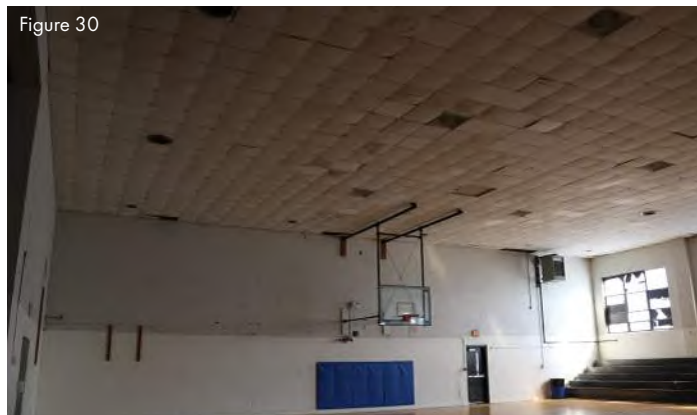
Figure 29
Chimney should be inspected if it is to be reused in the future for boiler and water heater flues.

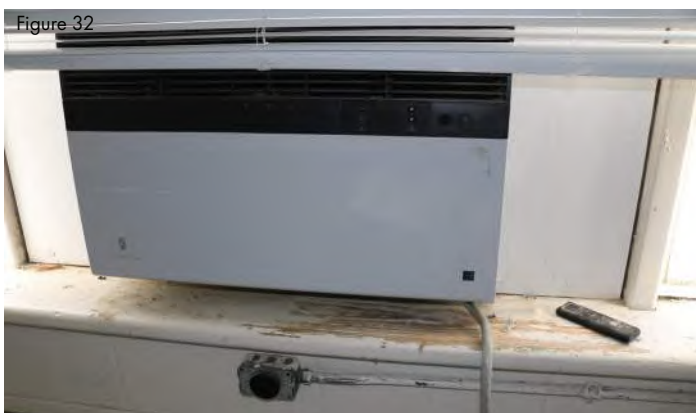
Figure 31
Wall mounted gas heater #2 in good condition.

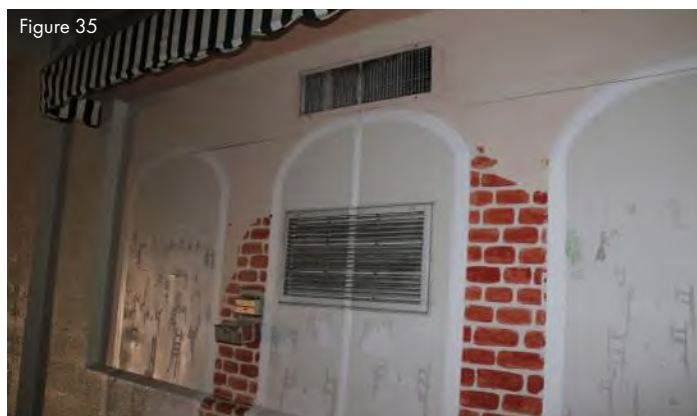
Figure 34
Cafeteria Bard unit supply and return grilles need to be cleaned and are in good condition.

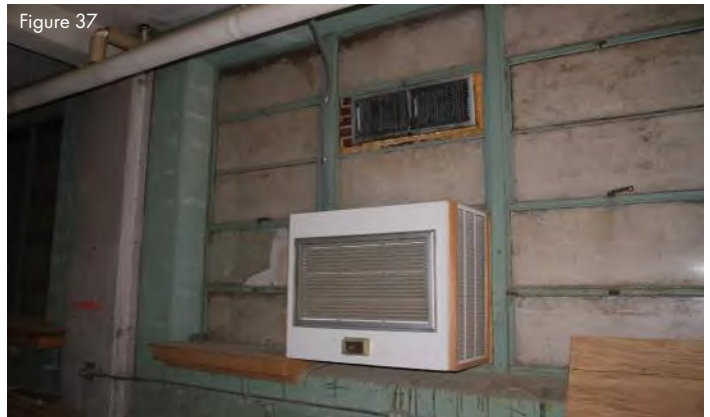
Figure 37

Shop Bard unit supply and return grilles. Supply grille needs to be cleaned.

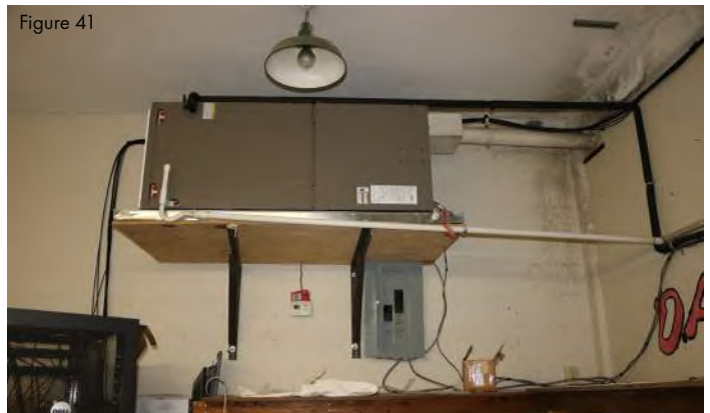
Figure 41

I.T. room split system air handler in good condition. Note moisture issue on right hand wall.

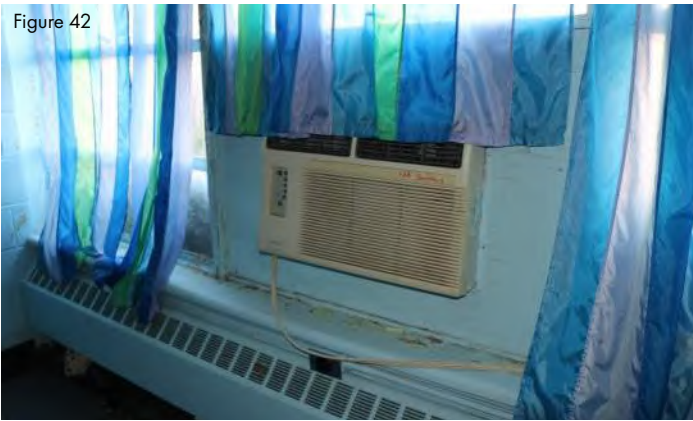
Figure 42

All lower-level window air conditioners are in fair condition. Could not verify age or operation but equipment has exceeded its normal service life.

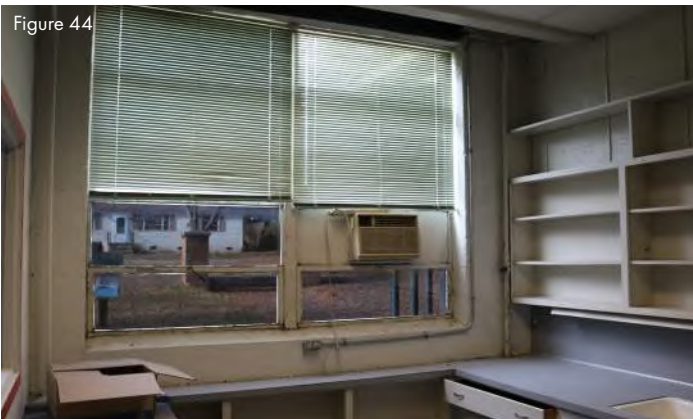
Figure 44

Window air conditioned not properly installed.

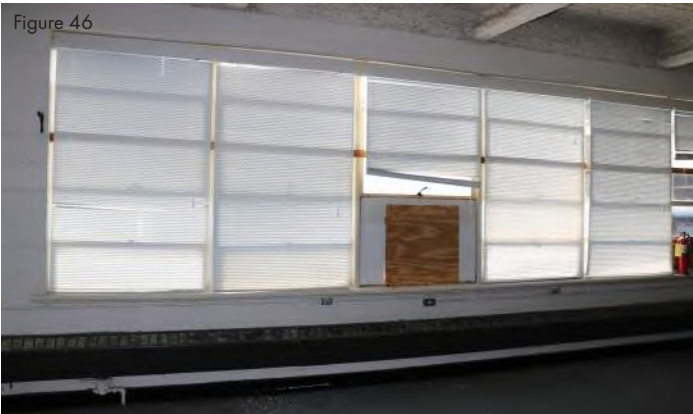
Figure 46

Classroom missing window air conditioner.

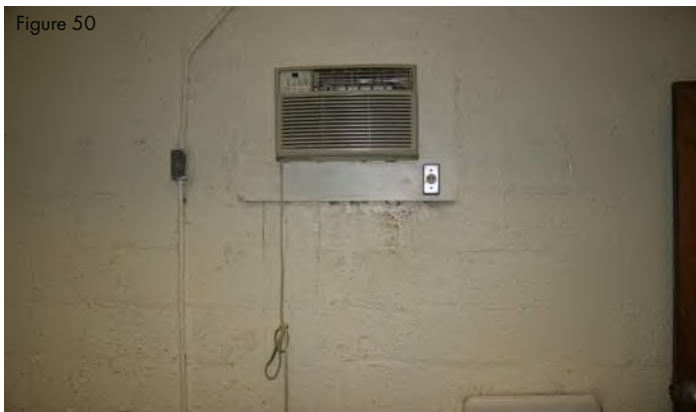
Figure 50

Thru wall air conditioner discharges into the boiler room. Unit should be removed.

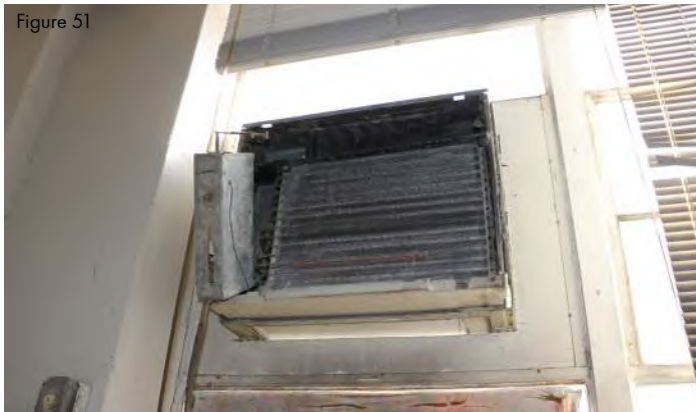
Figure 51

Thru wall air conditioner missing cover. Could not verify age or operation but equipment has exceeded its normal service life.

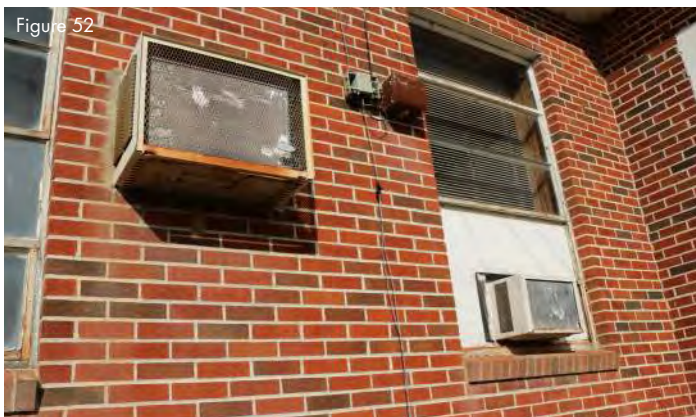
Figure 52

Thru wall air conditioner in bad condition. Could not verify age or operation but equipment has exceeded its normal service life.

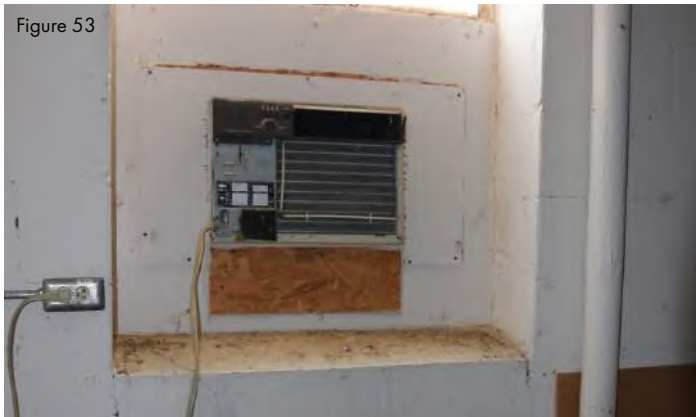
Figure 53

Description Thru wall air conditioner in bad condition. Could not verify age or operation but equipment has exceeded its normal service life.

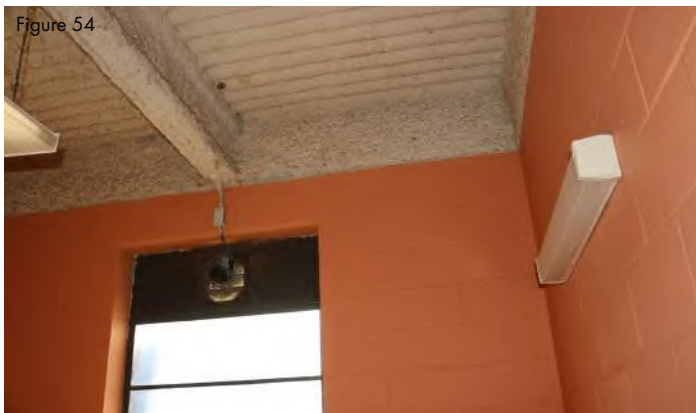
Figure 54

Women's toilet exhaust fan installed in window needs to be replaced.

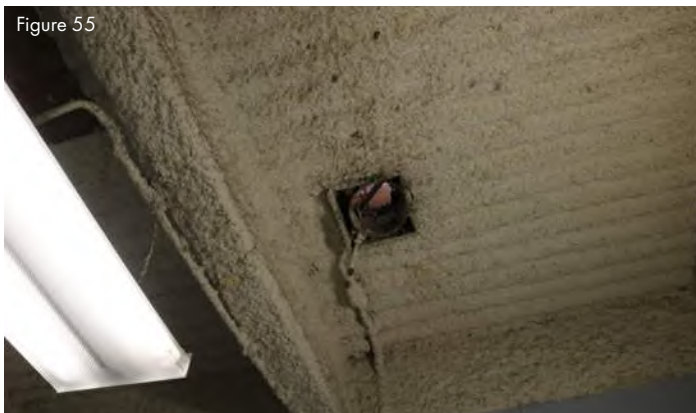
Figure 55

Men's toilet roof mounted exhaust fan needs to be replaced.

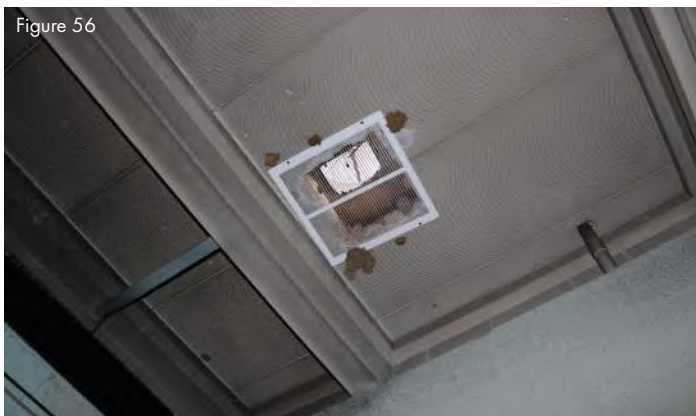
Figure 56

Ventilation/exhaust opening in classroom should be sealed up if not needed in the future.

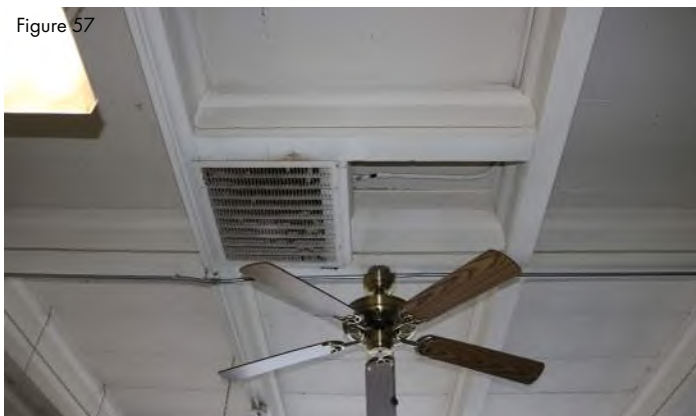
Figure 57

Exhaust fan and grille in classroom should be removed and sealed up if not needed in the future.

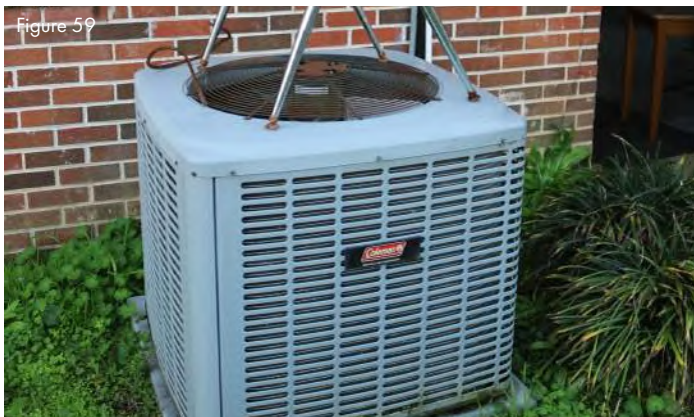
Figure 59

I.T. room heat pump. Could not verify age or operation but equipment has exceeded its normal service life.

The outdoor sections of the heat pumps are located on concrete pads at grade level. The unit cabinets are rusting. Most of the refrigerant piping insulation has deteriorated due to exposure to the elements. All outdoor units are at the end of their service life (Figure 59).

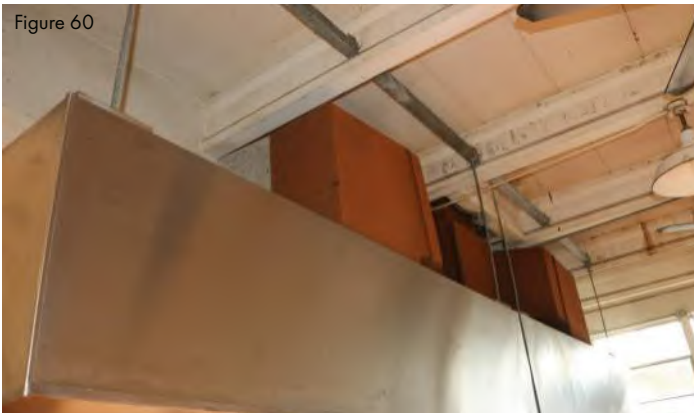
Figure 60

Kitchen good in good condition. Grease duct needs to be fire wrapped.

The kitchen hood is in fair condition. The grease exhaust duct is in good condition but is not fire wrapped (Figure 60). The make-up air duct is in good condition, but the make-up air system is not tempered (Figures 61-63). Both roof mounted fans are at the end of their service life.

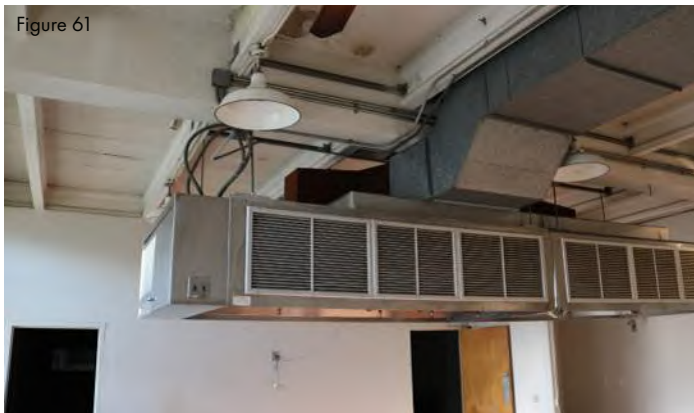
Figure 61

Kitchen hood make-up air sections in good condition.

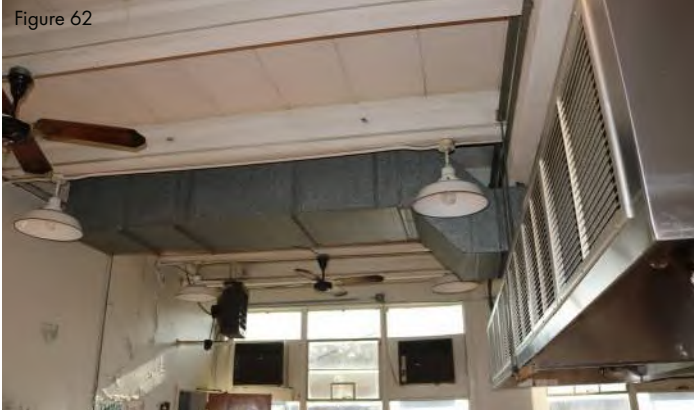
Figure 62

Make-up air duct in good condition.

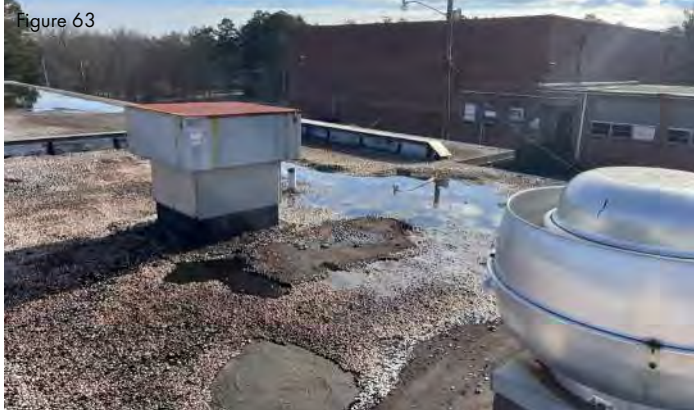
Figure 63

Kitchen hood exhaust and make-up air fans on roof are in fair condition.

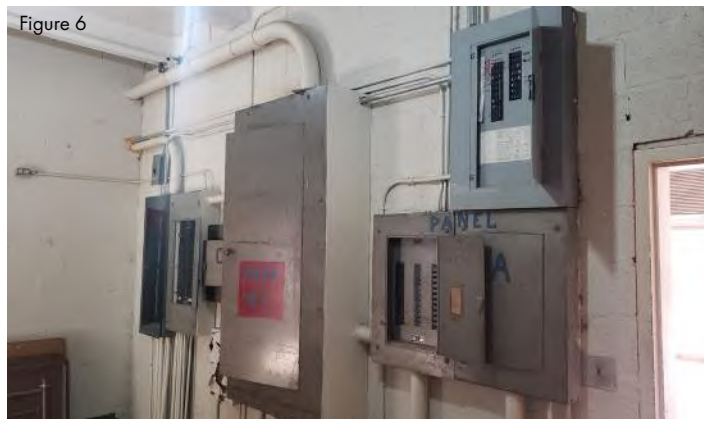
Figure 6

Main electrical room serving the original facility.

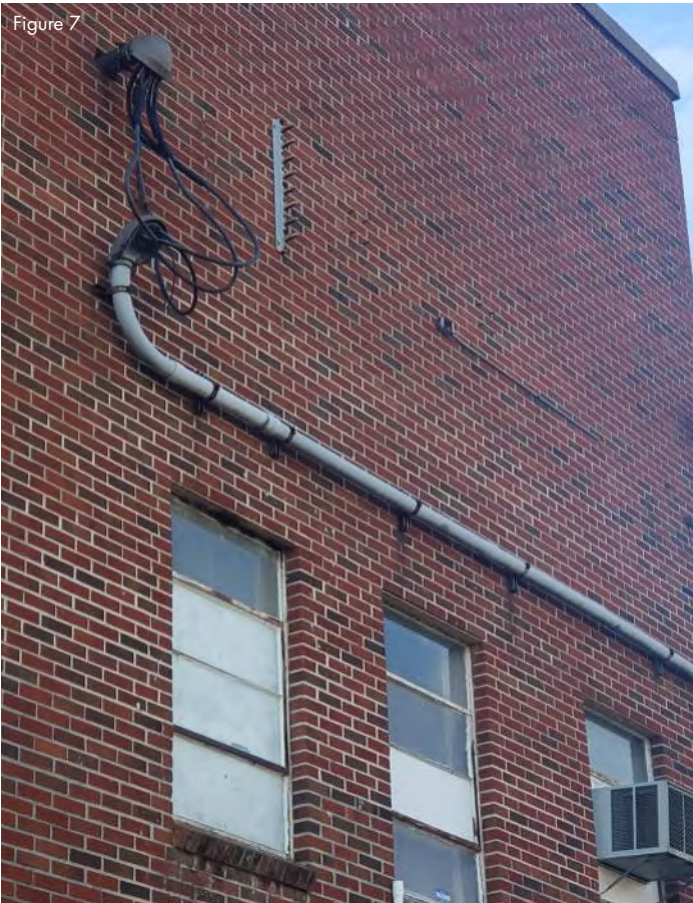
Figure 7

Electrical service serving the south wing is installed in an unconventional manner.

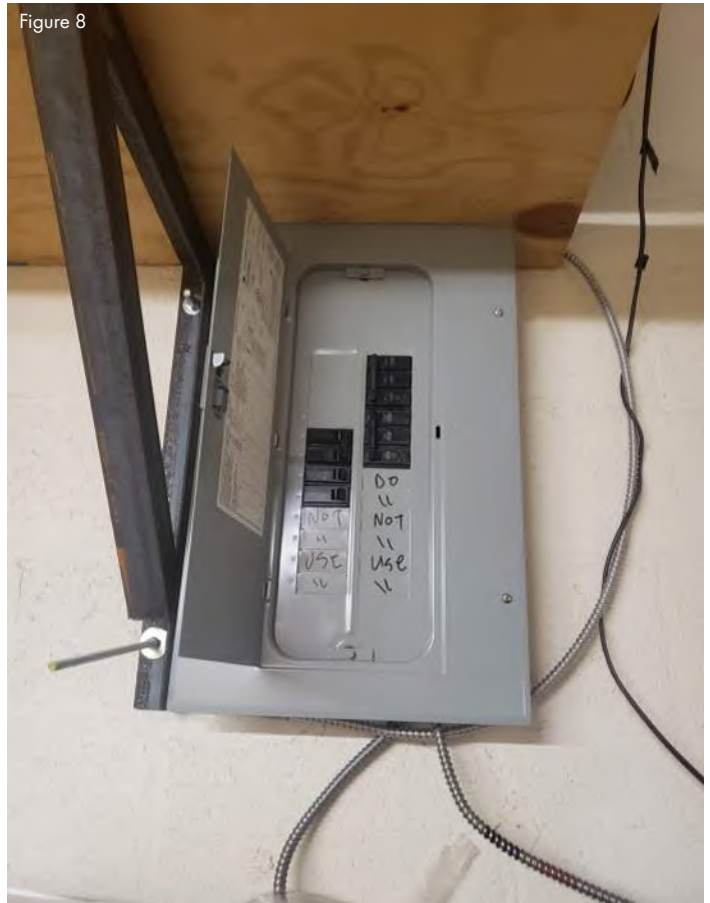
Figure 8

Electrical panel located directly under an air handling unit.

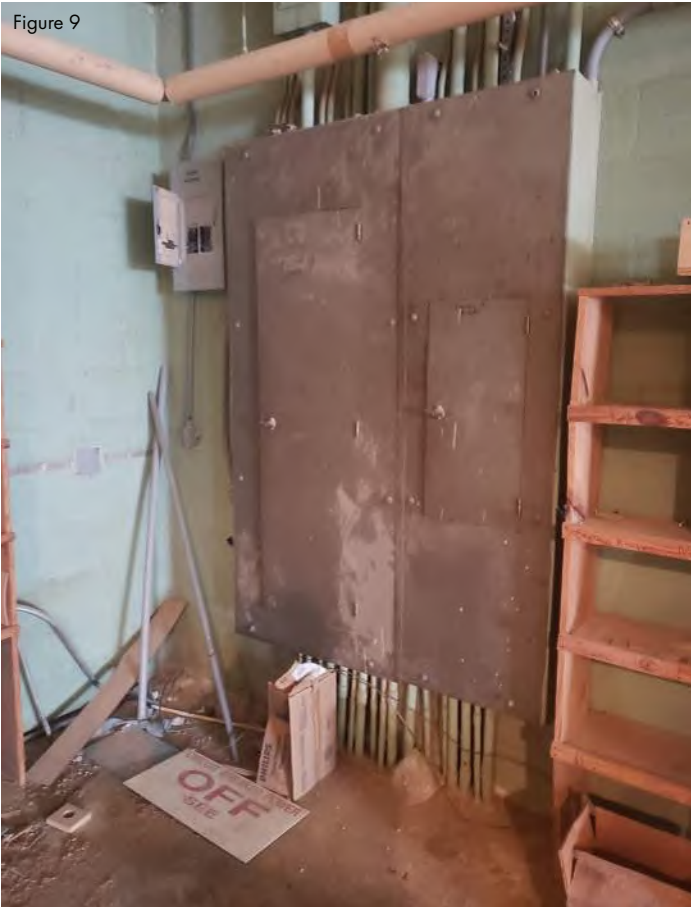
Figure 9

Gymnasium main and sub panel are at the end of their useful service life.

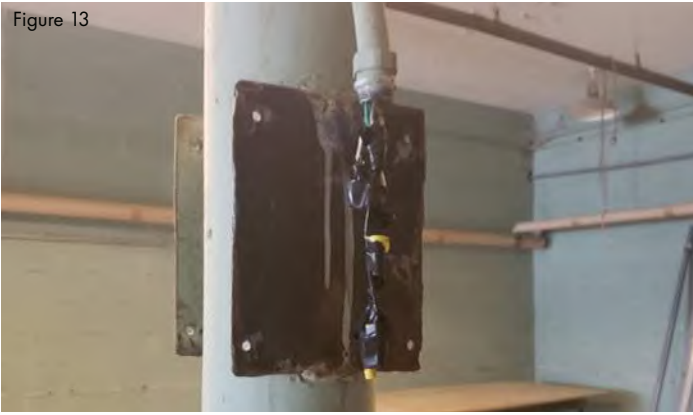
Figure 13

Several circuits throughout the facility have not been terminated properly.

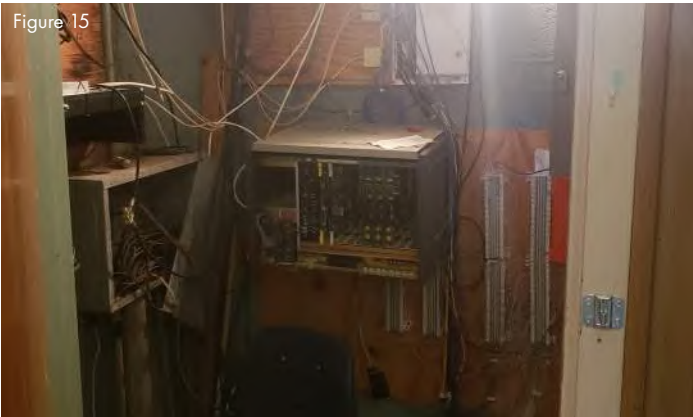
Figure 15

Telephone and IT room equipment is missing cover and not secured properly.

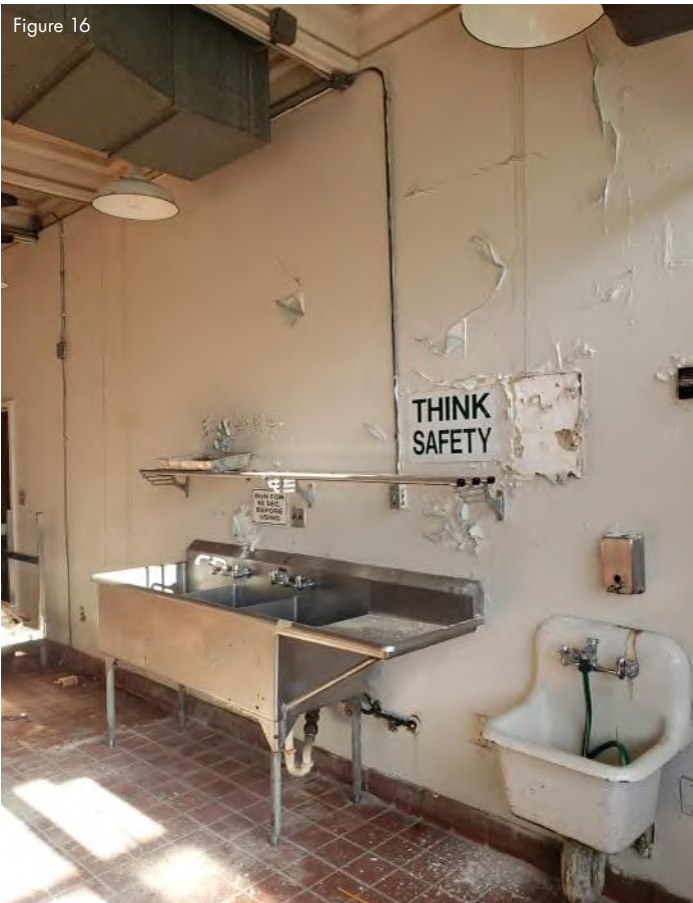
Figure 16

Light switches and receptacles located above and within 6' of plumbing fixtures are not ground fault interrupt protected as require by code.

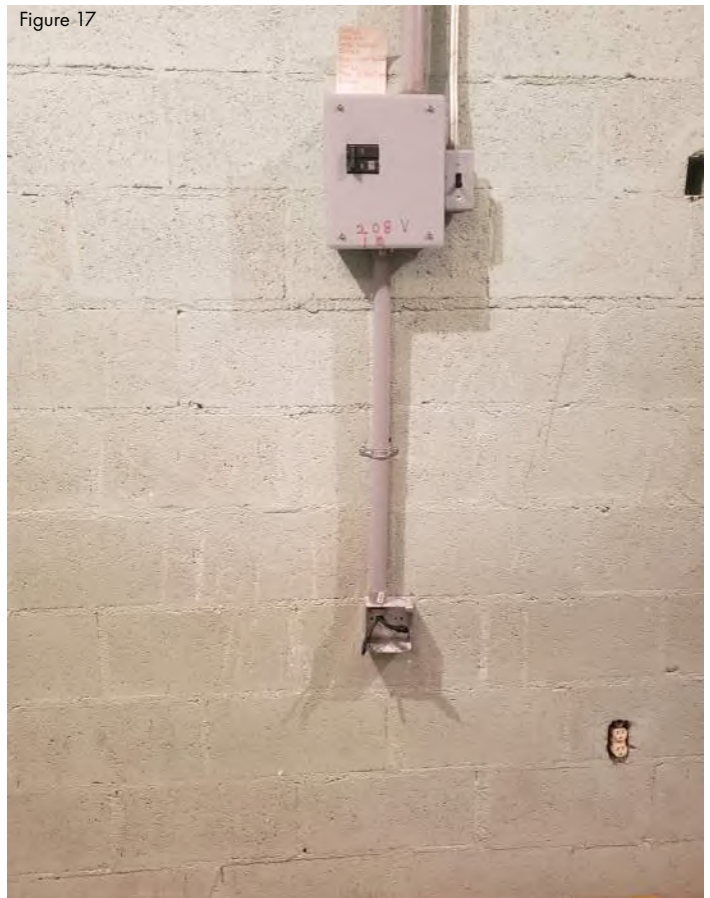
Figure 17

The kiln room circuit is not terminated properly.

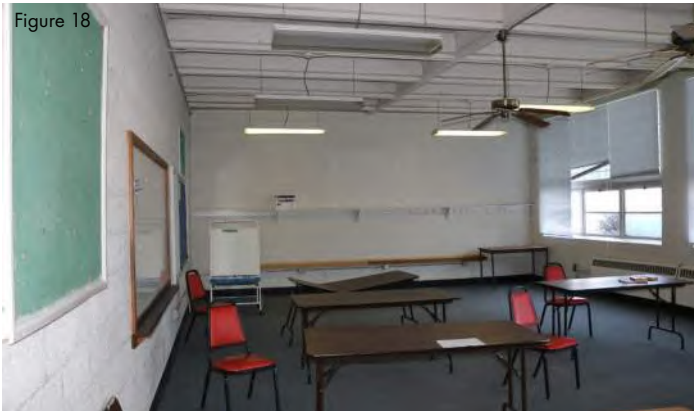
Typical Original Building Classroom Lighting. Several fixtures are not operating.

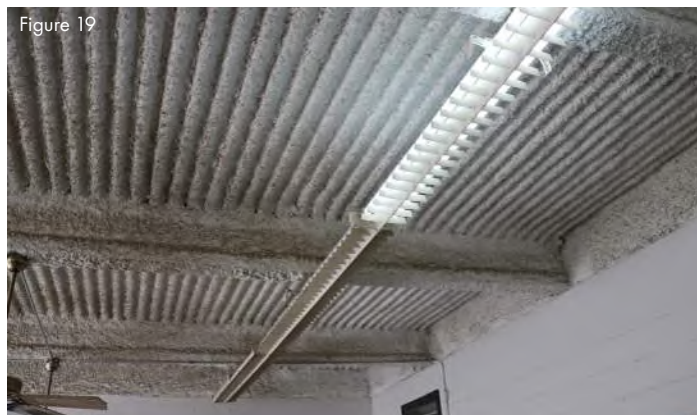
Typical Building Addition Classroom Lighting. Several fixtures are not operating.

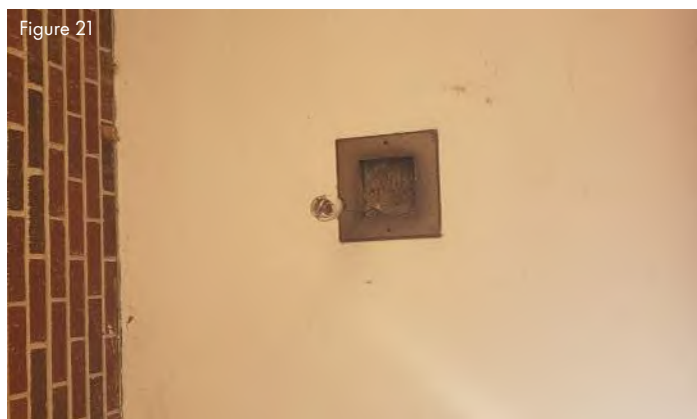
East exterior recessed light is damaged.

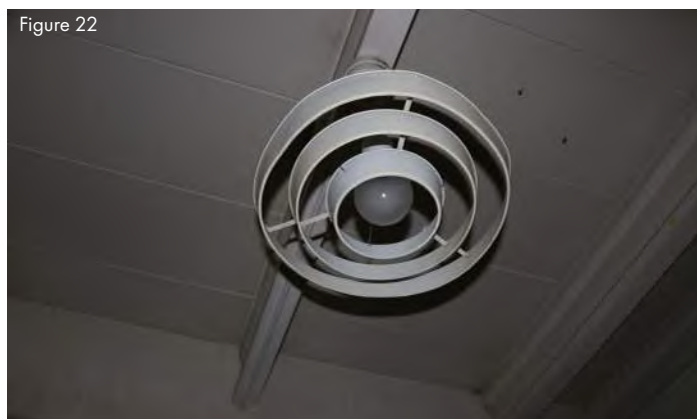
General deformed condition of Cafeteria lighting fixture.

their service life and should be replaced during future renovations.

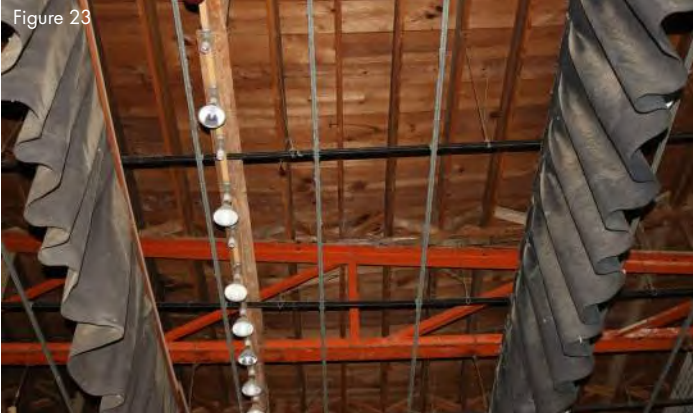
Figure 23

Stage Lighting. Several sockets do not have bulbs installed.

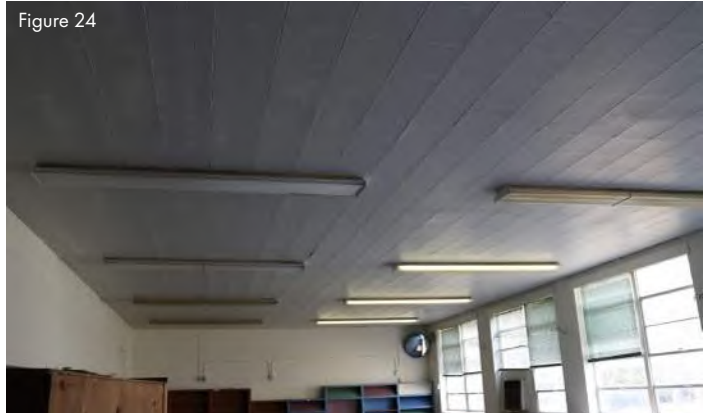
Figure 24

Library Lighting. Several fixtures are not operating.

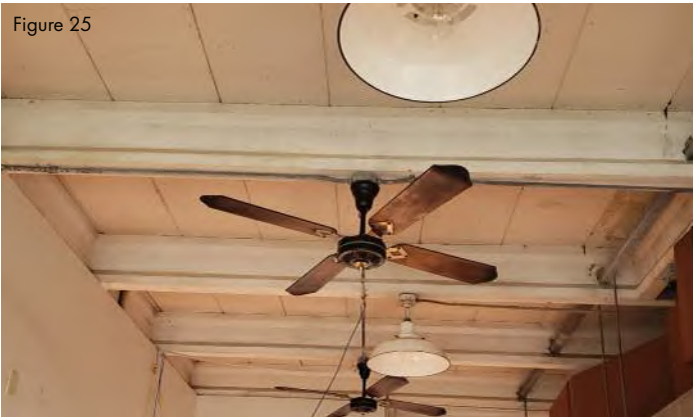
Figure 25

Light fixtures in the kitchen are not cleanable and don't meet current SCDHEC standards.

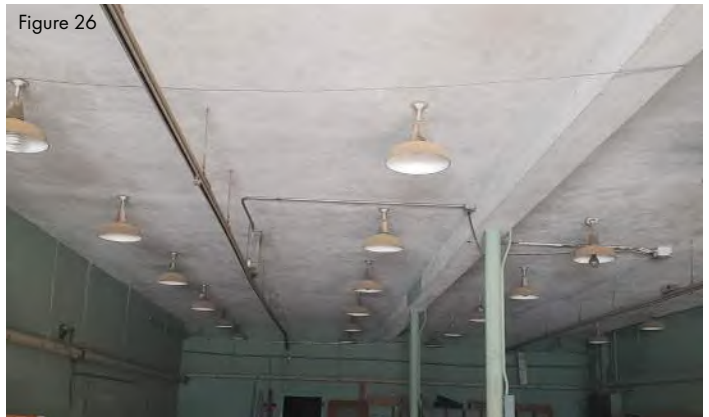
Figure 26

Lower-level Gymnasium building lighting. Several of the light fixtures are operating.

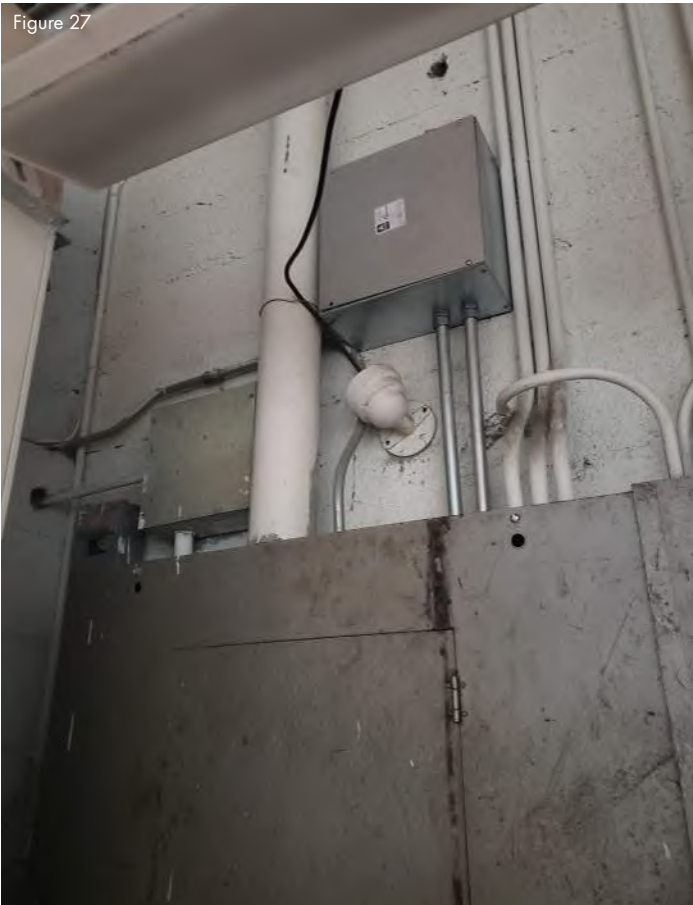
Figure 27

Light fixture was reworked in an unconventional manner to provide power to a light strip.

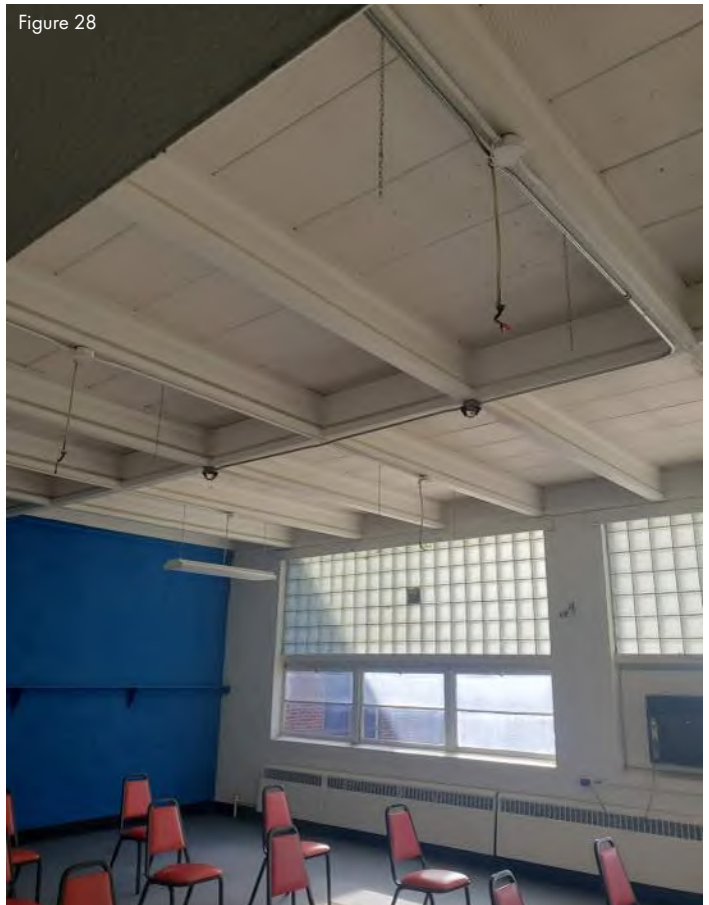
Figure 28

Typical lighting and ceiling fan circuitry not terminated properly.

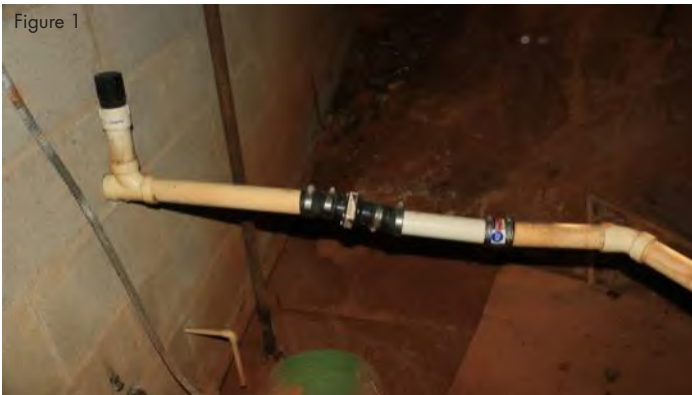
Waste piping from lower-level classroom sink needs to be replaced.

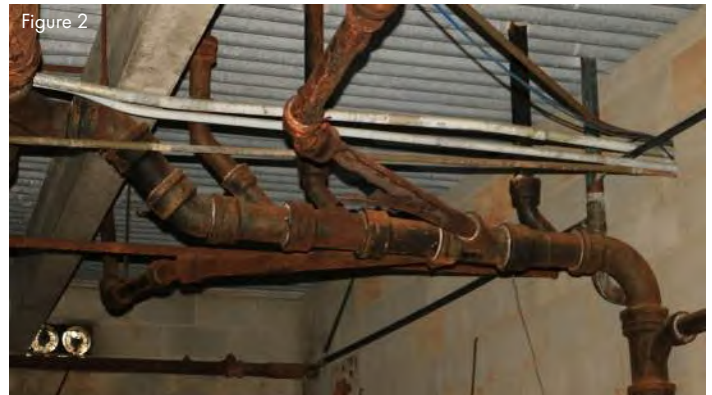
Cast iron pipe under expansion gang toilets needs to be replaced.

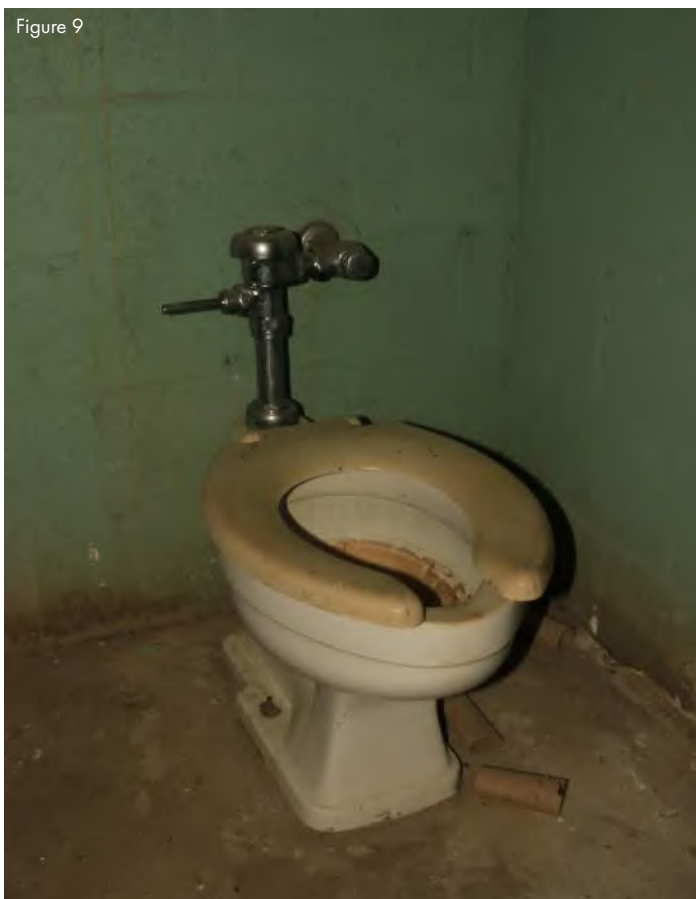
All toilet plumbing fixtures were not in working order and some may not meet ADA requirements. The existing toilets (Figures 3-11) are flush valve type and the urinals are also flush valve type (Figures 12-14). All lavatories are wall hung type with chrome faucets (Figures 15-23). Most of the fixtures are stained and the flush valves are pitted (Figure 24). Wall hung sinks P-trap are rusting through and most sinks do not have hot water piped to them (Figure 25). All plumbing fixtures are at the end of their

Typical lower-level toilet conditions.

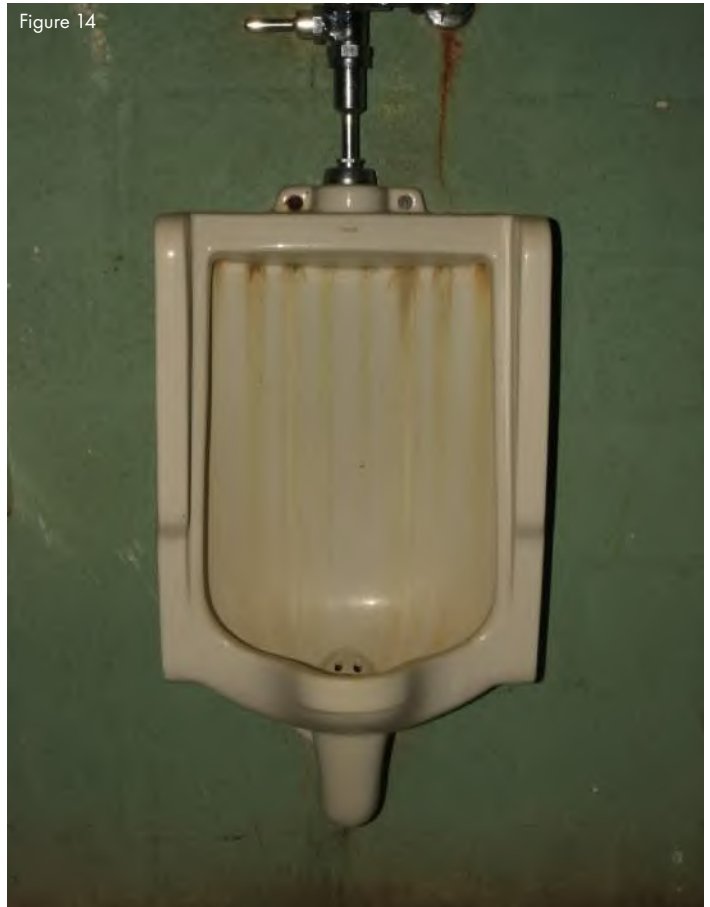
Figure 16

Typical lower-level urinal conditions.

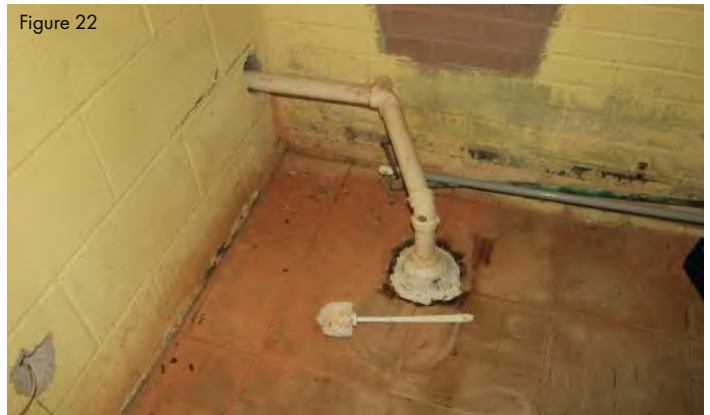
Figure 22

Lower level classroom wing bathroom – sink waste piped to removed toilet flange.

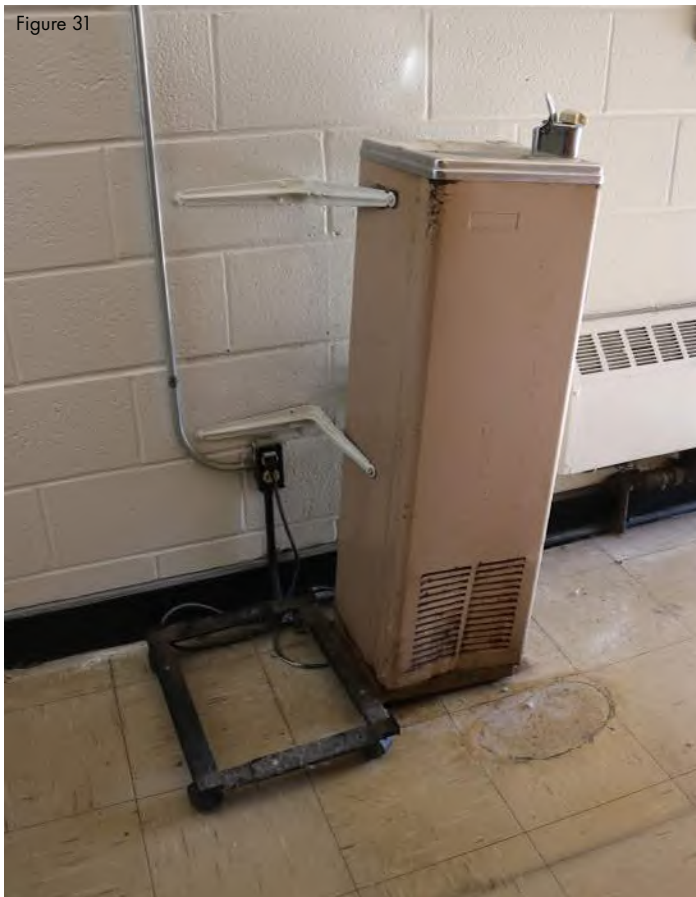
Figure 31

Water cooler not installed properly.

The existing water coolers are all single units (Figures 31-35). All are in fair condition. All existing drinking fountains/water coolers should be replaced with a dual water coolers that are ADA compliant.

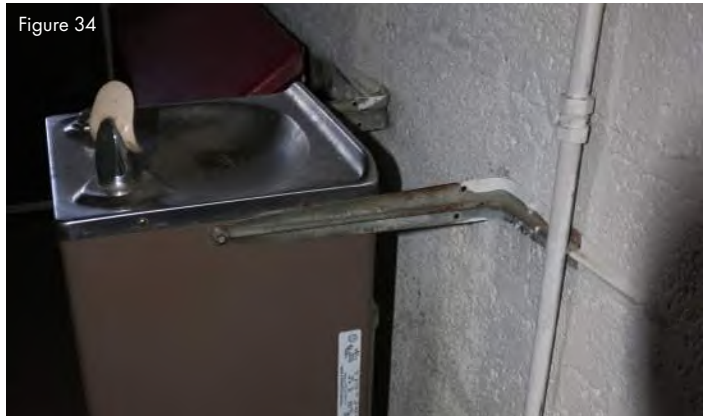
Figure 34

Water cooler at Gym not properly installed.

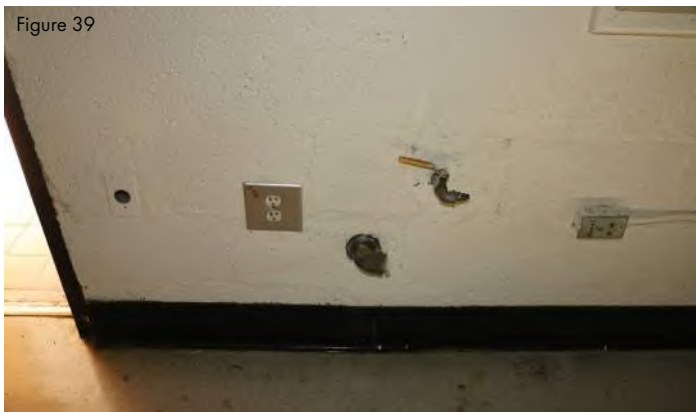
Figure 39

The three compartment sink in the kitchen is in fair condition as well as the service sink (Figures 36-39).

Abandoned plumbing needs to be terminated properly throughout the facility.

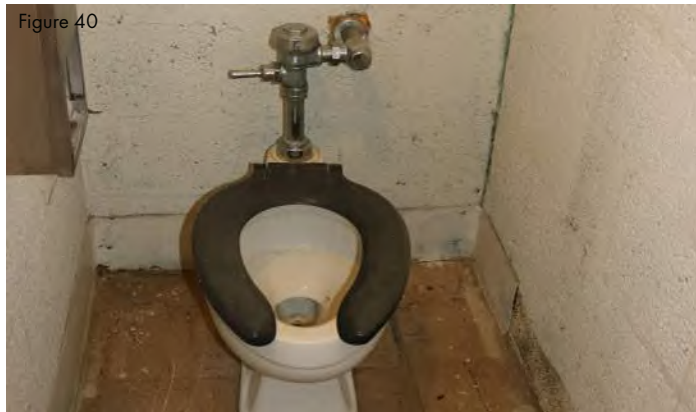
Figure 40

Toilet room off the kitchen has a wall mounted lavatory and a flush valve toilet that are both in fair condition (Figure 40). These plumbing fixtures are at the end of their service life and should be replaced.

Kitchen flush valve toilet

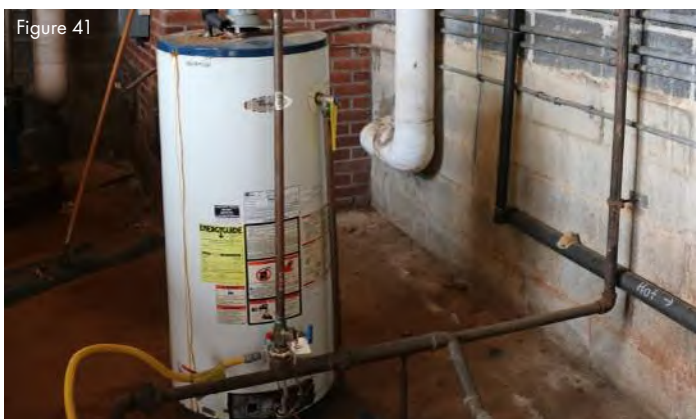
Figure 41

The main water heater, approximately 16 years old shows signs of corrosion and water leakage (Figure 41). The water heater P&T is not piped to the exterior. The water heater does not have an expansion tank, seismic restraints, vacuum breaker, or heat trap nipples. These safety components should be installed during water heater replacement to extend the service life and to conserve energy. The first 8 feet of hot water piping should be insulated with 1" thick fiberglass insulation. If a new gas water heater is installed it is recommended that the chimney be inspected. There were several small under the counter type water heater in the facility that could not be identified, or age confirmed. All water heaters are at the end of their service life and should be replaced.

16-year-old gas water heater

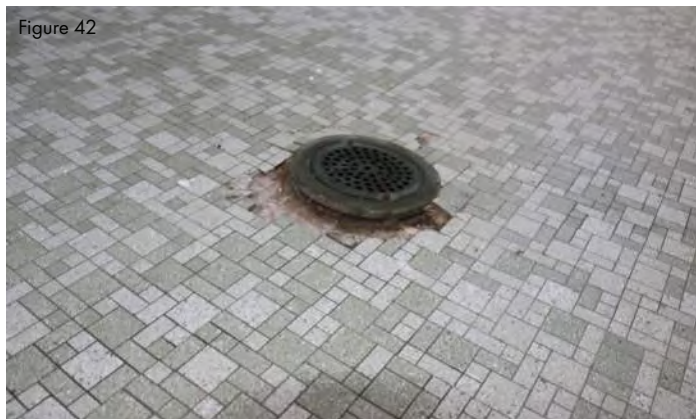
Figure 42

There are several locations where the floor drains are not flush with the floor creating trip hazards (Figures 42-43). Most floor drains are filled with sediment and trash and need to be cleaned out (Figures 44-45).

Men's gang toilet #2 – Raised floor drain causing trip hazard.

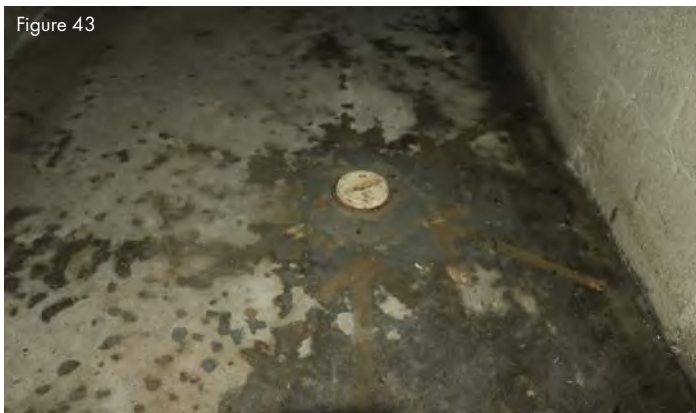
Figure 43

Gym lower-level back hallway – Raised floor drain causing trip hazard.

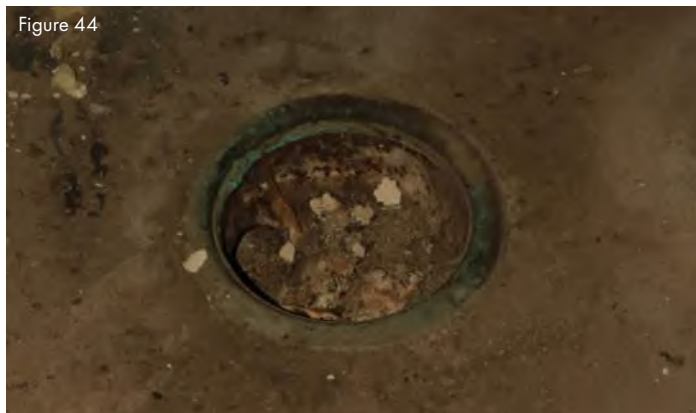
Figure 44

Floor drain in shower room is clogged.

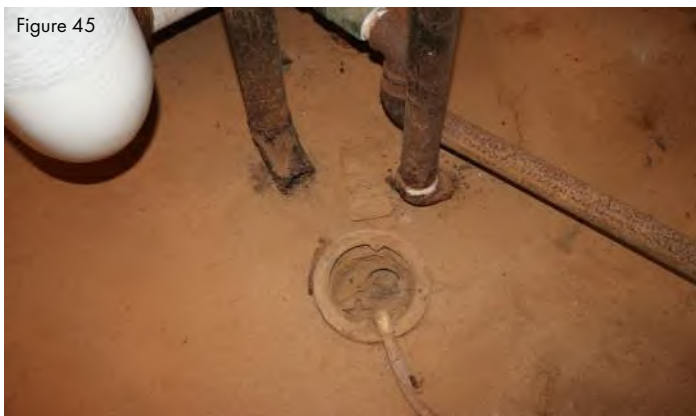
Figure 45

Boiler Room Floor drain is clogged.

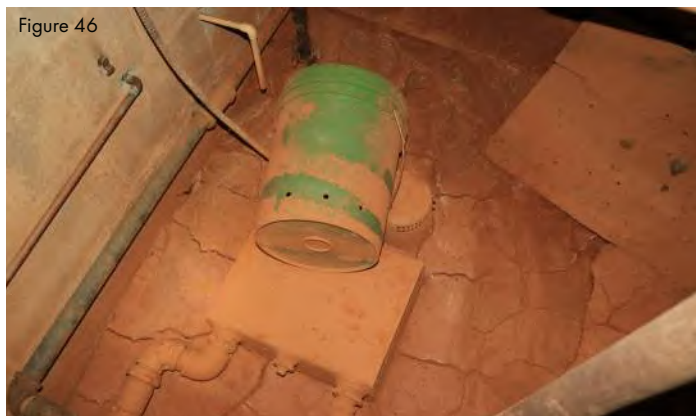
Figure 46

The crawl spaces on either side of the boiler room have standing water (Figure 46). Removal of standing water needs to be addressed.

Sump pump needs to be replaced.
