REPORT OF PHASE I ENVIRONMENTAL SITE ASSESSMENT

**FORMER GALLMAN SCHOOL
NEWBERRY, SOUTH CAROLINA**

JANUARY 4, 2024

**GALLMAN SCHOOL
BUILDING CONDITION ASSESSMENT**

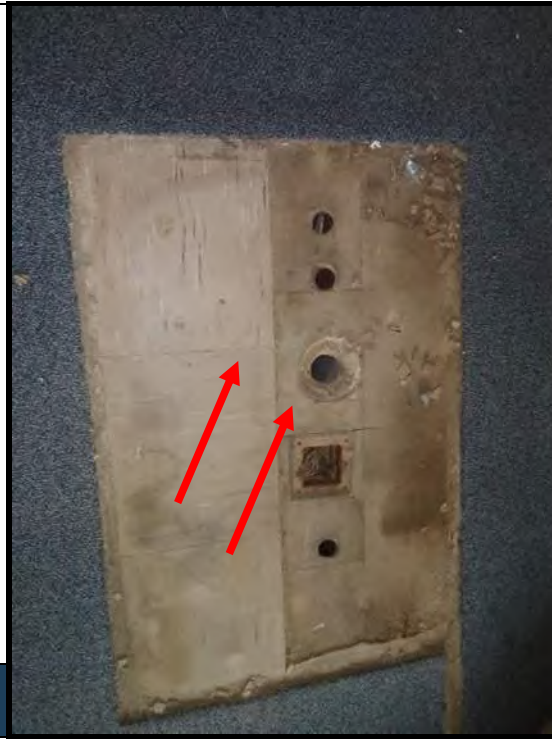
3 12-inch dark tan vinyl floor tile and black mastic and 9-inch brown vinyl floor tile and mastic tested positive for asbestos (3%-6% chrysotile).

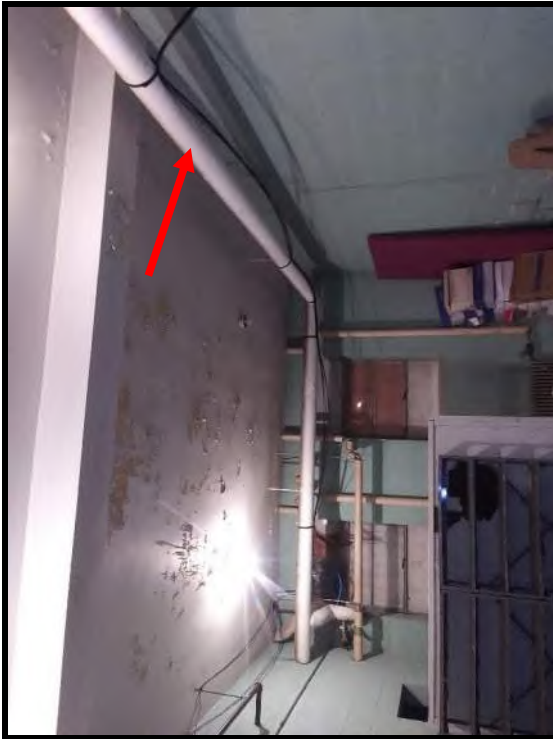
5 TSI tested positive for asbestos (15% amosite and 3% chrysotile).

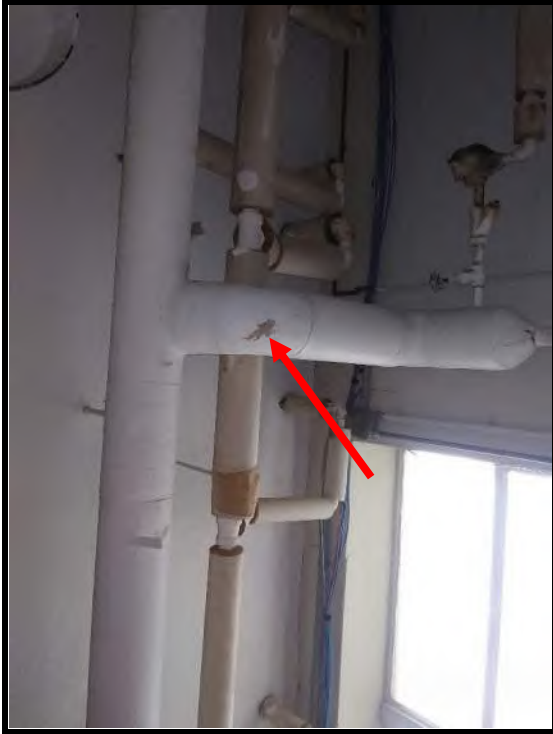
6 Hard joint tested positive for asbestos (65% chrysotile).

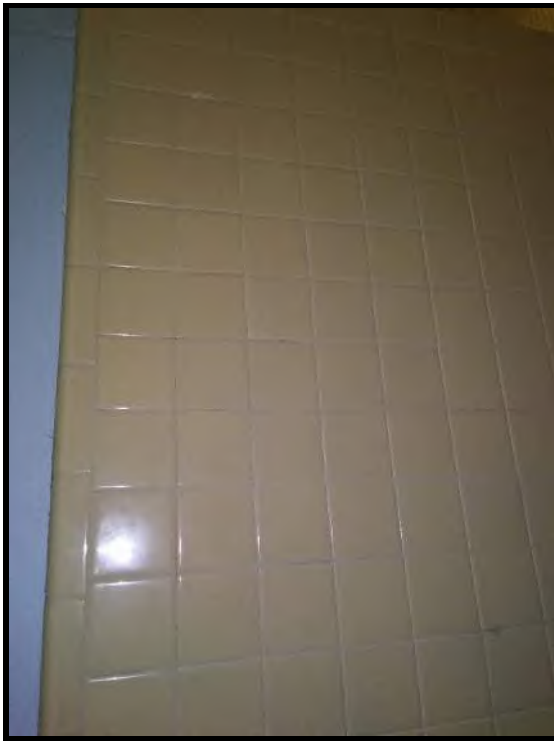
9 Yellow ceramic tile in men's restroom tested positive for lead-based paint (**7.70 mg/cm²**).

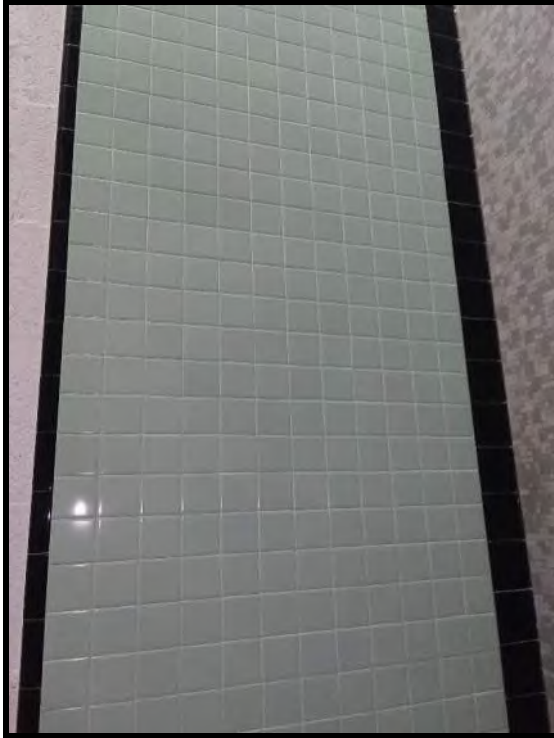
10 Green and black ceramic tile in men's restroom tested positive for lead based paint (**5.40-19.90 mg/cm²**).

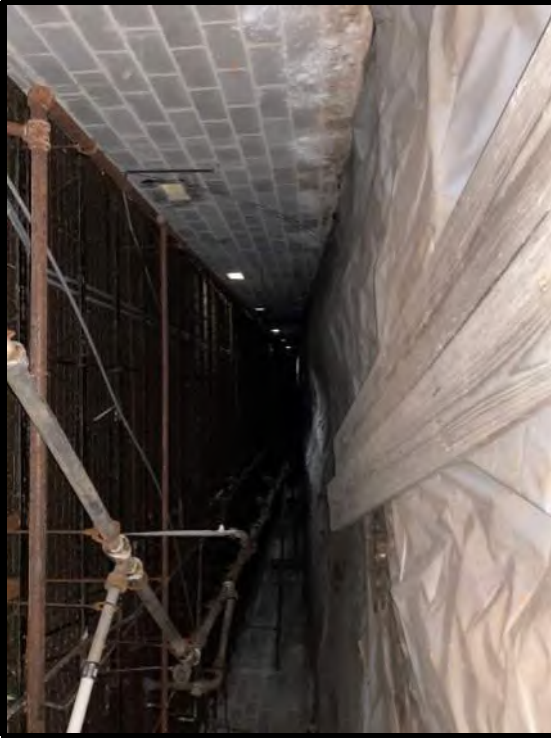
12 General view of crawlspace.

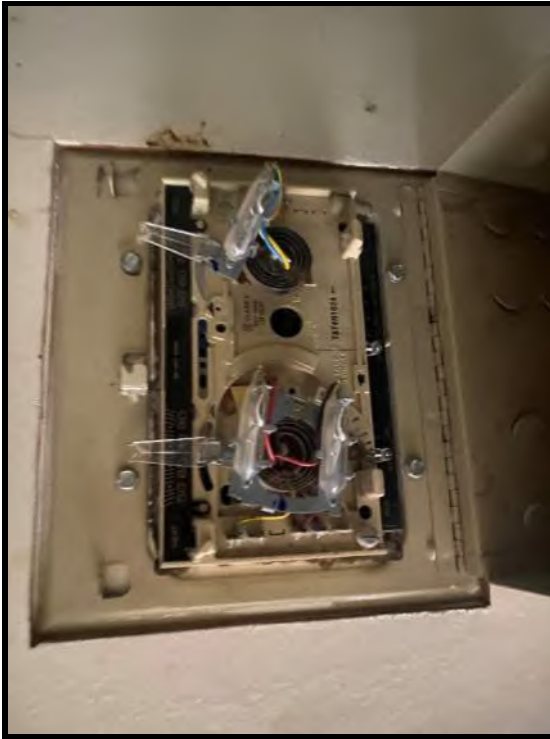
13 Mercury thermostat in the cafeteria.

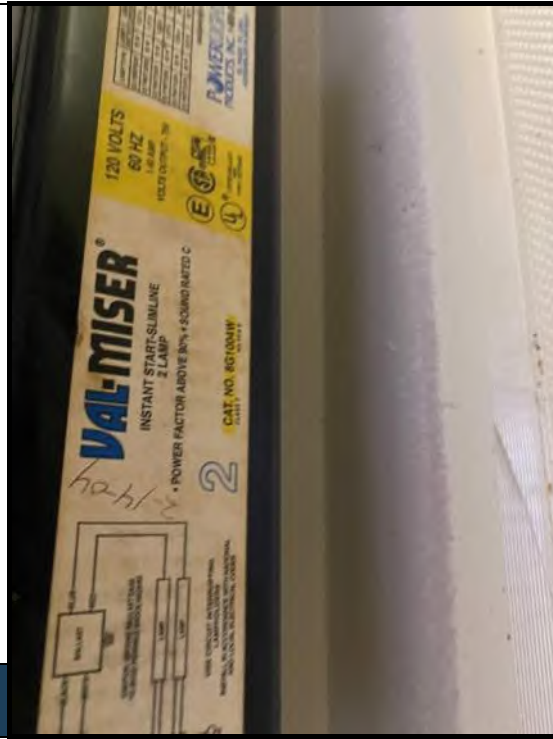
15 Ballast presumed to contain PCBs.

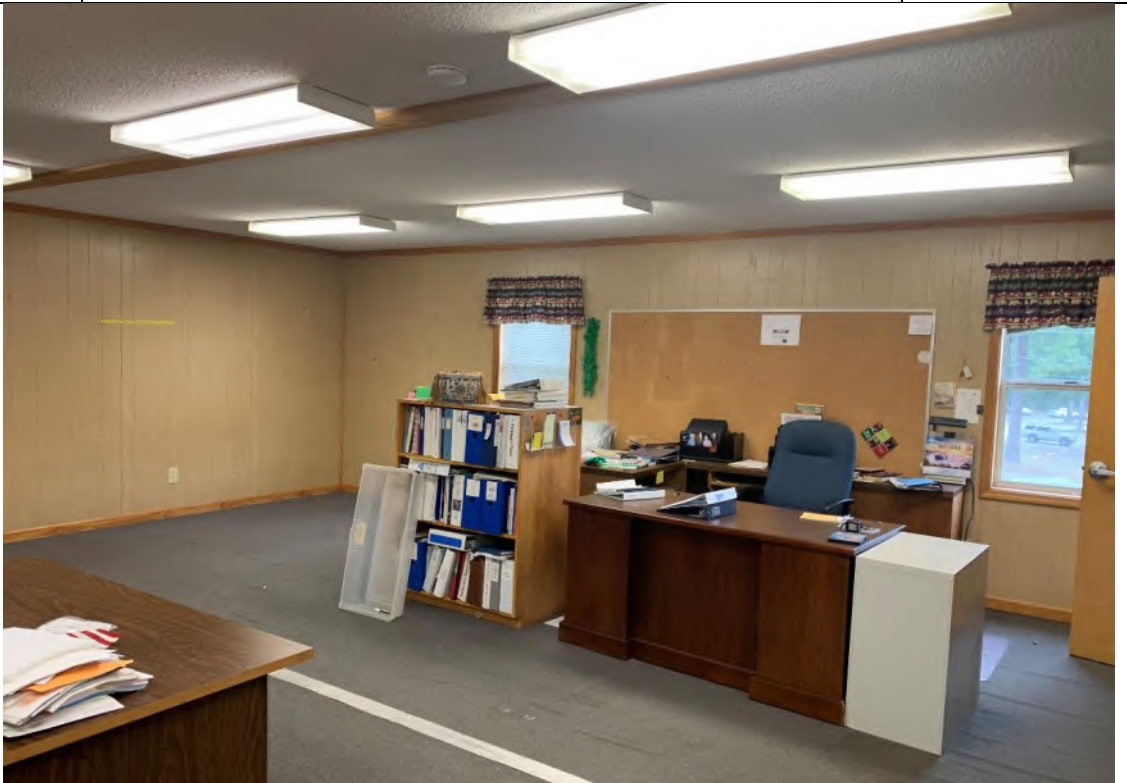
Client Name: City of Newberry		Site Location: 540 Brantley Street, Newberry, SC	Project No. 00.5633.16
Photo No. 25	Date: 10/16/23

SynTerra observed the interior of the trailers. The trailers are of wood frame construction. The trailer closest to the school contained a small office space (Photograph No. 25). The trailer furthest from the school was filled with spare desks and office cubicles (Photograph No. 26). Both trailers contained restrooms and were connected to the sanitary sewer.

Direction of Photo: Interior			
Description: Interior of trailer closest to the school containing a small office space

Photo No. 26	Date: 10/16/23	 
Direction of Photo: Interior		
Description: Trailer furthest from the school containing spare desks and cubicles

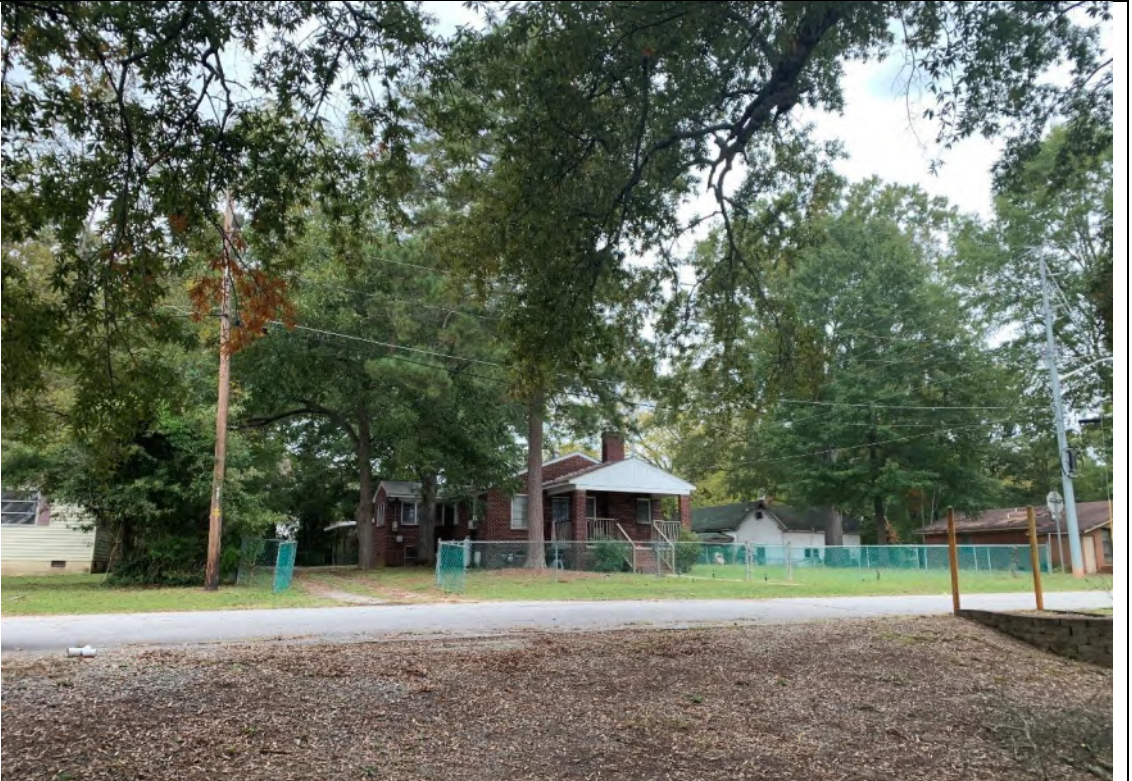
Client Name: City of Newberry		Site Location: 540 Brantley Street, Newberry, SC	Project No. 00.5633.16
Photo No. 27	Date: 10/16/23

Direction of Photo: North			
Description: Brantley Street across which is single family residences that adjoin the subject property to the north

Photo No. 28	Date: 10/16/23	 
Direction of Photo: Southeast		
Description: McSwain Street followed by single-family residence adjoining the subject property to the east

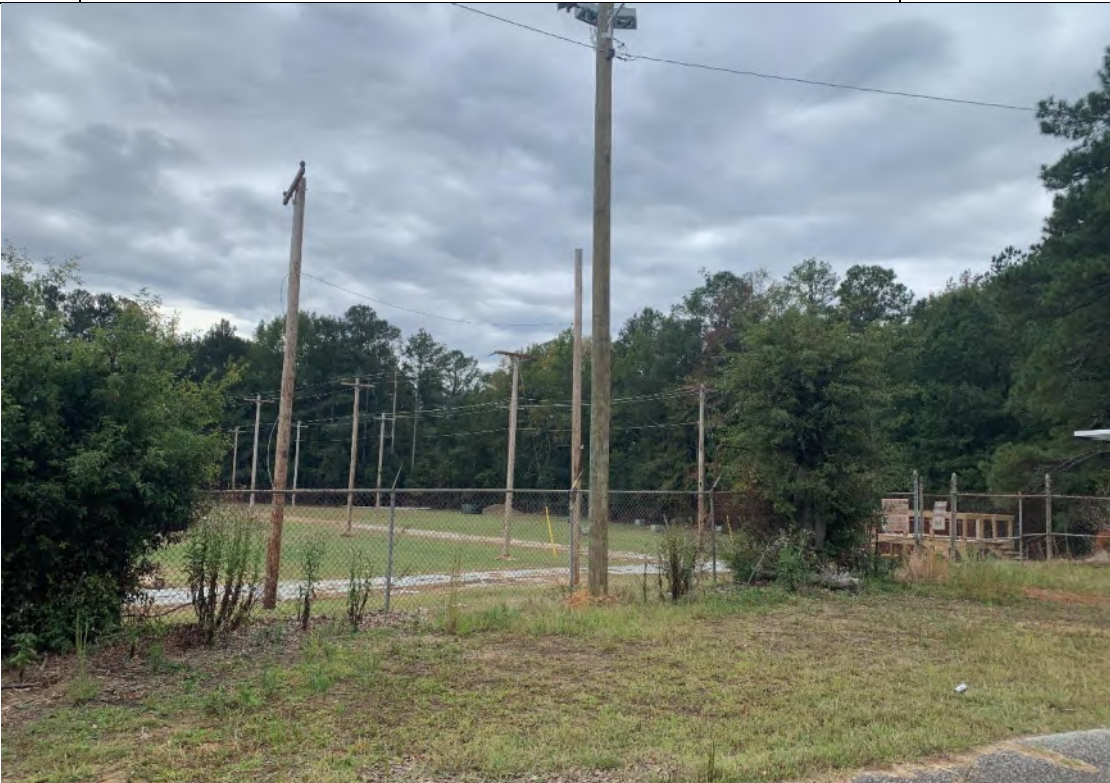
Client Name: City of Newberry		Site Location: 540 Brantley Street, Newberry, SC	Project No. 00.5633.16
Photo No. 29	Date: 10/16/23

Direction of Photo: South			
Description: McSwain Street across which is the Municipal Training Center that adjoins the subject property to the south

Photo No. 30	Date: 10/16/23	 
Direction of Photo: West		
Description: McSwain Street across which is wooded land which adjoins the subject property to the west
